AIRCRAFT ACCIDENT REPORT (Ref. N0 1/2017)

Report on the Accident of Aircraft Reg. No. 9H-SEP. *Crash Landing.*

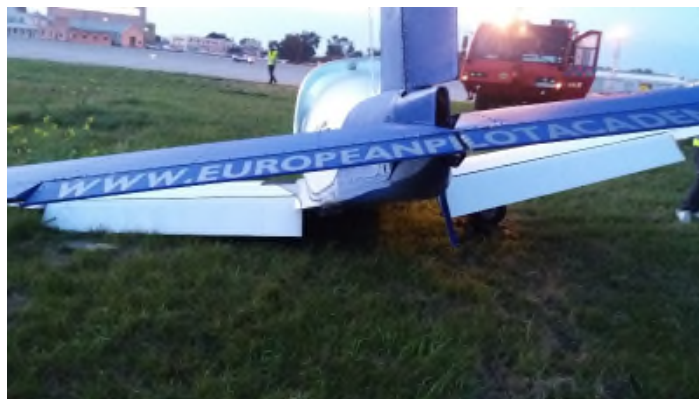
Fig 1

A two-seater single engine aircraft of the type P2002JF-TECNAM (*Reg. No. 9H-SEP*) crashed while landing on RWY 23. The aircraft impacted the runway on the threshold and skidded for approximately 60 meters to the left and finally came to rest on the grass between TWY Juliet and the TWY Zulu about 5 meters from the TWY Juliet and RWY23. (*Abeam TWY Juliet*)

There was no noticeable damage to the RWY, RWY lights, vehicles or any structure at the Airport. No fatalities or injuries were reported but the damage to the aircraft was significant.

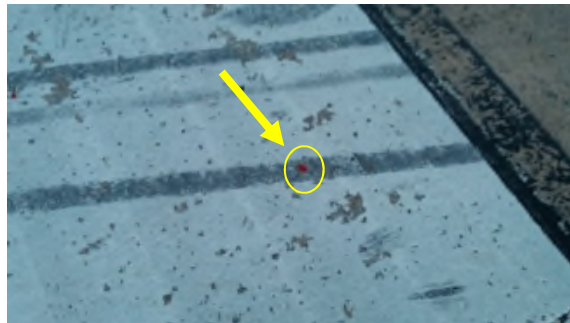
Fig2

- (1.1) The investigation started by surveying the area and the aircraft wreck; including skid marks and fragments of the aircraft which might have detached from the aircraft on impact with the RWY. It was determined that the Aircraft came in touch with the RWY in the mid-section of the painted area (*threshold markings*) of the RWY threshold.

The arrow indicates a piece of glass from the right wingtip lights on the RWY threshold.

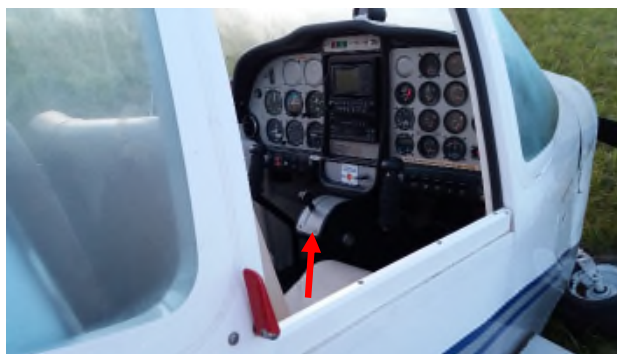
Fig3

- (1.2) The pilot and his passenger were still visibly under shock but had sustained no physical injuries. In a preliminary interview at the site of the accident the pilot said that he lost control of the aircraft while trying to perform a *go-around*. This was confirmed by his passenger who is also a licensed pilot but was not involved or responsible for flying the aircraft.
- (1.3) When asked if the *go-around* was a planned manoeuvre, the pilot answered that the reason for the “*go-around*” was to avoid a flock of birds that were flying towards the aircraft from left to right. The pilot determined that the only way to avoid this apparent danger was to discontinue the landing manoeuvre by applying full thrust to initiate a “*go-around*”. An inspection of the flight-deck revealed that the throttle was slightly below the halfway mark which is not consistent with the full-thrust position.

(2.10) As stated in paragraph 1.3 Fig 3, the throttle position was found just under the halfway mark, meaning that the thrust selected was not consistent with either the "go-around" position (full thrust) or the landing position (idle thrust).

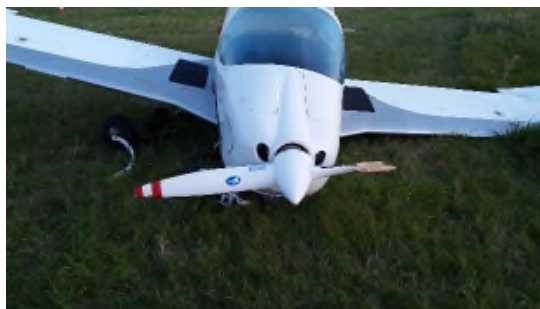
Fig4

- (1.4) The aircraft was inspected on-site to determine the extent of the damage sustained as a result of the accident and to gather other evidence which could assist the BAAI in its investigation. It was immediately clear that the aircraft could not move under its own power, therefore in accordance with SL 499.22, the Aircraft Operator was requested to provide assistance for the removal of the wreck.

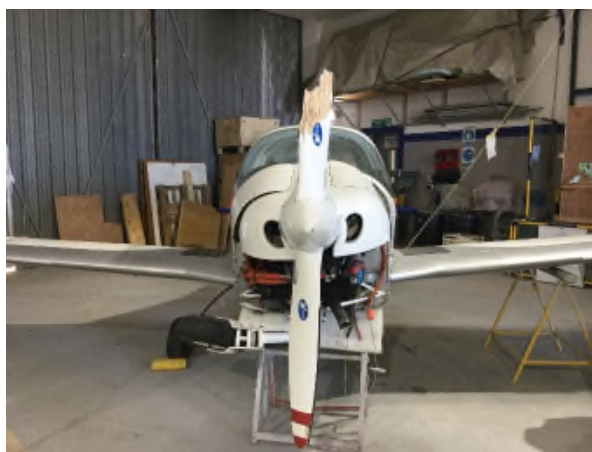
Fig5.

- (1.5) After the initial (on-site) inspection, the Aircraft Wreck was thoroughly inspected in the hanger where it was stored for repair. The investigation revealed that at the time of the accident, the aircraft was technically safe and that no part of the aircraft fuselage/control surfaces or any of its electronic or pneumatically operated instruments contributed to the accident. All aircraft documentation, permits and licenses were found to be correct and current.

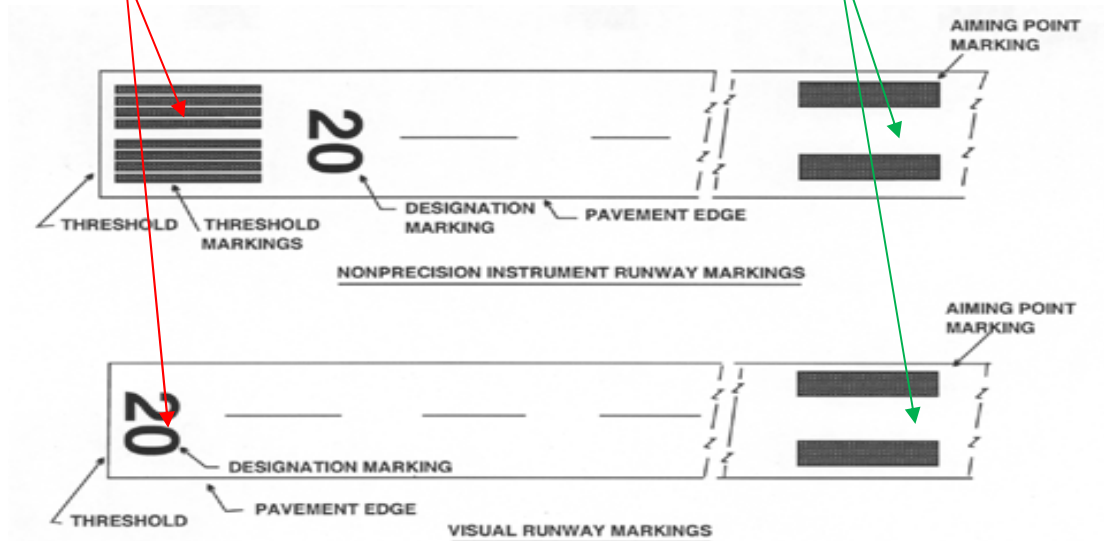
Fig6

- (2.4) The PIC stated that he started the approach by intercepting the “papiés” at the correct height and distance from the RWY. After that, the approach was continued by aiming for the “threshold” rather than the correct aiming point on the RWY.
Note. The aircraft was correctly configured for landing during the approach.

Actual Aiming point

Correct Aiming Point

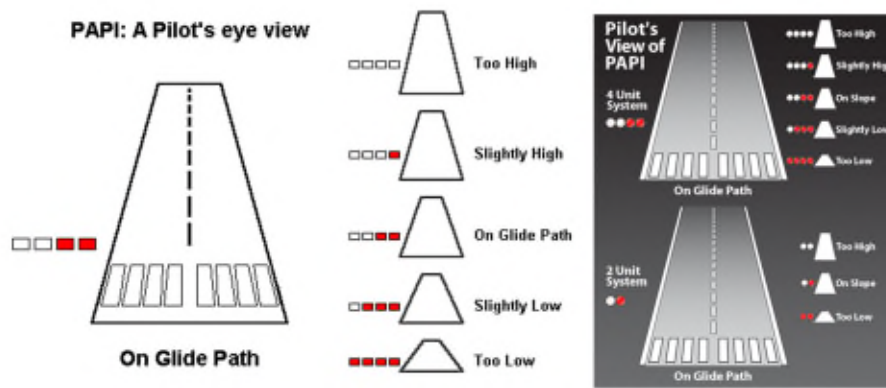
Fig7

The decision to aim for the threshold rather than the correct aiming point on the RWY resulted in the following:

- The rest of the approach was flown below the glide slope thus increasing the rate of decent which would have required a reduction in power to maintain the correct approach speed.
- The established VFR procedure was not being followed thus considerably reducing safety for the persons on board the aircraft as well as third persons living beneath the “glide-path” (glide-slope), motorists and pedestrians using the adjacent road.

- Putting in danger other aircrafts and airport vehicles that could have been standing-by on TWY Juliet.

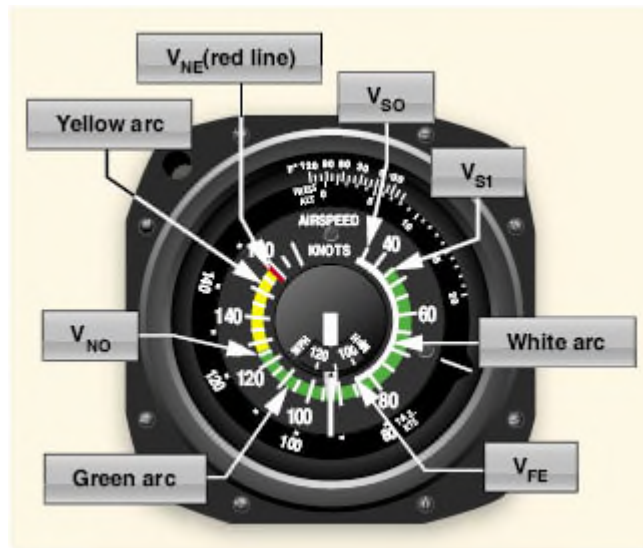
Fig9

- (2.5) Misconceptions of what is, and how to fly a short field approach and landing, led the PIC to believe that it is acceptable to fly the approach below the correct approach speed.
- (2.6) The PIC acknowledged that he ignored the “*stall warning*” because someone told him that the operator has increased the stall warning by about 10KTS. The operator was questioned about this and said that in an effort to increase safety, the school decided to increase the speed at which the stall warning sounded in the flight deck. He said that the speed was increased by about 4KTS which is 6KTS less than what the PIC was told. This precaution should have indeed increased safety as it would give the pilot advanced warning of an impending stall.
- (2.7) The fact that on this day, the pilot deliberately ignored the stall warning is both curious and disturbing. To add to this, the PIC also ignored other

information which was available to him in the flight deck. *The Airspeed Indicator* provides visual information to the pilot that a stall is imminent and therefore could be used to compare the validity of an audio warning.

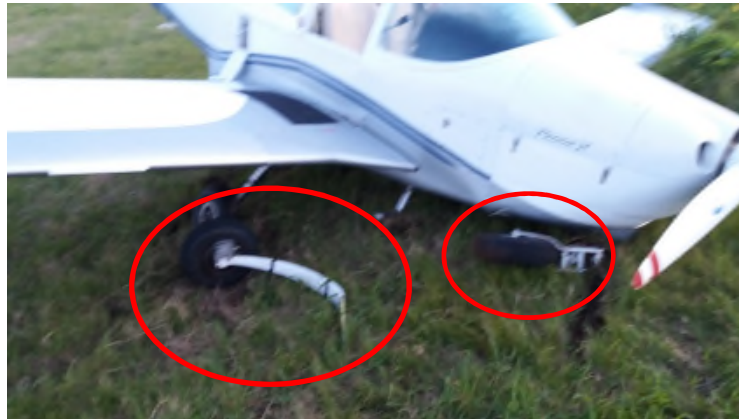
Fig.10

(2.8) CCTV footage provided by MATS, shows the aircraft approaching the RWY at a steeper than the normal angle for landing. Just before stalling, the nose was slightly drawn up, the aircraft turned to the right by approximately 60-80 degrees as it fell roughly 30ft to the ground; violently hitting the nose and right wing, turned and continued to slide off the RWY. The impact broke the propeller (*fig. 4 and 5*), folded the nose-gear up against the skin of the aircraft, whereas the left main landing assembly detached completely from the aircraft. The Engine cowling and the right wing suffered severe damage while there was also some damage along the left wing and elevator assembly.
