A safety investigation report into the loss of separation between 9H-IAN and 9H-EFA

Accident Number: BAAI/SIR-001-2021	
Defining Event: Loss of separation in flight	
Location: Malta International Airport	
Date & Time: 18 th December 2020, approximately 09:40 am (Local)	
Aircraft 1: Tecnam P2002 JF Sierra	Aircraft 2: Piper PA-28-161
Registration Aircraft 1: 9H-IAN	Registration Aircraft 2: 9H-EFA
Aircraft Damage: None	
Injuries: None

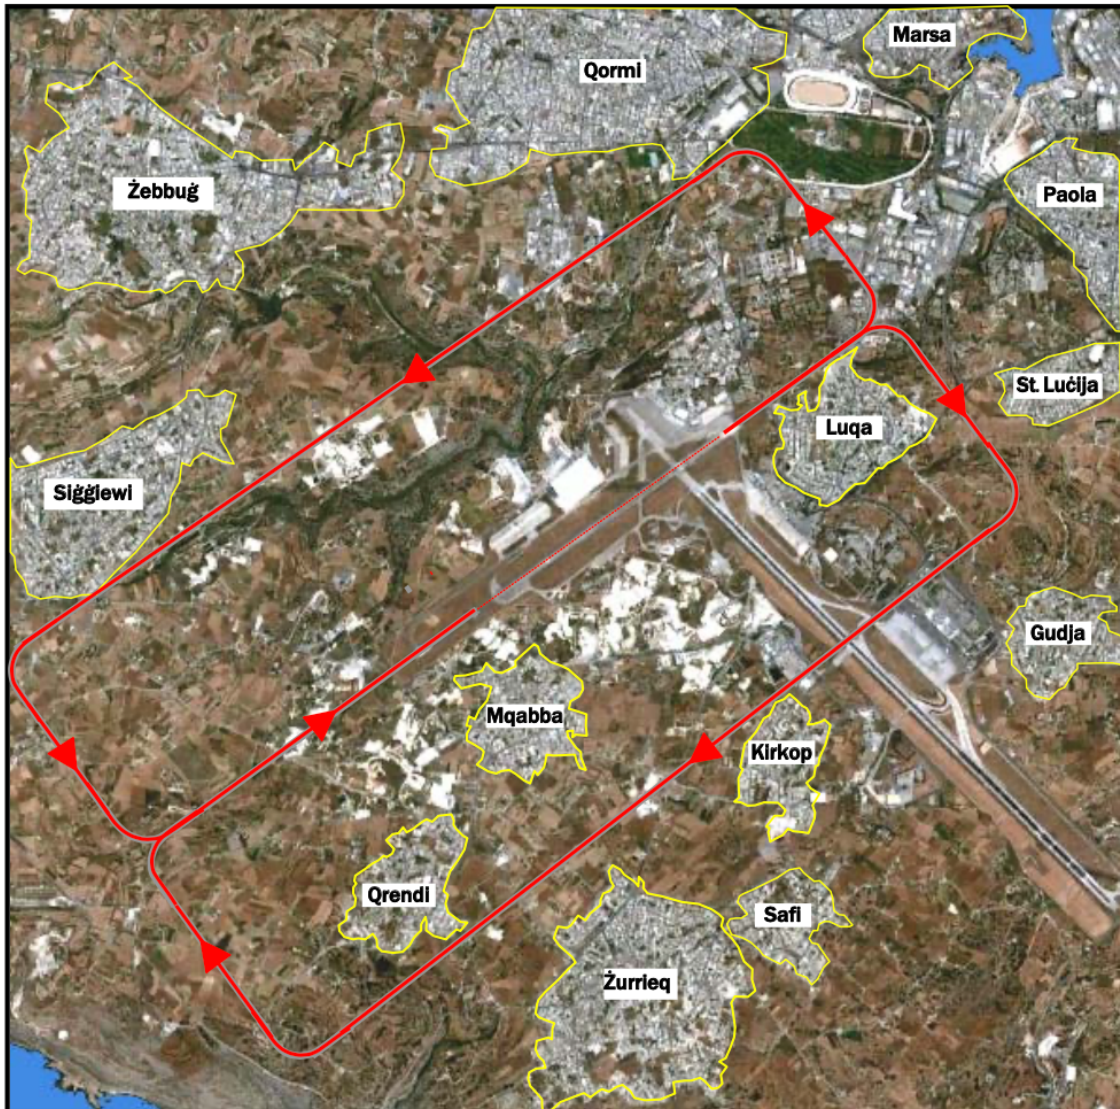
Figure 1: The circuit on RWY05 as taken from the current AIP

The circuit on RWY05 is shown in Figure 1 below.

9H-EFA turned right at an altitude of 500 ft QNH. The airport is at an altitude of 300 ft above sea level and therefore the aircraft joined the right-hand crosswind too early.

5.1 Throughout this investigation it was noted that the AIP does not fully define the circuit for general aviation. Specifically, it lacks the definition of some critical units. After takeoff a pilot would be expected to maintain track/heading until the aircraft is 500 ft above ground (QFE). However, inadvertently some pilots may not make the correction between QFE and QNH. In the specific conditions of Malta, this results with some aircraft turning 300 ft too low.

That that AIP is updated to include specific units and include restrictive details of the circuit altitudes, turning and entry points.
