A safety investigation report for the runway excursion of the Cessna 172, Reg No. 9H-AEX

Location: Malta International Airport	Accident Number: BAAI/SIR-001-2020
Date & Time: 3 rd November 2019, approximately 8:45 am (Local)	Registration: 9H-AEX
Aircraft: Cessna 172	Aircraft Damage: Aircraft suffered a punctured nose wheel and damaged nosewheel hub.
Defining Event: Runway excursion following landing on RWY 31	Injuries: No injuries Reported

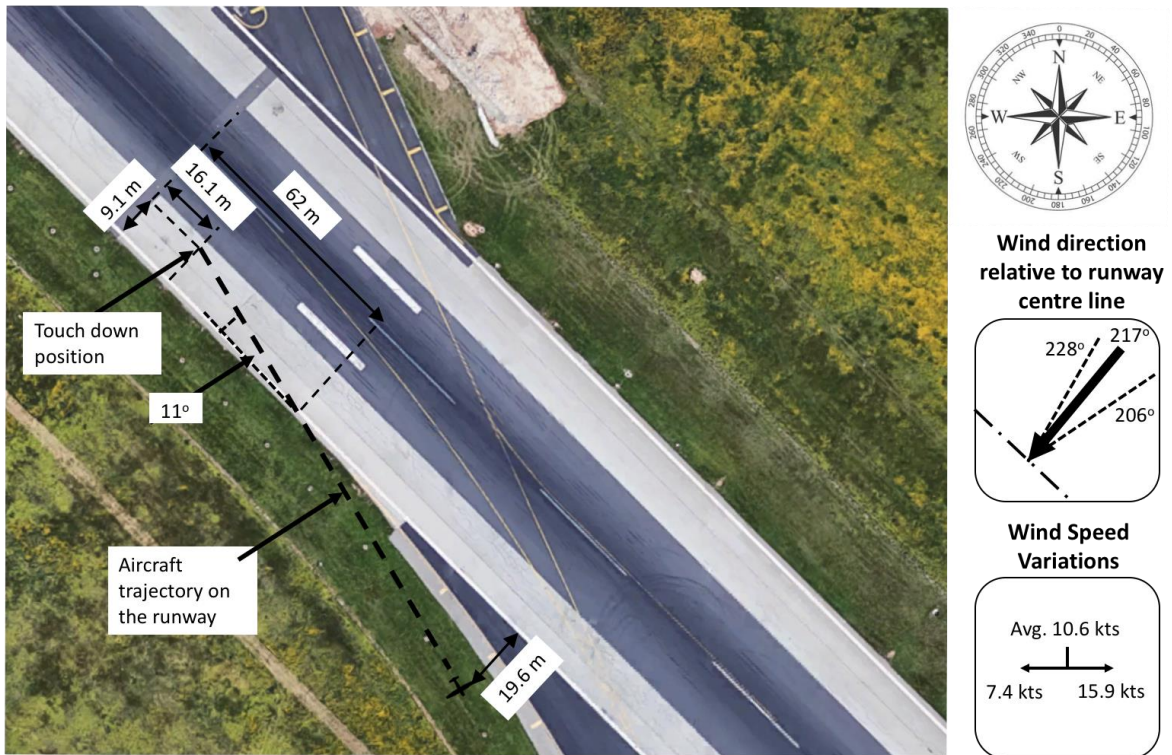
Fig. 3. Sketch of the final resting position of the aircraft.

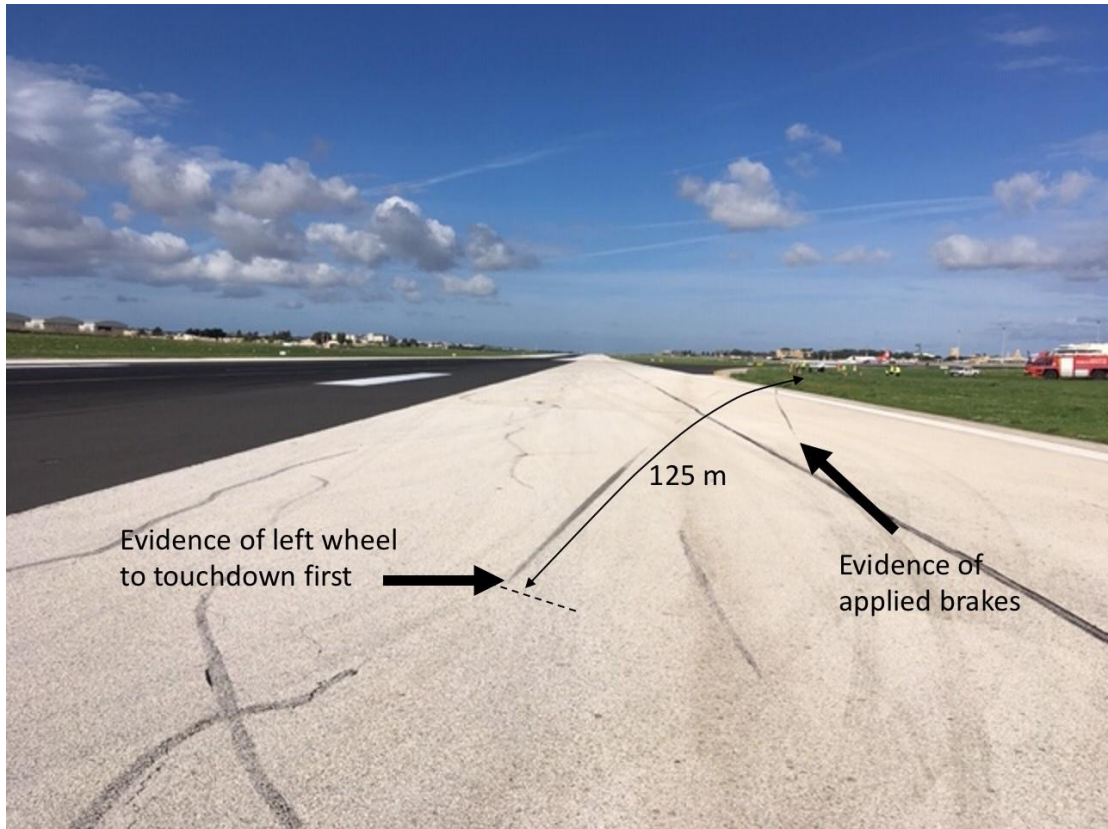
Fig. 4. Touch down marks and locked right wheel.

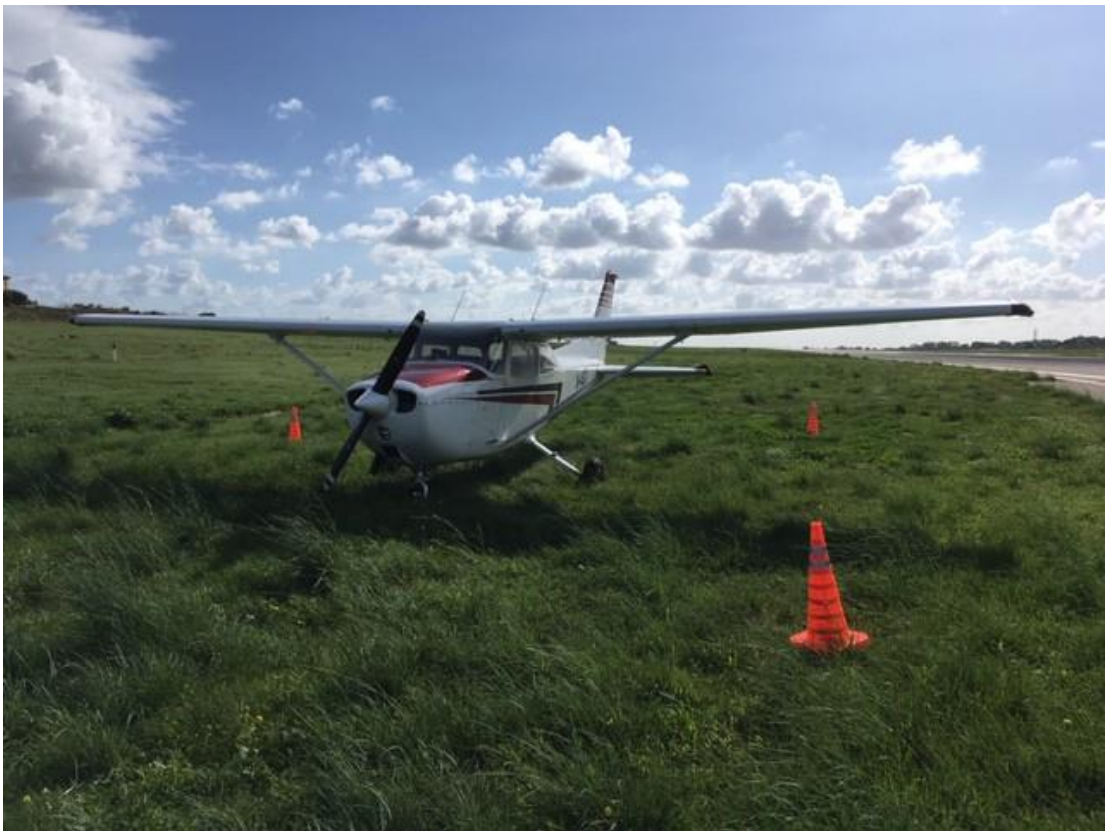
Fig. 5. The aircraft in its final resting position.

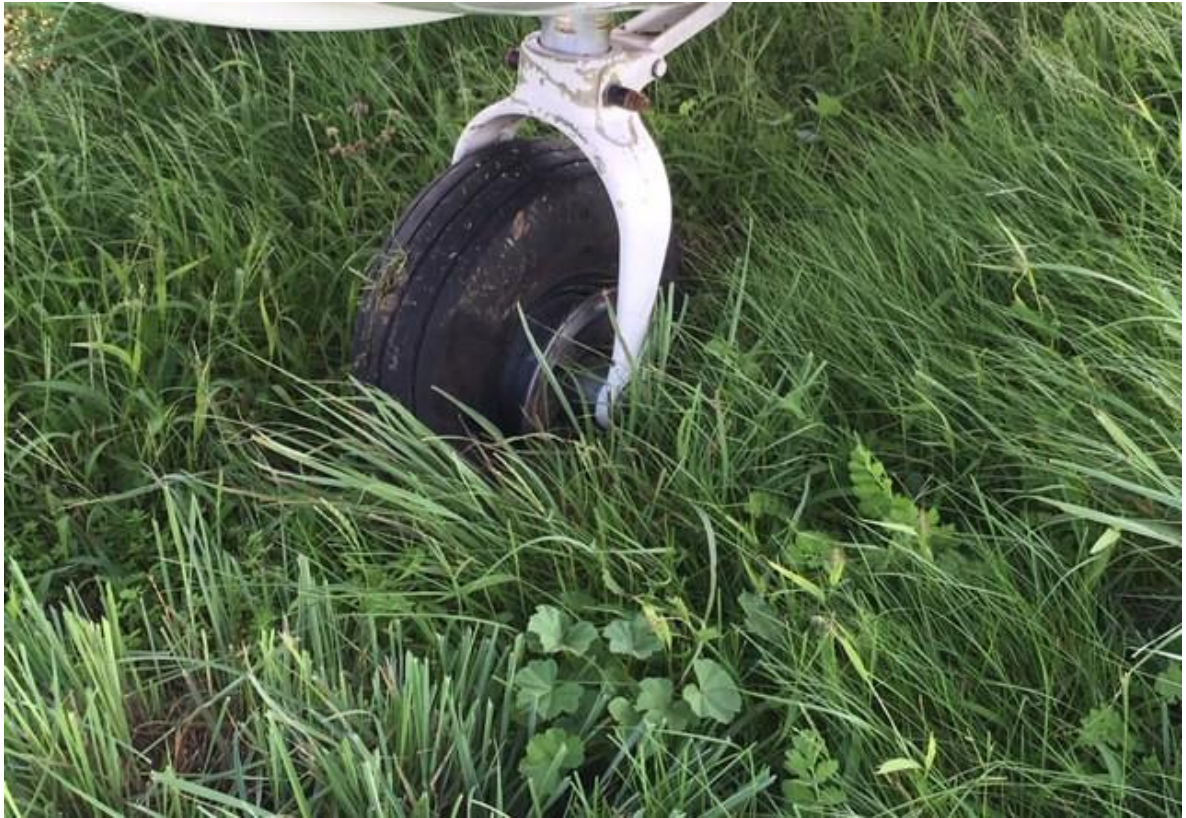
Fig. 6. The nose wheel punctured tyre and damaged wheel-hub at the aircraft's final resting position.

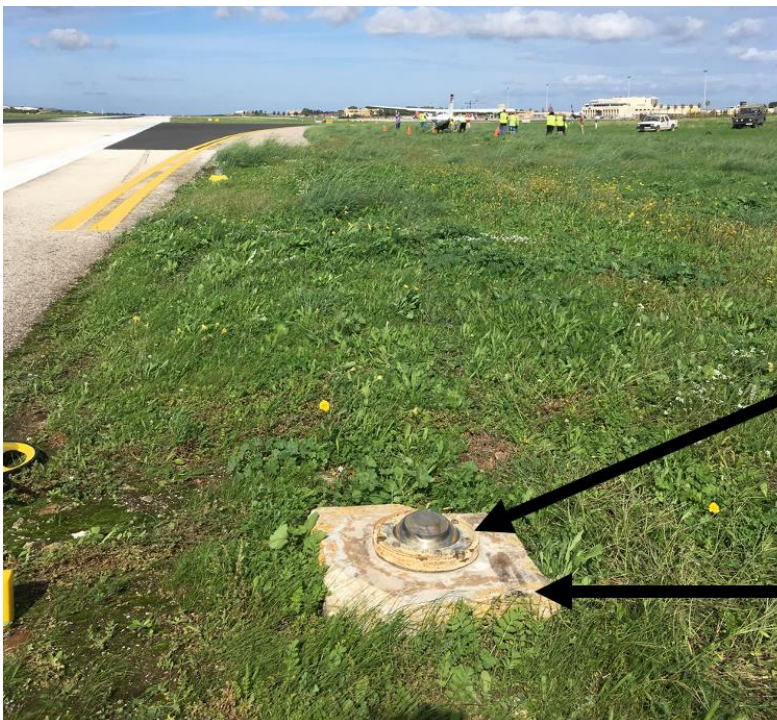
The RWY edge light's metal frame was found to be the cause of the punctured nose wheel

Evidence of wheel marks on RWY edge light concrete base

Fig. 7. Cause of punctured nose wheel tyre following runway excursion.

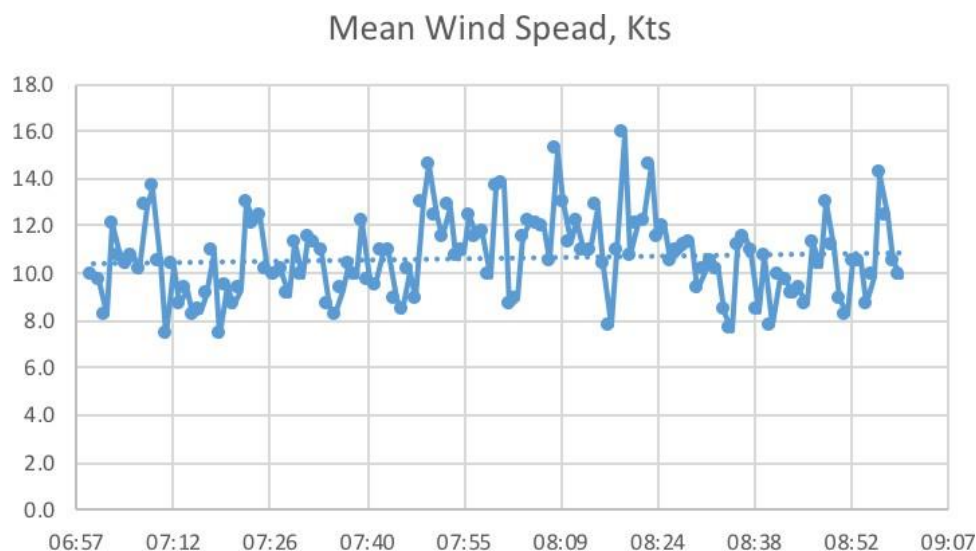
The wind is reported to be 230°/12kts varying between 180° to 240°. The wind speed and direction retrieved through the MET Office station located close to RWY 31 are shown in Fig. 8 and Fig. 9.

Fig. 8. Wind speed measurements

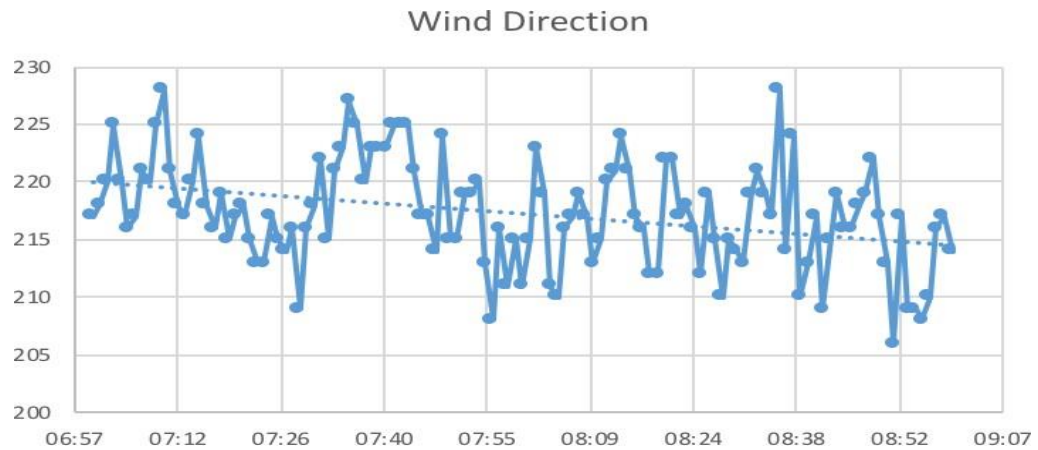
Fig. 9. Wind direction measurements
