A safety investigation report for the runway excursion of the Tecnam P2002 JF, Reg No. 9H-PIC

Location: Malta International Airport	Accident Number: BAAI/SIR-002-2020
Date & Time: 1 st February 2020, approximately 8:00 am (Local)	Registration: 9H-PIC
Aircraft: Tecnam P2002 JF Sierra	Aircraft Damage: Significant: Damaged right wing-tip and buckled leading edge; Damaged propeller; Nosewheel collapse; Damaged engine and gearbox
Defining Event: Runway excursion following landing on RWY 23	Injuries: Slight injury reported

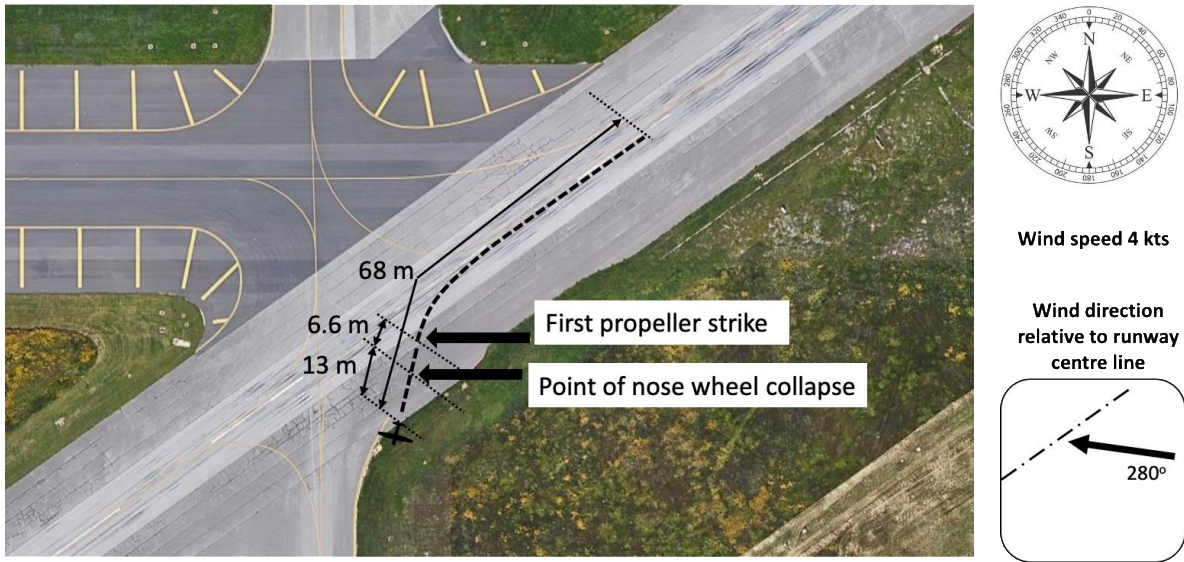
The aircraft was found on the grass just off the edge of RWY23 and at an angle to the RWY. The RWY showed marks of the propeller hitting the ground and of the nosewheel collapse. The aircraft right wing had scratching signs and suffered from a slight buckling at the leading edge.

Fig. 3. Sketch of the final resting position of the aircraft.

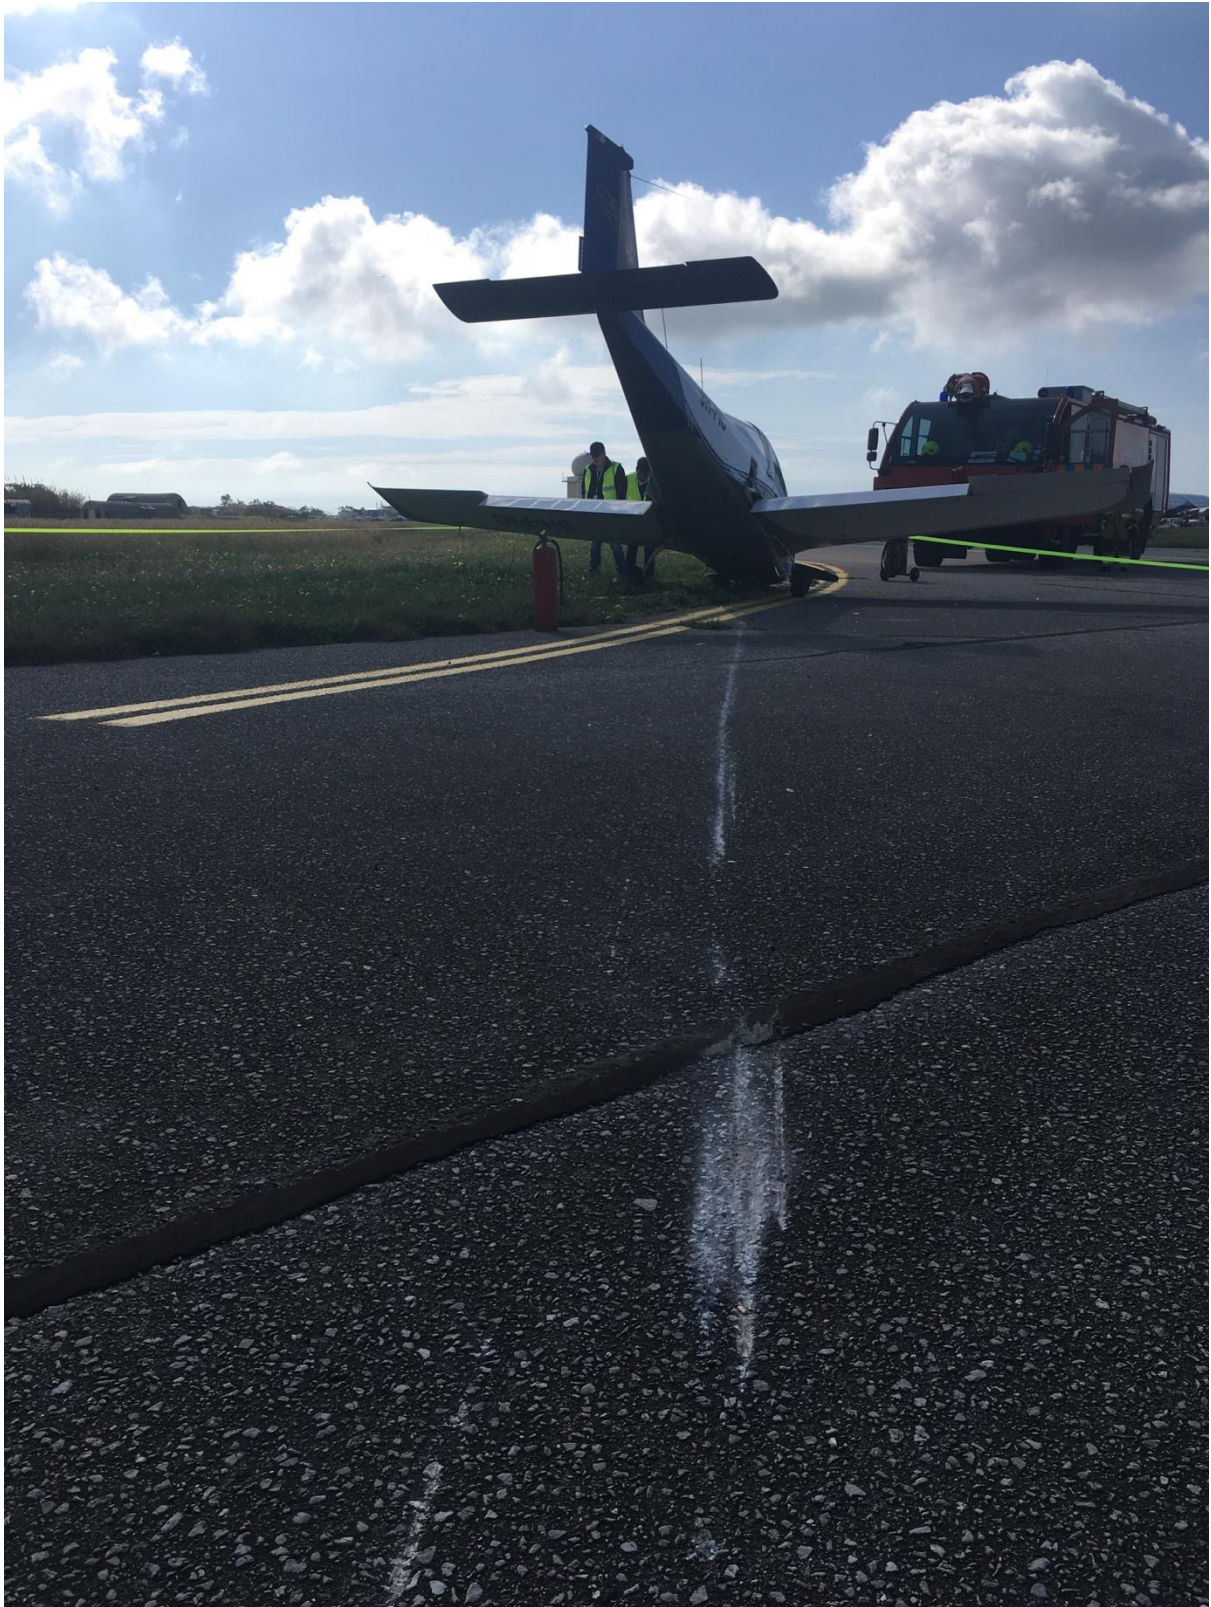
Fig. 5. Scratch marks on the ground close to the aircraft's final resting position.

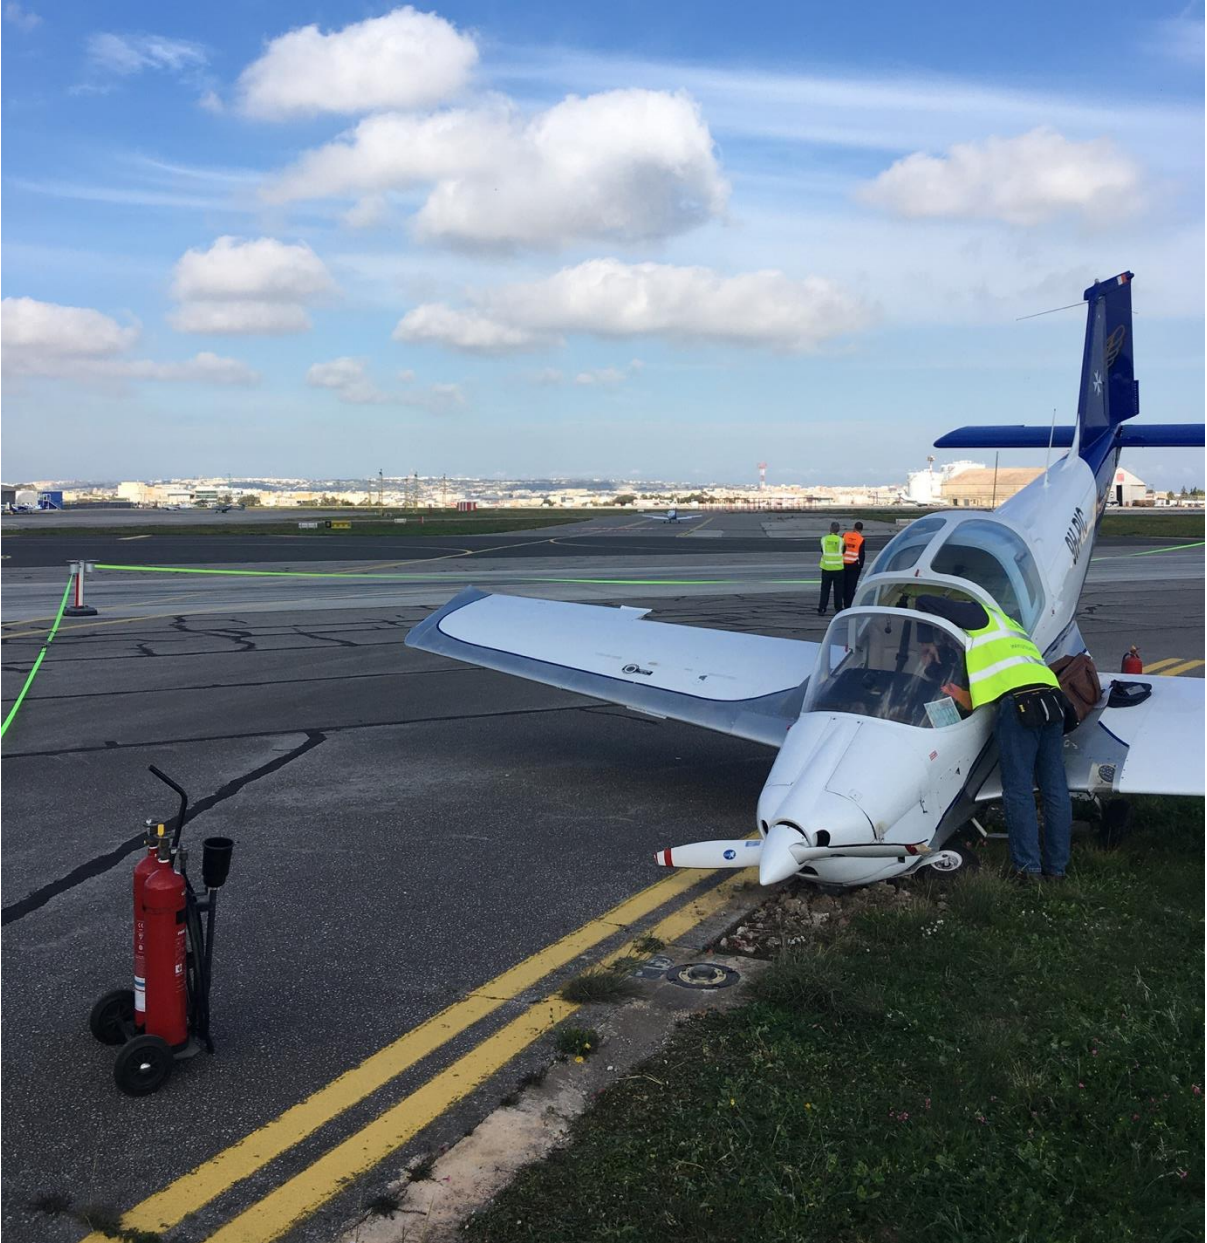
Fig. 5. The aircraft in its final resting position.

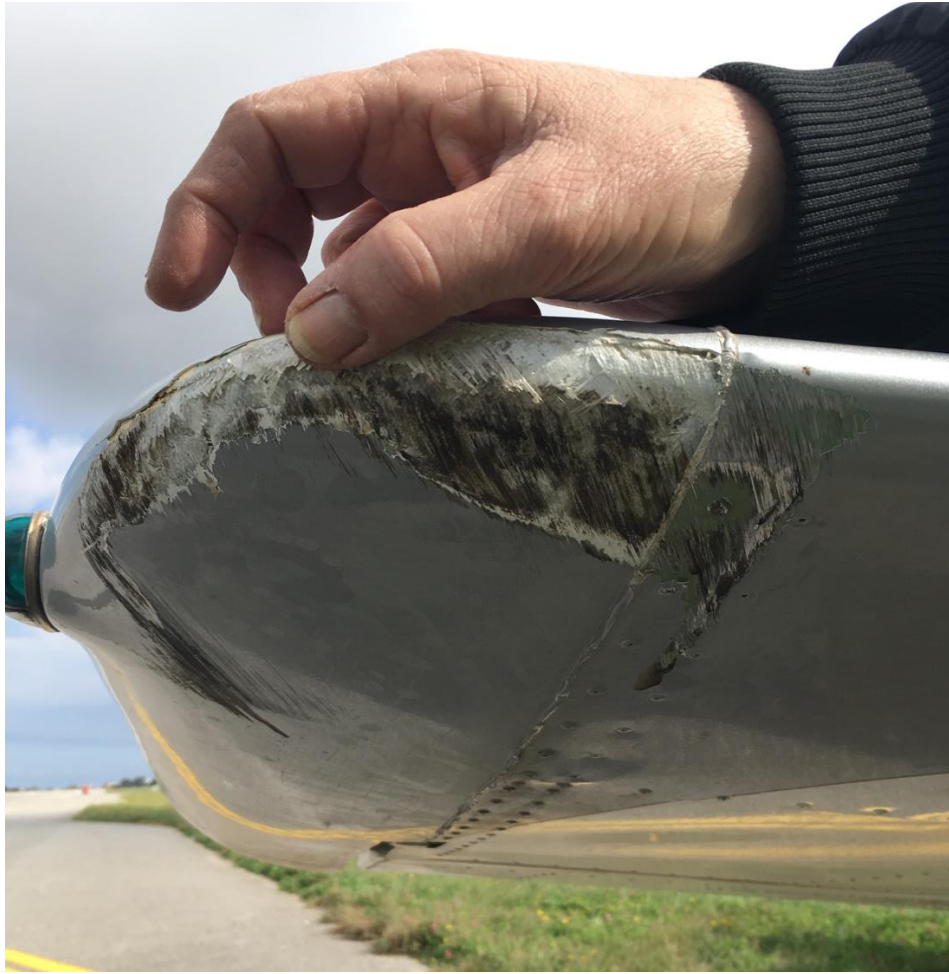
Fig. 5. Damage on the right wing-tip.

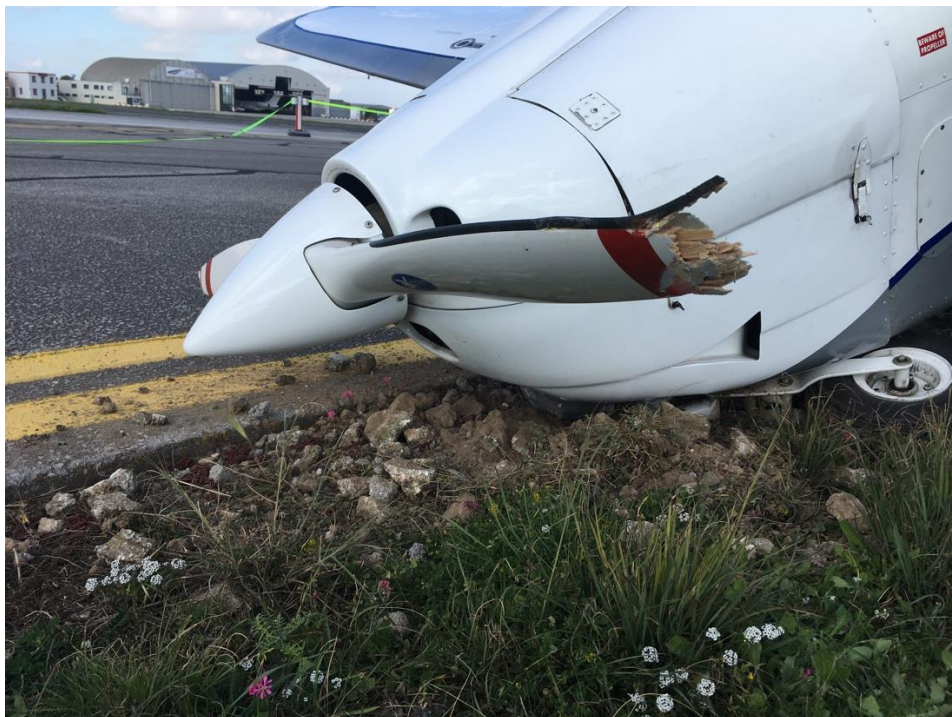
A Tecnam P2002 JF Sierra landed on the RWY 23 in good metrological conditions. The aircraft stalled during the flare maneuver resulting in a hard landing on the nosewheel. This caused the propeller and the right wing to hit the ground which caused considerable damage to the propeller, the wing tip assembly and the engine to seize. Following the impact, the aircraft veered left, and in an attempt to stop the aircraft from entering grass, heavy braking was exercised.

Fig. 6. Nose wheel collapse and damaged propeller.

Following the accident, it was confirmed that the correct components are used on the aircraft. Moreover, the aircraft did not suffer a deflated tyre, and therefore the only way to hit the propeller on the ground is if the aircraft was still airborne and suffered a sudden and violent nosedive. Therefore, the possibility of a propeller strike solely from hard braking is discarded.
