A technical review of the safety investigation report of the Fly Synthesis Amphibian aircraft, model: Catalina NG 582, registration number 9H-UTA

Summary and short description of the accident.

Aircraft: Fly Synthesis, Catalina NG 582 , Amphibian aircraft, registration no.: 9H-UTA.

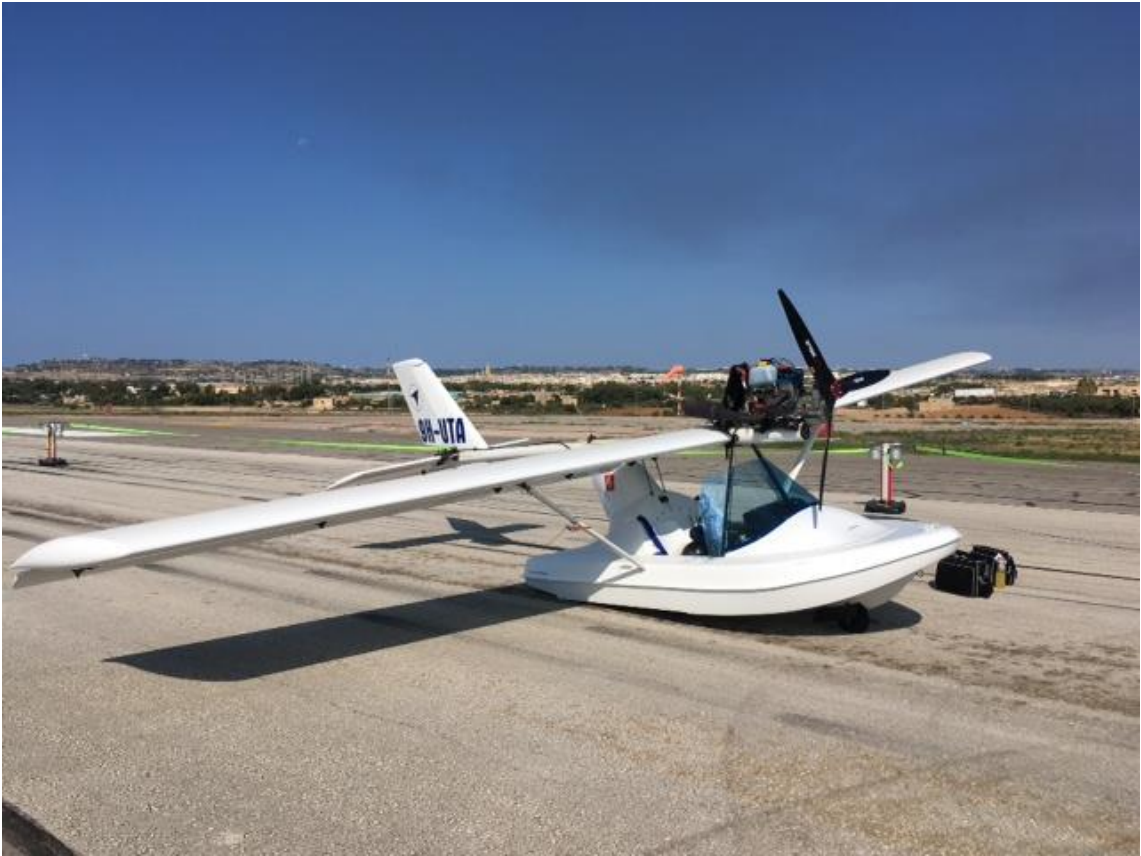
On-site Evidence: The aircraft was found on the centre line of **RWY 05**, tilted to the right due to the retracted main wheel. Evidence of the touchdown position could be traced back from the surface scratches on the runway. It was estimated that the aircraft skid for approximately 107 m.

Fig.2. The aircraft in its final resting position.

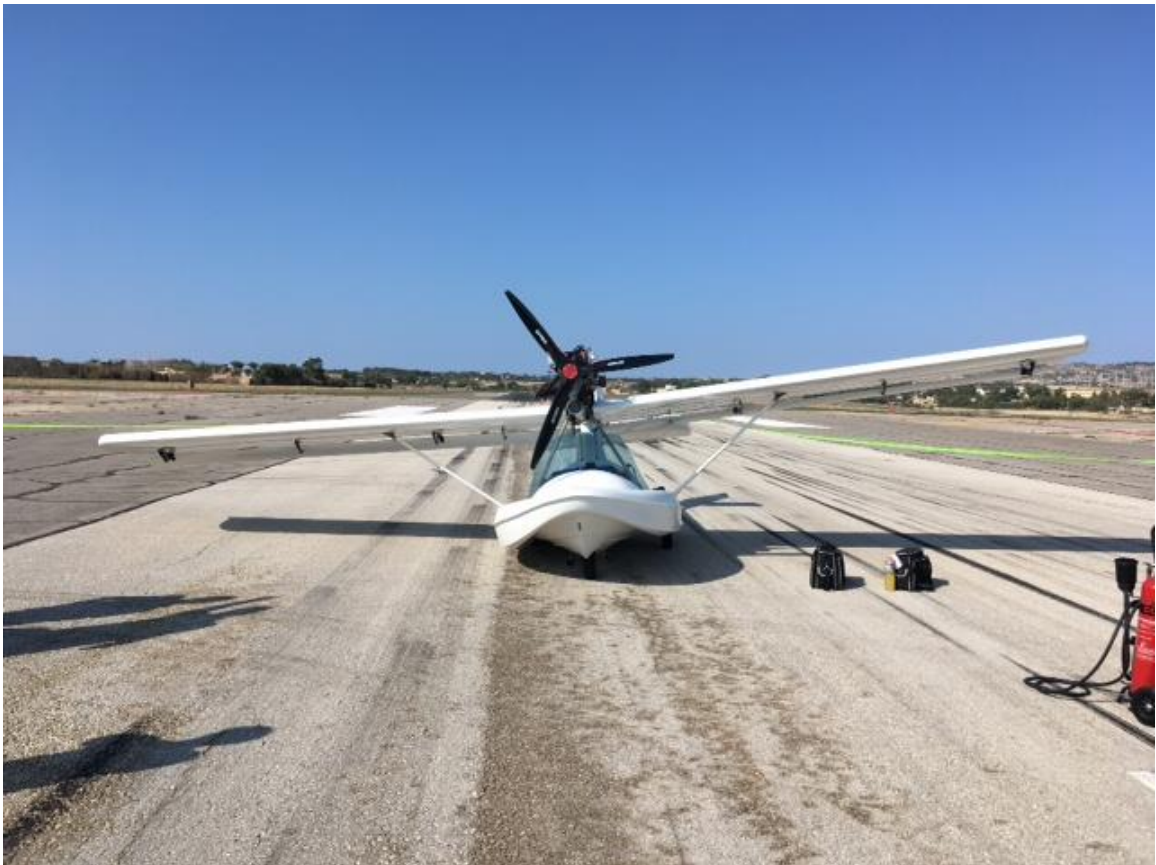
Fig.3. Front view of the aircraft in its final resting position.

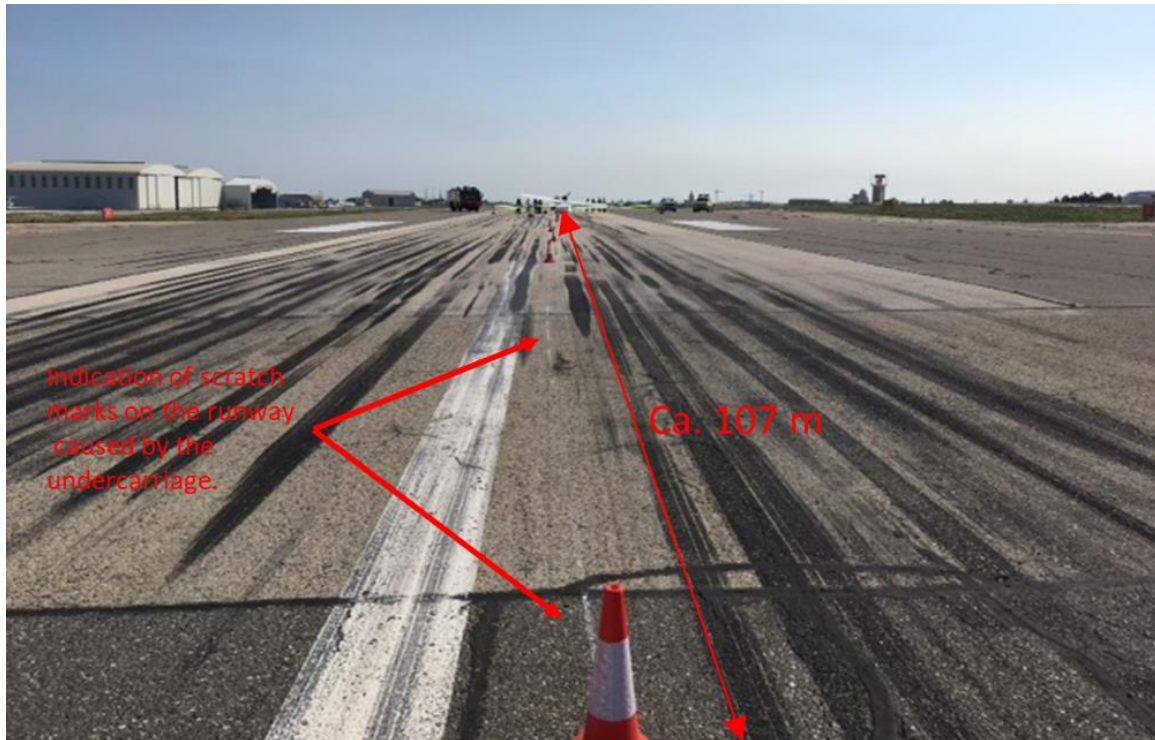
Other damage: Superficial scratch marks on the runway.

Fig.4. Superficial scratch marks on the runway as a result of the landing incident could be traced back to the final position of the aircraft.

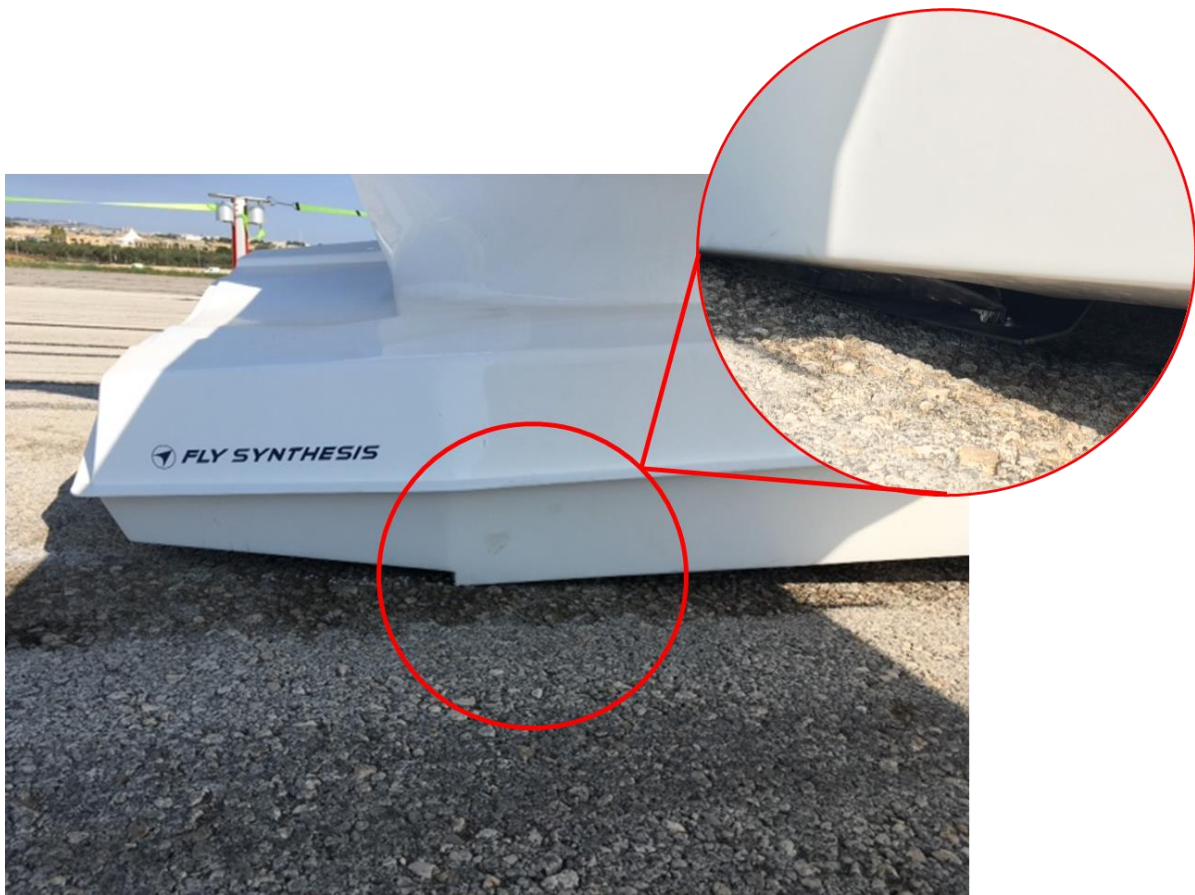
Fig.5. Details of the *unextracted* left wheel.

Having established the dynamics of the accident, this section delves into understanding the causes of such accidents. This investigation found that a tyre change was performed the night before the flight. It was later found that a braking cable restricted movement of the wheel, therefore impeding the full retraction of the wheel. While a full check could have highlighted the problem before the flight, this investigation finds that the instruction manual fails to provide a detailed guideline on how such checks could be safely implemented. The manual also fails to include photos and/or diagrams of the critical processes related to landing gear maintenance.

The landing gear of this amphibious aircraft is a critical component both for landing on the ground and for landing on the sea (due to the risk of overturning the vehicle as a result of the drag caused). While the manual or the aircraft includes maintenance procedures for the landing gear in Chapter 9, it is recommended that this is expanded further to include step by step diagrams and warnings for critical processes, such as how to avoid that the brake lines get entangled with the kinematics of the landing gear. It is also recommended that the manual includes a statement, whereby following any maintenance procedures on the landing gear, this is to be extracted and retracted as a final check on the ground, thereby ensuring that the system functions as expected.

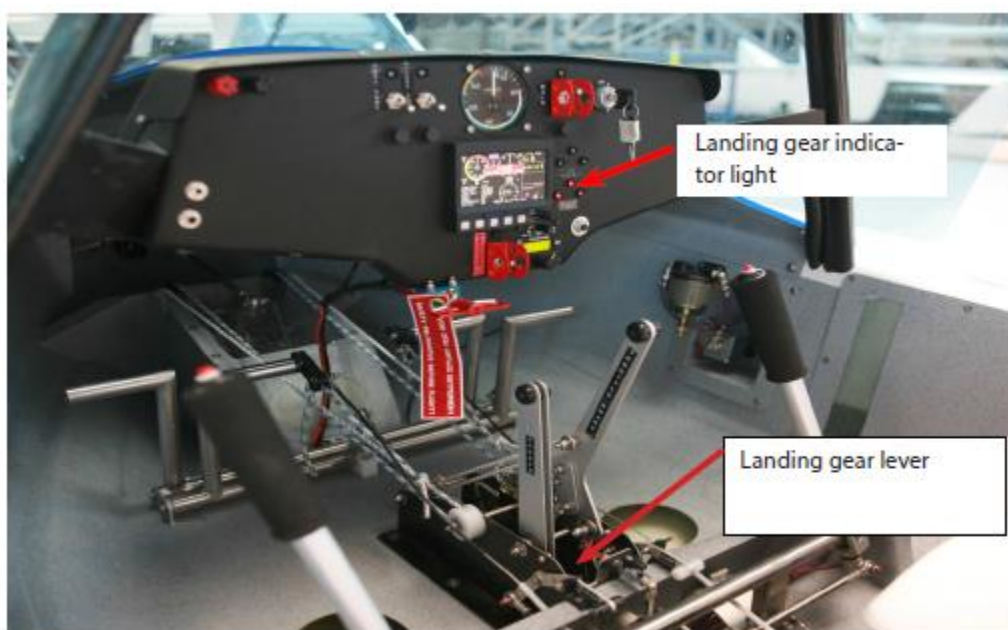
Fig. 6. An extract from the aircraft manual showing the landing gear indicator light and landing gear lever.

This accident involves an amphibious aircraft that can take off and land on the ground and on the water. Whilst in flight, the pilot notes that out of three undercarriage indicators two were green and one red. In this amphibian aircraft, green is an indication that the landing gear has fully retracted, making it safe to alight on water. Conversely, red indicates that the landing gear is completely or partially extracted. The indicator lights are shown in Fig. 6. If a water landing is attempted under this unsafe condition, the drag resulting from the wheel in contact with the water would risk overturning the aircraft. This is also highlighted in the aircraft manual, which makes use of the keyword **PRUDENCE** indicating that if the instruction or procedure is not correctly observed it could cause an accident or death. It is noted that the indicators are inverted in this aircraft compared to traditional ground type aircraft. This is because the most dangerous phase is to alight or take off from water. The inversion of the lights is however considered to have NO contribution to the accident.
