Small Accident/Incident Report

Location: Malta International Airport	Accident Number: BAAI/SIR-001-2019
Date & Time: 15 th January 2019, approximately 1500hrs (Local)	Registration: 9H-PIC
Aircraft: Tecnam P2002JF Sierra	Aircraft Damage: Significant
Defining Event: Runway Excursion after landing.	Injuries: No injuries reported
Flight Conducted Under: VFR	Nature of Flight: Private Local Flight

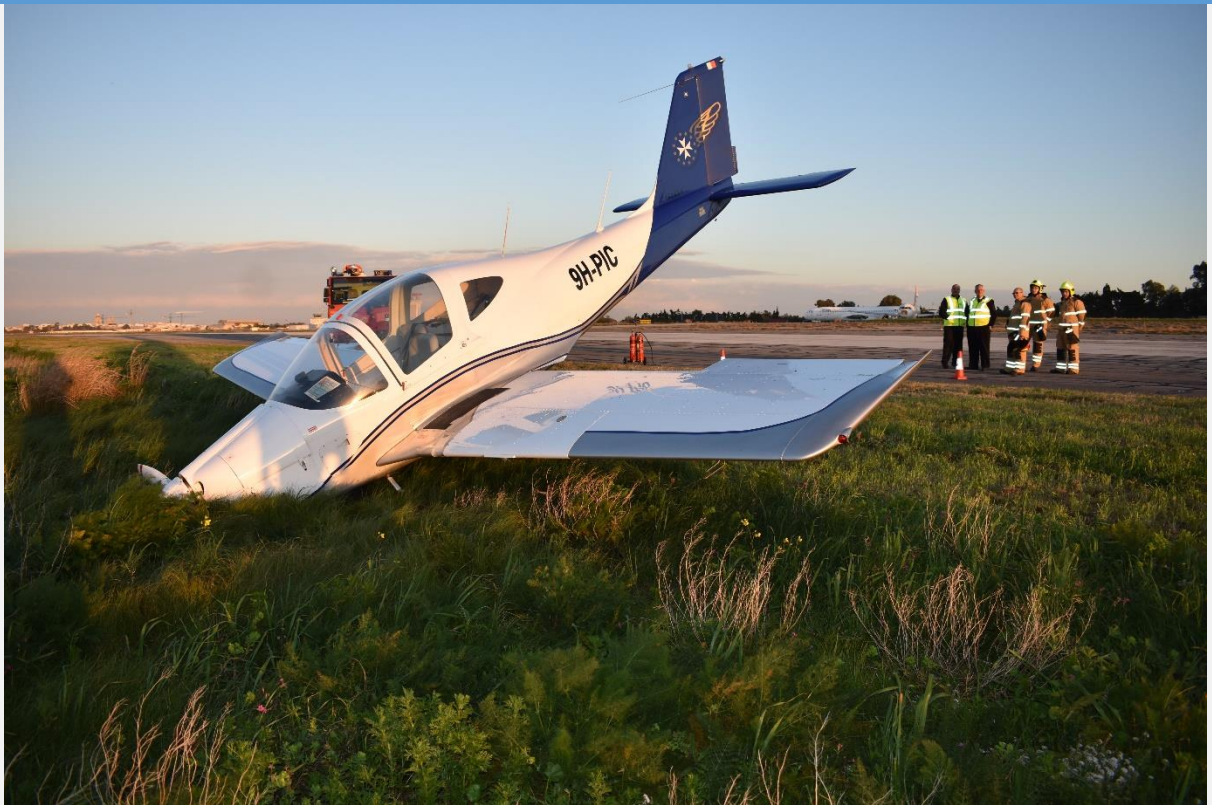
The pilot landed the aircraft on Runway 05 and turned off the runway, coming to rest on the grass 12m from the left shoulder of the runway on a heading of 325° (Magnetic), approximately 700m from the runway threshold.

The aircraft at rest following the accident.

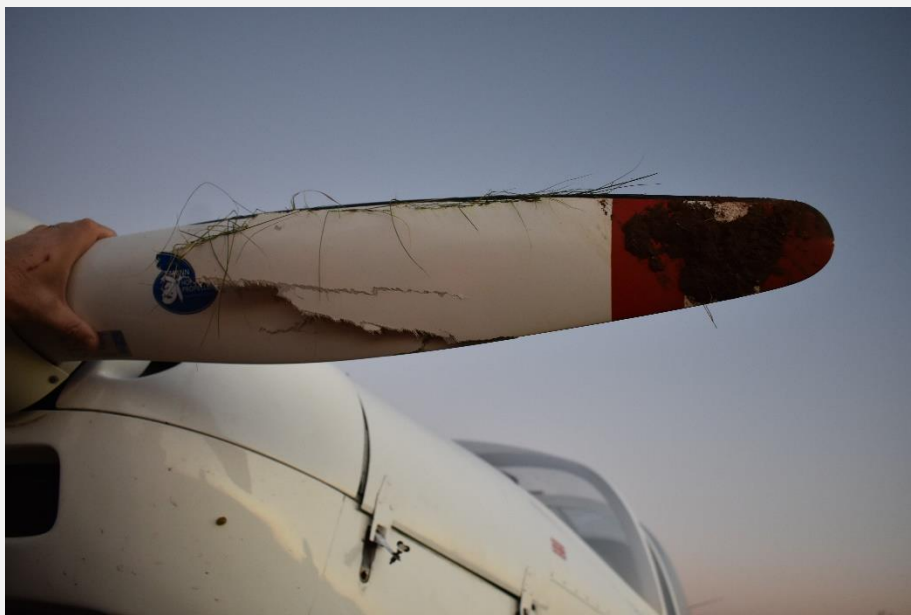
The damage sustained by the propeller is consistent with the engine running at idle trust at the time of the runway excursion (Figure 2).

The damage sustained by the propeller, pictured at the accident site.

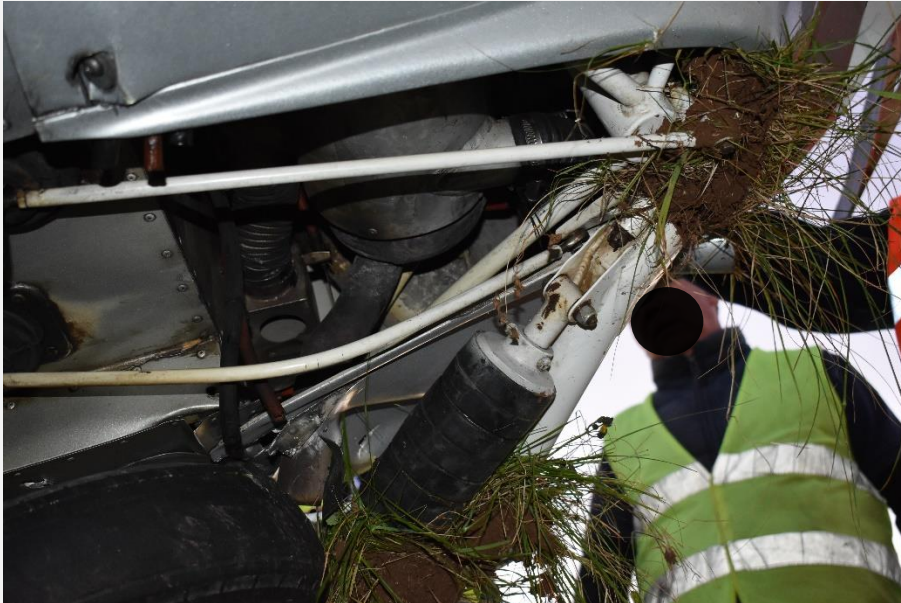
The left control rod connecting the nose-wheel to the rudder pedals was bent. This damage is consistent with it developing as a consequence of the nose landing gear collapse following runway excursion (Figure 3).

The nose-wheel control rods, showing the bent left control rod, pictured at the accident site.

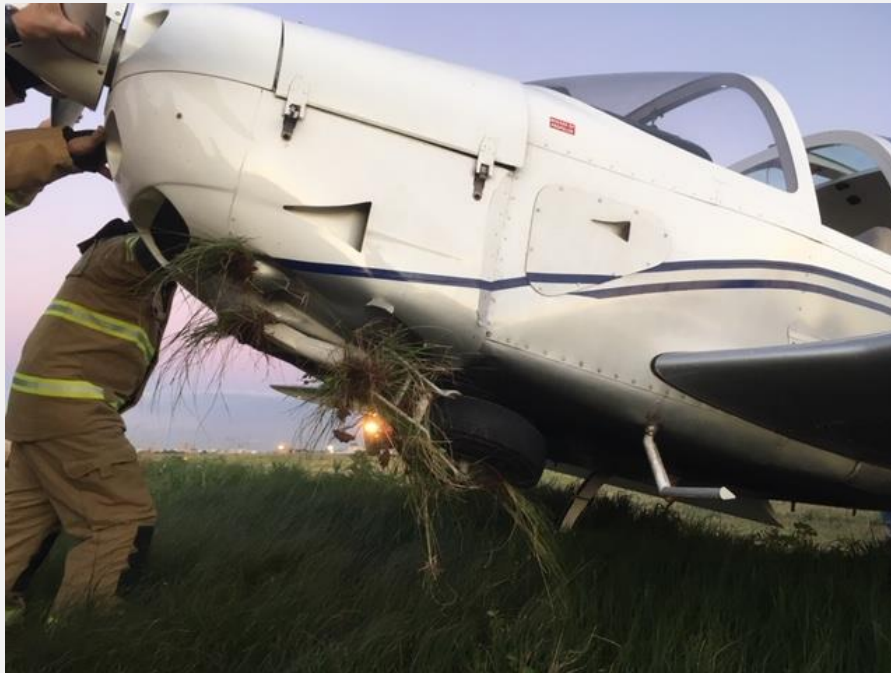
The nose landing gear collapse is consistent with it failing following runway excursion and the nose-wheel digging into the soil. The folding of the gear backwards with the wheel turned to the left indicates a forward motion of the aircraft (no significant side slip or skid) with the nose-wheel turned to the left at the time of failure (Figure 4).

The collapsed nose gear with the nose-wheel turned to the left, pictured at the accident site.

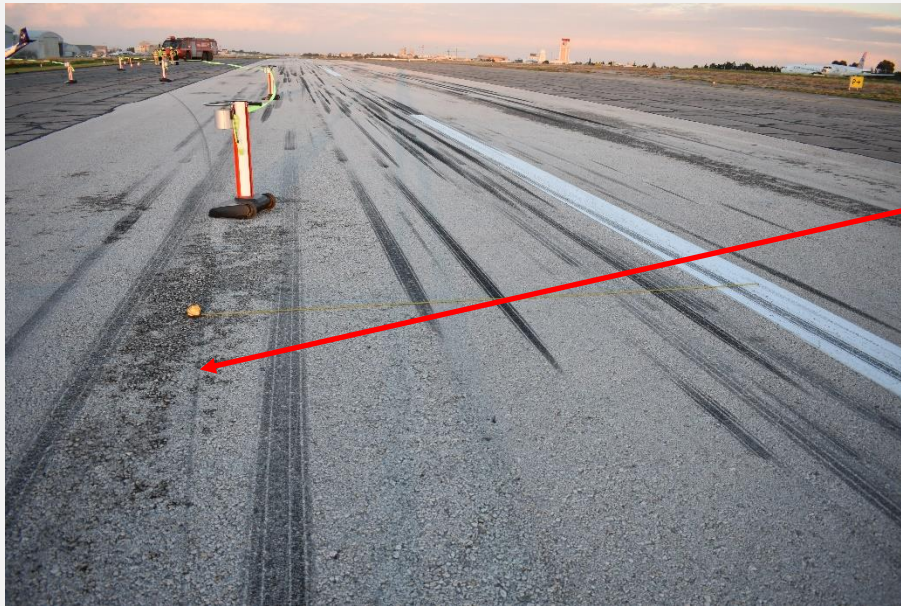
Inspection of the tyre-marks on the runway and its shoulder in the vicinity of where the aircraft came to rest indicates that touch-down occurred near the aiming point markings of Runway 05, slightly to the left (upwind) of the centreline (Figure 5). Only one tyre mark, that corresponding to the right main landing gear tyre, was observed for the first part of the landing run (Figures 5 & 6). The measured distance of the right main landing gear tyre mark from the centreline at the point shown in Figure 5 (just after the end of the aiming point markings) was 12 feet (3.7m). At this point, the tyre mark was nearly parallel to the centre-line. The tyre mark diverged from the centreline towards the point where the second (left main landing gear) tyre mark was observed and then on to where the aircraft exited the runway, indicating an exit angle of approximately 40° from runway heading (Figure 7).

The presence of only the right main landing gear tyre mark in the first part of the landing run is consistent with the aircraft landing right wing down and continuing so for a significant distance whilst turning left into the wind before the aircraft settling wings level on the runway.

Tyre mark of the right main landing gear tyre of the accident aircraft

Runway 05 at the accident site, showing the tyre mark of the right main landing gear tyre of the accident aircraft (arrowed).

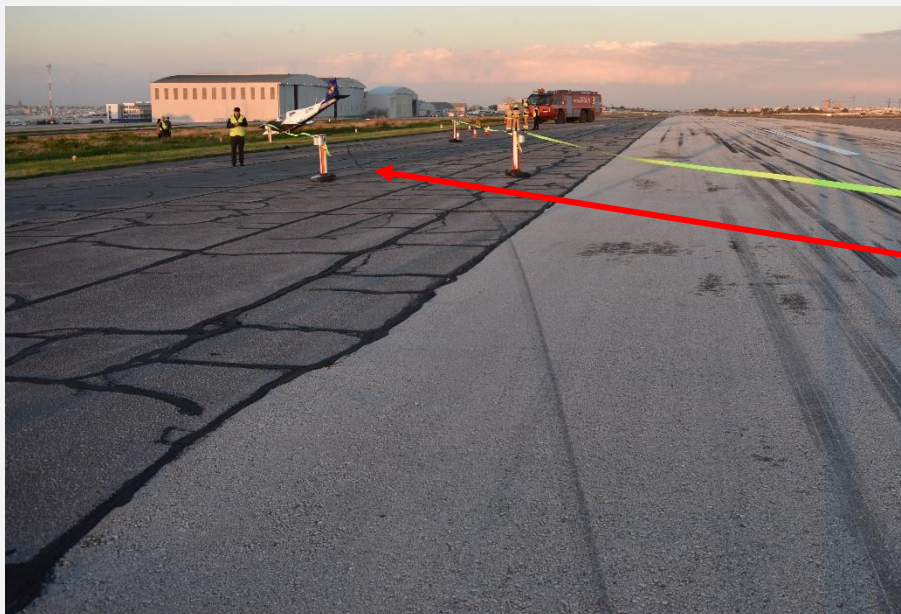
Start of the tyre mark of the left main landing gear tyre of the accident aircraft

Figure 1. Runway 05 at the accident site, showing the start of tyre mark of the left main landing gear tyre of the accident aircraft (arrowed).

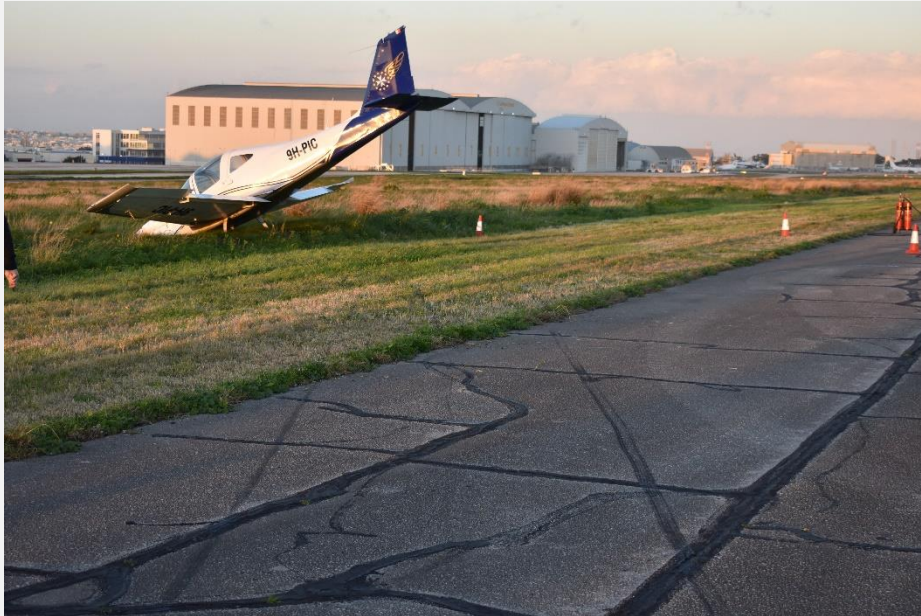
Figure 2. The three tyre marks at the runway shoulder at the accident site.
