Small Accident/Incident Report

Location: Malta International Airport	Accident Number: BAAI/SIR-002-2019
Date & Time: 10 th September 2018, approximately 1200 hrs (Local)	Registration: 9H-MSF
Aircraft: Tecnam P92 JS Echo	Aircraft Damage: Significant
Defining Event: Main landing gear failure after landing	Injuries: No injuries reported
Flight Conducted Under: VFR

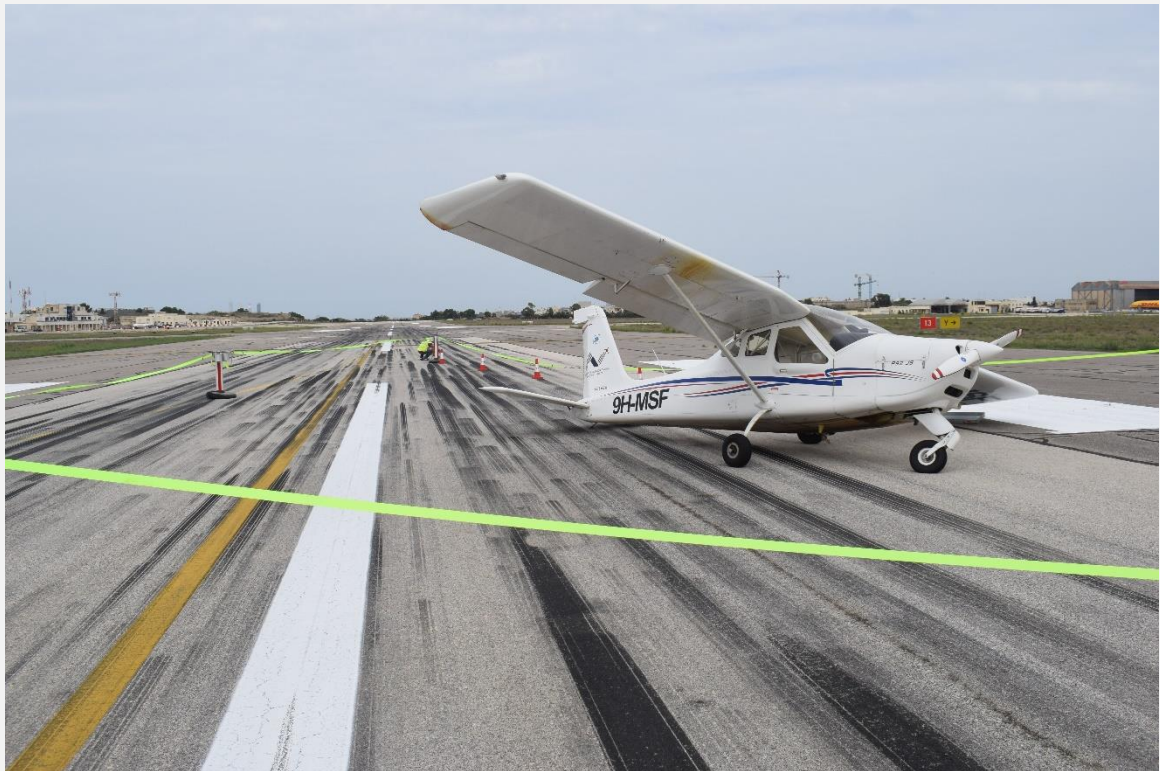
Figure 1. The accident aircraft following the incident.

- Collapsed left main landing gear
- Broken left main landing gear attachments to airframe
- Damaged airframe structure in the area of the left main landing gear attachment
- Scraped left main wing tip
- Scraped left tail plane tip

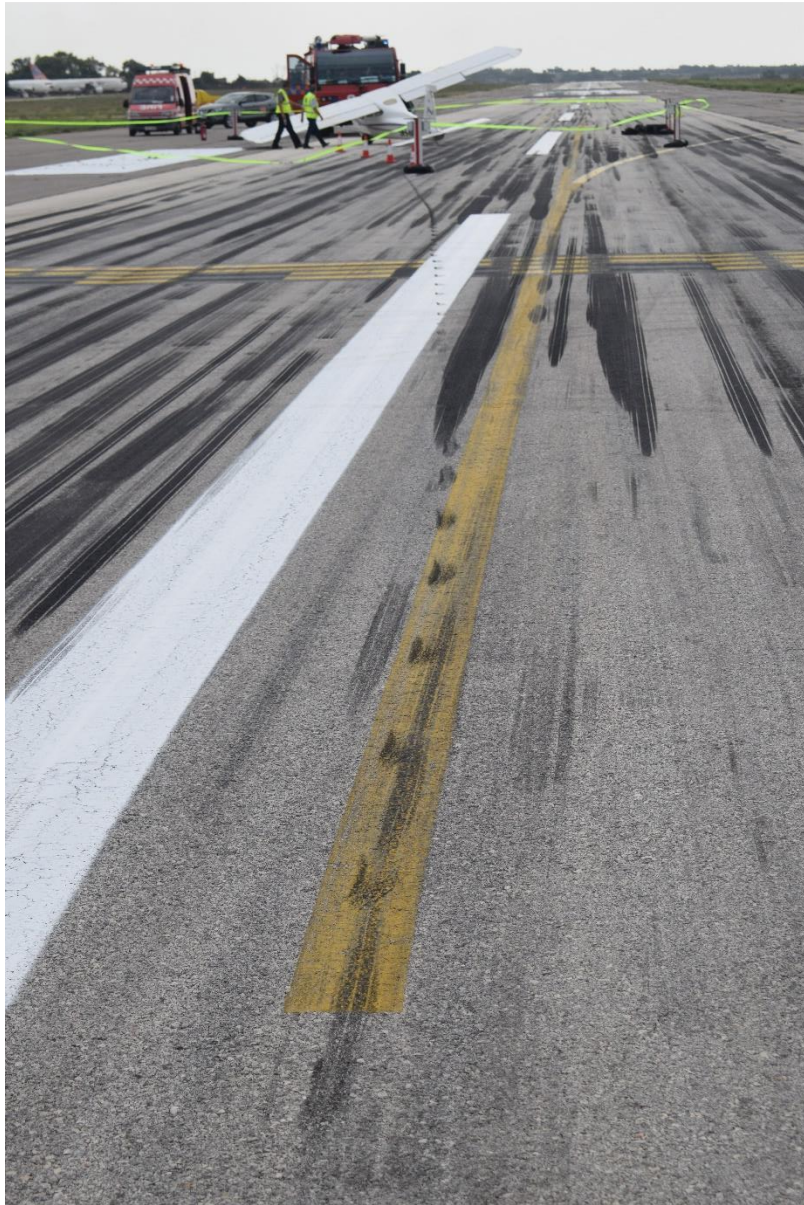
There was no debris left on the runway or its environs. Tyre marks identified to be that of the accident aircraft were identified from 57m from where the aircraft came to rest, starting and continuing to the right of the centerline until the left tyre mark became discontinuous, which corresponds to vibration of the wheel following undercarriage failure. The tyre marks then turned to the left leading to where the aircraft came to rest (Figure 2). There was no evidence of tyre skid due to locked brakes noted on the tyres at the accident site.

Figure 2. The accident aircraft at rest and the tyre marks generated by the left main undercarriage.

The discontinuity of the left tyre mark (Figure 2) is consistent with that of a failed landing gear, with the tyre being presented at an oblique angle to the direction of travel of the aircraft. This will have resulted in the tyre vibrating on the failed gear. The higher rate of discontinuity as the aircraft slowed down to come to rest (Figure 3) further corroborates the finding, indicating that the landing gear failed after touch-down and during the roll-out phase.

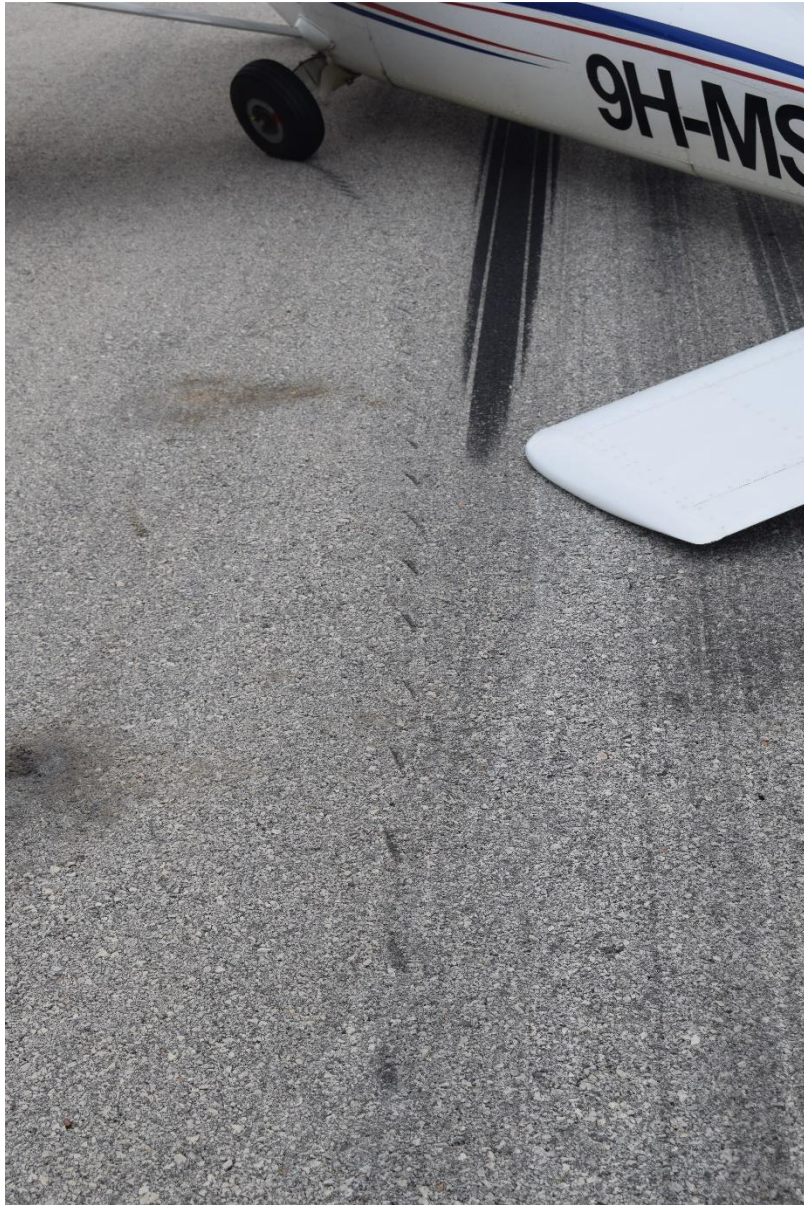
Figure 3. The left main undercarriage leg of the accident aircraft and the tyre marks generated by the left main undercarriage immediately prior to coming to a halt.

Investigation of the failed undercarriage at the accident site revealed that, whilst the spring appeared undamaged, the fastening system failed. The structure is shown in Figure 3. The undercarriage leaf spring (1) is attached to the airframe via three bolts/nuts, with the outer two (5) holding a clamp (4) and the inner one (6) together securing the spring in place against the airframe structural beam. Leather liners (2, 3) cushion the spring on the beam.

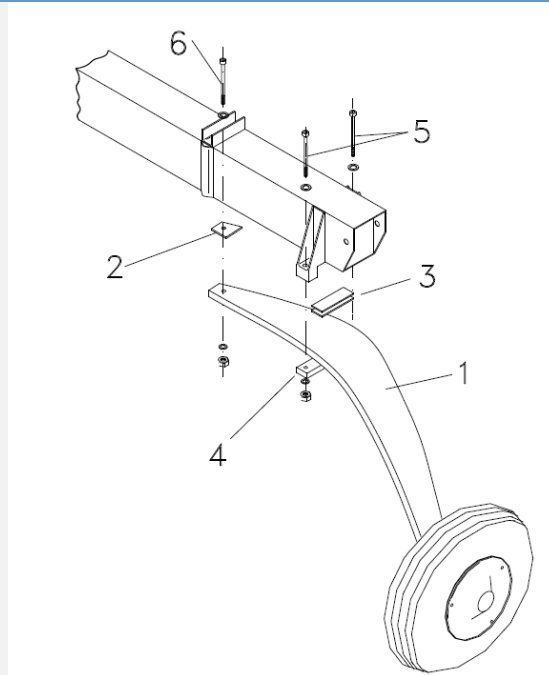
Figure 4. The main undercarriage and its attachment to the airframe on the P92 JS (Source: Tecnam, reproduced with permission).

Maintenance personnel of the company owning the aircraft reported that the aircraft type suffered from compression of the leather liners (Items 2, 3 in Figure 4), resulting in the nuts tightening against the shank of the bolt rather than against compression of the liners, leaving some play in the undercarriage. The company was in communication with the manufacturers on the matter.

Although it is possible that such play could have affected the integrity of the undercarriage anchorage, there is no evidence that this contributed to the accident.

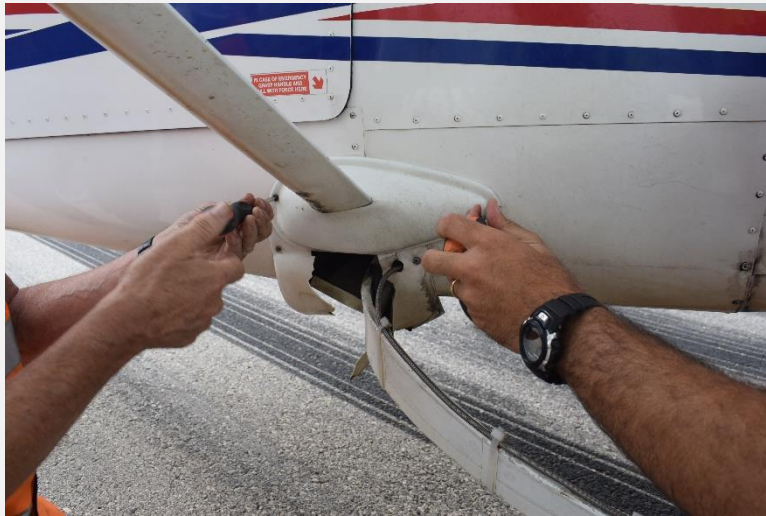
The failure of the undercarriage leg occurred due to the failure and stripping of the front outer nut when being subjected to an axial (tensile) load during braking. The failure of the nut allowed the leaf spring to rotate, prising the clamp open and resulting in the bending of the rear outer and inner anchoring bolts. The nuts on these bolts, which will also have been subjected to high tensile loads, did not fail. The prising open of the clamp allowed the rotation of the undercarriage leaf spring, which came to rest in a general horizontal position.

Figure 5. The collapsed left main undercarriage leg showing the leaf spring turned backwards.

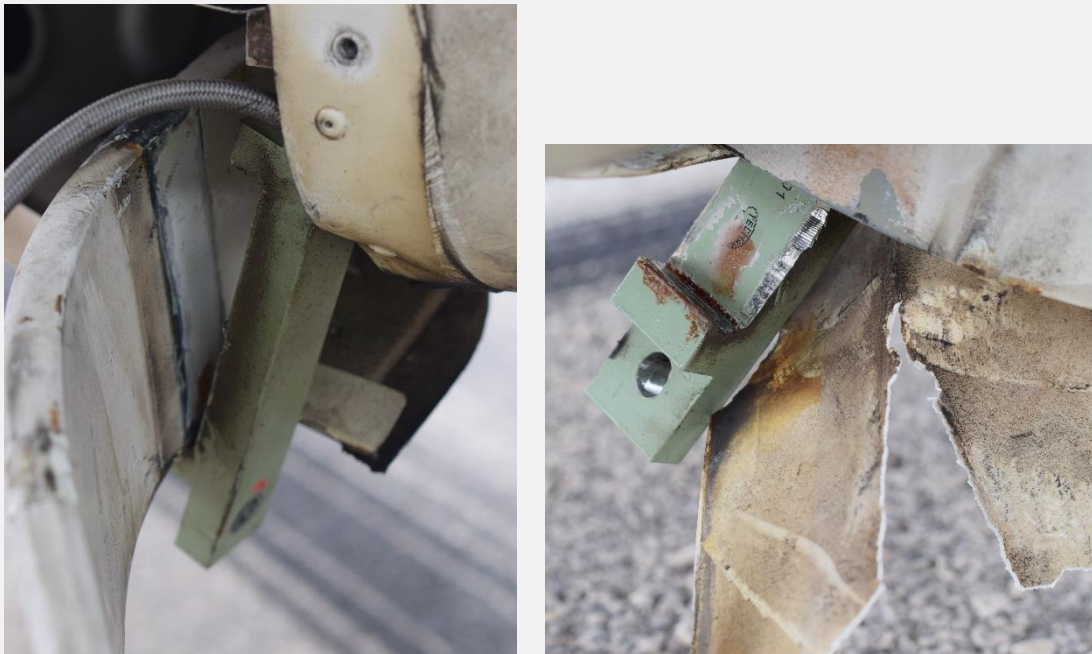
The rear outer bolt (5) and inner bolt (6) were bent but still had the nut secured on them. The clamp (4) was scraped and the front hole was widened on the outer part (Figure 6 Right), which is damage consistent with the folding motion of the undercarriage leg and the clamp slipping out of the front outer bolt (5).

Figure 6. Views of the collapsed left main undercarriage leg following the accident, showing the clamp (green) pulled off the front outer bolt.

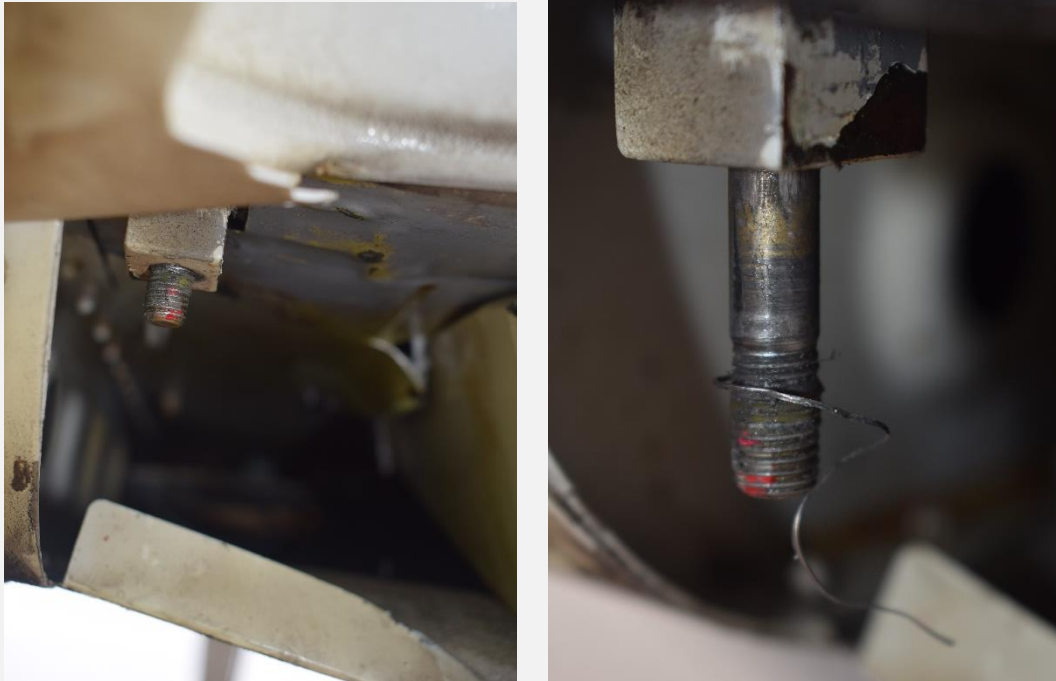
The nut of the front outer bolt (5) was missing. The bolt and its thread were intact and a swarf was found on the thread (Figure 7). This is consistent with material that would be left behind on a nut being stripped off a bolt under tension. The bolt was partially recessed in its location (Figure 4 Left), in a position that is inconsistent with it retaining the clamp and bolt. It was extended to its fully seated position, exposing the shank, on site (Figure 7 Right). Presence of the swarf and of seal material (red, Figure 7) is consistent with a nut being installed.

Figure 7. The front outer bolt, as found following the accident, without the nut (left) and after extracting the swarf from the thread (right).

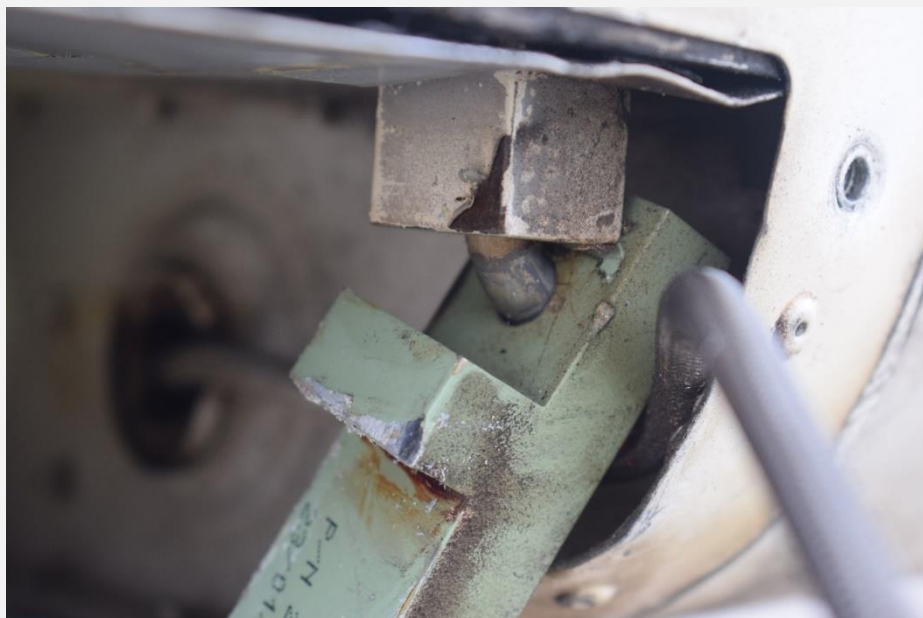
Figure 8. The rear outer bolt, as found following the accident, bent by the clamp on the collapse of the undercarriage leg.

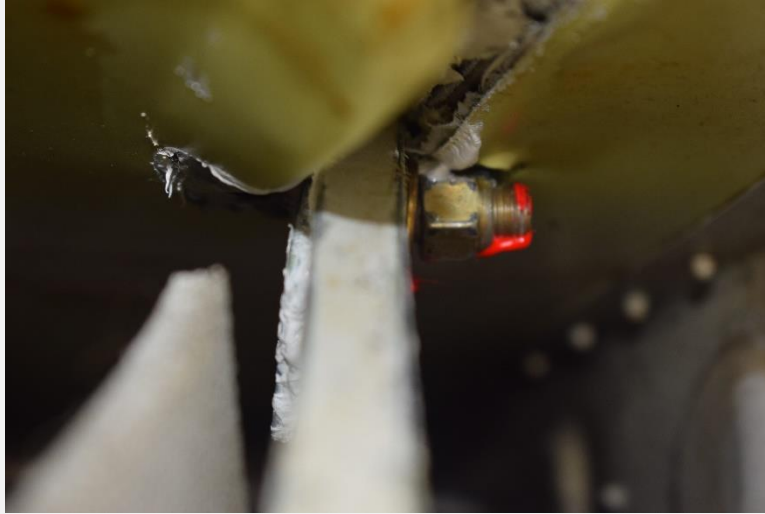
Figure 9. The inner bolt, during aircraft recovery following the accident, bent through 90 degrees by the undercarriage leg on its collapse.
