Basic Report

Classification: Accident

- File Number 10022022
- Responsible entity BAAI
- Occurrence status Accident (nose-wheel detached from the aircraft on landing)

- Registration 9H-LQA
- State of Registry Malta
- Flight Number Falcon 5E
- Manufacturer Tecnam
- Model P92 Echo JS
- Year built N/A
- Serial Number N/A
- Aircraft category Single Engine Category "A"

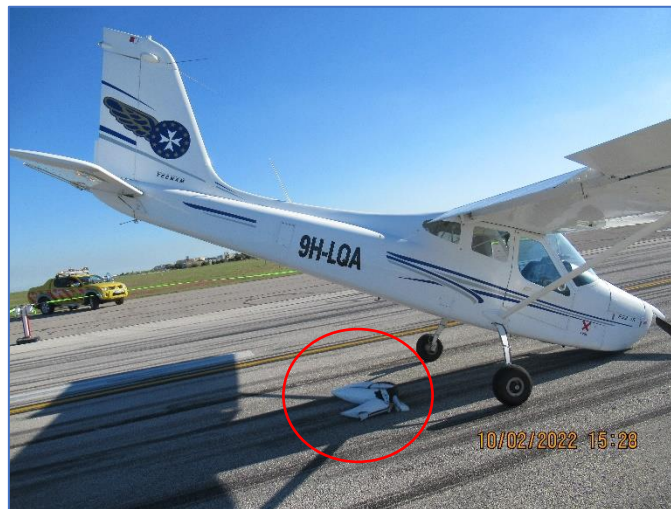
A stable approach was followed by a 3-point touchdown which resulted in the aircraft bouncing off the RWY and subsequently making a hard landing with the nose gear touching the RWY surface first. Although the debris found on the RWY indicate that the nose wheel assembly was damaged during the second touchdown, the aircraft was able to maintain (approximately) the runway centreline until the nose-wheel separated from the aircraft (Fig. 1). Examination of the airplane by the BAAI Chief Investigator revealed substantial damage to the nose-wheel assembly and the propeller and minor damage to the front underside of the aircraft (Fig. 1 & 2). No Injuries or damage to third party property was noted.

Fig 1 Nose-wheel assembly

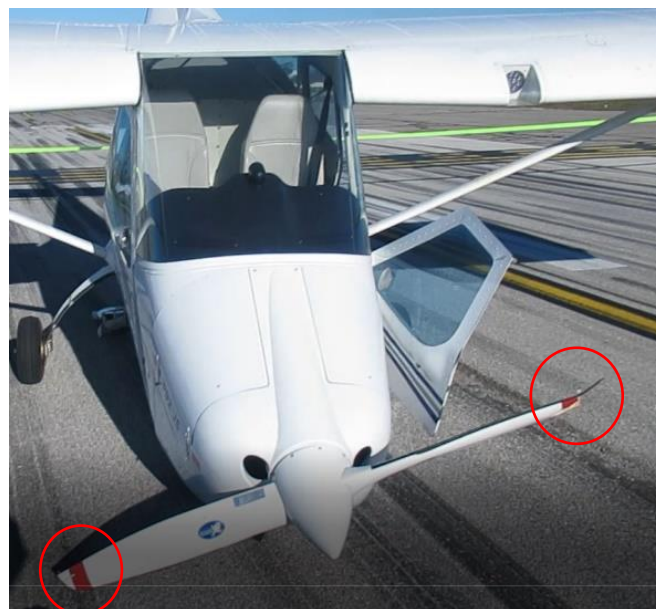
Fig. 2 Damage to the propellers and underside of the aircraft

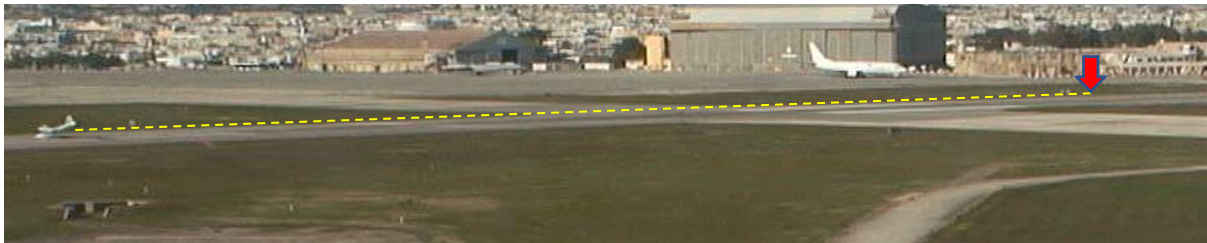
Video surveillance of the occurrence indicates that the aircraft approached the runway at the appropriate angle and aimed for the correct touchdown zone on the runway. A close examination of the video surveillance footage reveals that the probable cause of the accident, was that the flare was too low and too shallow leading to a hard and flat landing. The hard impact with the RWY resulted in a series of bounces which damaged the nose-wheel rendering the aircraft's nose-wheel unusable (*see appendix 1 for correct flare procedure*). After the first impact, the aircraft continued down RWY 23 for approximately 220 meters and (*more or less*) maintaining the centreline until the nose-wheel detached (*Sheared off*) from the aircraft causing the aircraft to skid to the right on the underside of the fuselage and the propeller to come in contact with the RWY.

Fig. 3 Showing touchdown point and aircraft final position on RWY 23

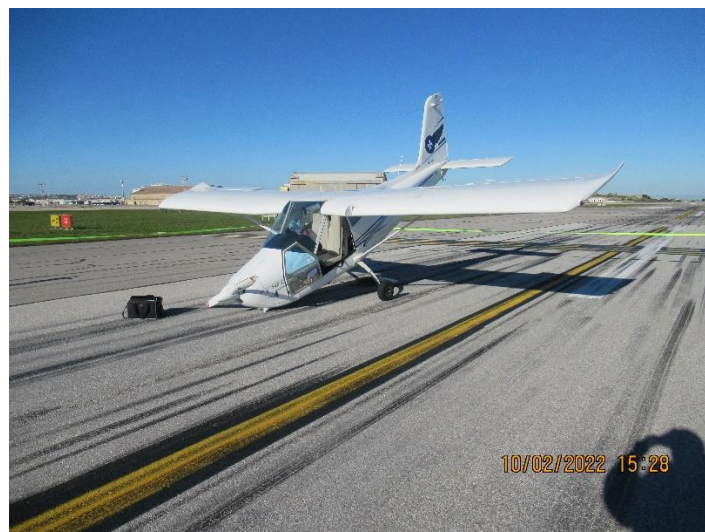
Fig. 4 Front view of the aircraft
