Preliminary Report

CLASSIFICATION: Accident/Incident

• File Number: BAAI/13042023

Registration: 9H-VVH

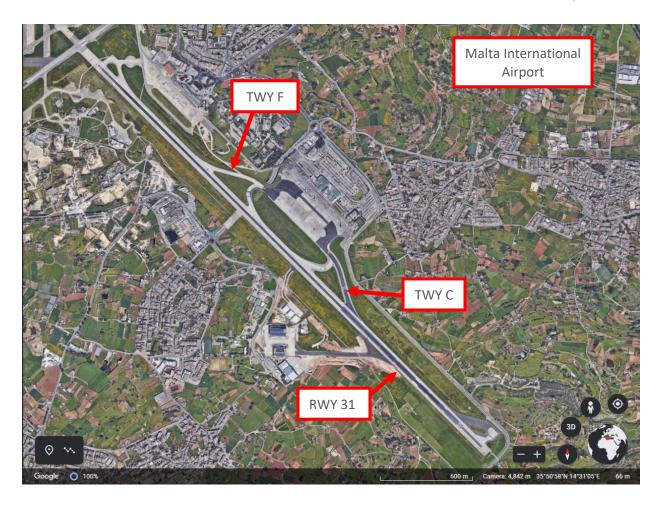
A strike mark with the colour corresponding to that of the aircraft was found on the centerline of RWY 31 just beyond the intersection with TWY F. The crew reported that the take-off had been initiated at the intersection with TWY C.

Figure 1: RWY 31 at LMML, showing TWY C and TWY F. (Source: Google Earth)

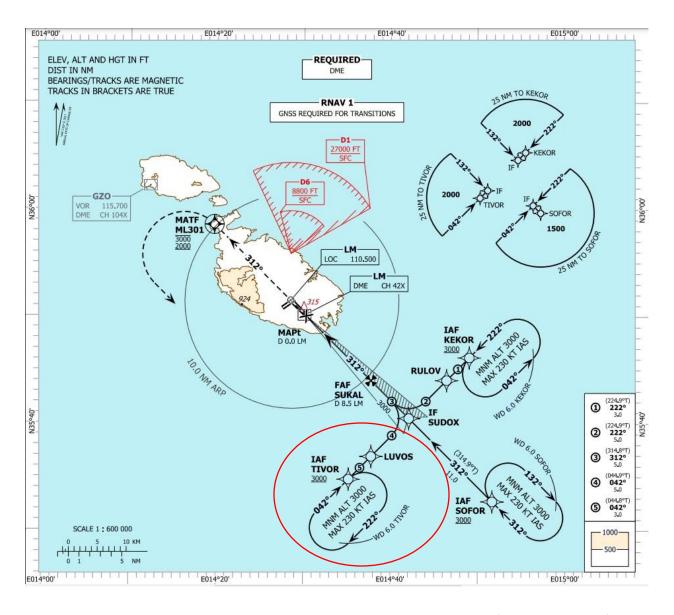
The aircraft suffered a tail strike on rotation during take-off from RWY 31. The crew reported that they continued the take-off and climbed to 5,500 ft before joining the hold at TIVOR (IAF RWY 31) to burn fuel and returning to land on RWY 31. The aircraft landed 38 minutes after take-off without further incident.

Figure 2: The Instrument approach to RWY 31 at LMML, showing IAF TIVOR (Source: Malta AIP).
