Basic Report

**B737-800 instructed by ATC to perform a go-around RWY 13
due to Tecnam P2002 Sierra JF departed RWY 05 without authorisation,
on Wednesday 1 June 2022**

Classification: Incident

- File number BAAI/01062022
- Responsible entity BAAI [Bureau of Air Accident Investigation]
- Occurrence status Incident - Runway Incursion
Aircraft took off without Air Traffic Control [ATC] take-off clearance

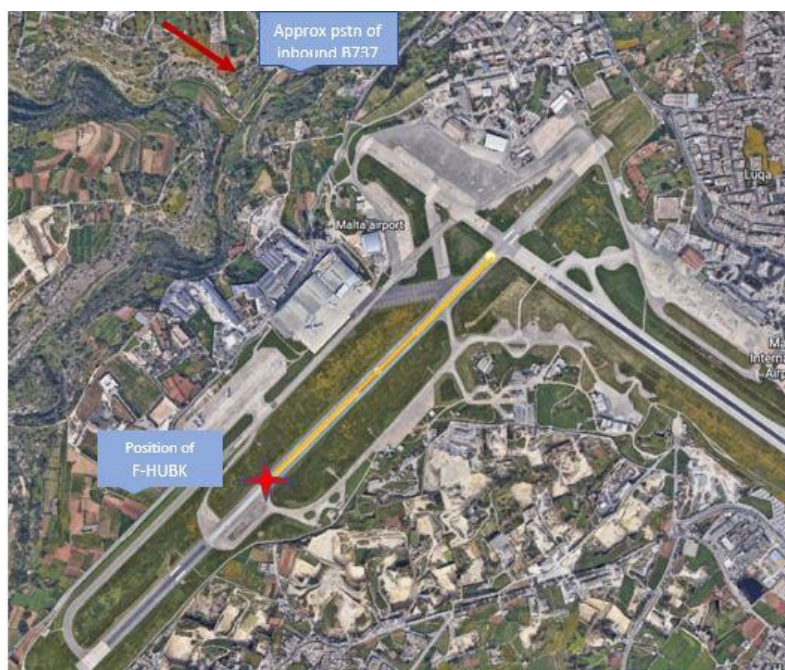
At 13:27:24 UTC, the crew of the Tecnam informed Aerodrome Control [ADC] *“ready for departure”*. ATC instructed the Tecnam to *“line up RWY 05, intersection PAPA, and wait”*, and the crew acknowledged, *“line up 05, intersection PAPA, and wait”*. ATC cleared the inbound B737 to land on RWY 13, and crew acknowledged landing clearance.

At 13:29, the Tecnam commenced take-off roll without having received a take-off clearance, and took off from RWY 05. ATC attempted to stop the Tecnam by giving the instruction to “*hold position, hold position*”, but, during the subsequent interview, the aircraft crew reported that they did not hear the instruction. ATC immediately instructed the inbound aircraft to perform a go-around, “*go around, go around*”.

The crew of the Tecnam continued with the take-off and, when airborne, levelled off at 300’ until the end of the runway so as not to infringe the path of the B737 going around, and continued climb when past the threshold of RWY 23. Crew apologised and requested to return for landing.
