**SERIOUS INCIDENT**

<b>Aircraft Type and Registration:</b>	Bombardier BD-700-1A10 Global 6000, 9H-VJM	
<b>No &amp; Type of Engines:</b>	2 Rolls-Royce BR710A2-20 turbofan engines	
<b>Year of Manufacture:</b>	2013 (Serial no: 9630)	
<b>Date &amp; Time (UTC):</b>	11 December 2019 at 0550 hrs	
<b>Location:</b>	Liverpool Airport	
<b>Type of Flight:</b>	Commercial Air Transport (Passenger)	
<b>Persons on Board:</b>	Crew - 3	Passengers - 1
<b>Injuries:</b>	Crew - None	Passengers - None
<b>Nature of Damage:</b>	None	
<b>Commander's Licence:</b>	Airline Transport Pilot's Licence	
<b>Commander's Age:</b>	53 years	
<b>Commander's Flying Experience:</b>	11,506 hours (of which 3,864 were on type) Last 90 days - 104 hours Last 28 days - 48 hours	
<b>Information Source:</b>	AAIB Field investigation

**Synopsis**

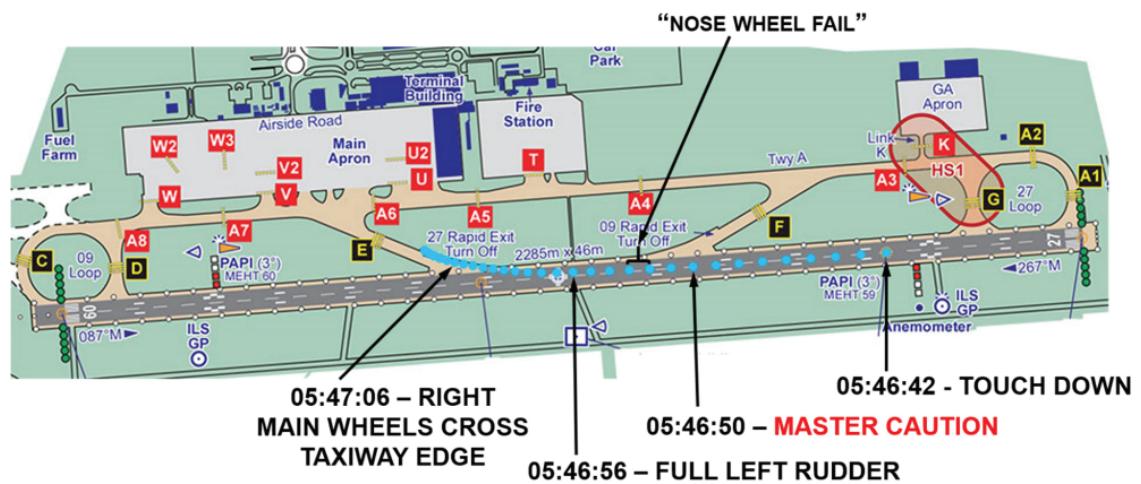
**Figure 1**

Liverpool Airport with the aircraft's ground track shown as blue dots (at one second intervals)

As the speed reduced, the aircraft turned more rapidly to the right and the commander was unable to keep the aircraft on the paved surface. The commander did not recall the speed at which the aircraft left the paved surface, but the co-pilot believed it was approximately 50 kt and he recalled seeing the NOSE STEER FAIL caution on the EICAS before the aircraft left the runway.

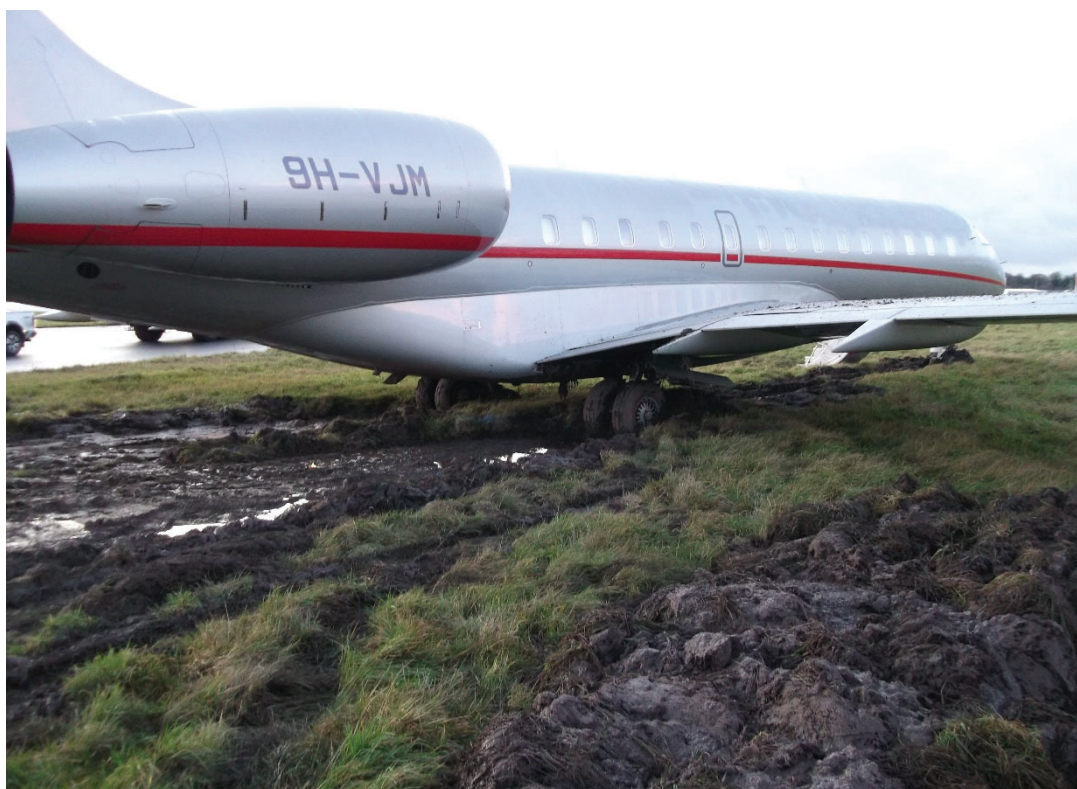
**Figure 2**

The aircraft had left the runway just before the start of runway rapid exit turnout (Exit E) to the right. It travelled approximately 30 m on the grassed area and its landing gear wheels sank into the topsoil and brought the aircraft to a stop. Mud and soil encased the lower parts of the landing gear (Figure 2). The flaps and slats were up, and mud and soil had been thrown upwards to become entrapped within the flap track mechanisms and fairings. Mud was also present on the wing leading edges and wheel bays and there were mud splatters on the engine intake rings.

9H-VJM on the soft ground

The aircraft had left a pair of faint right mainwheel tyre tracks on the runway surface up to the point where it had run on to the grass. There were no discernible marks made by the left mainwheels or nosewheels.

Apart from the deep wheel tracks in the grass there was no damage to any of the airport signage or fixtures.

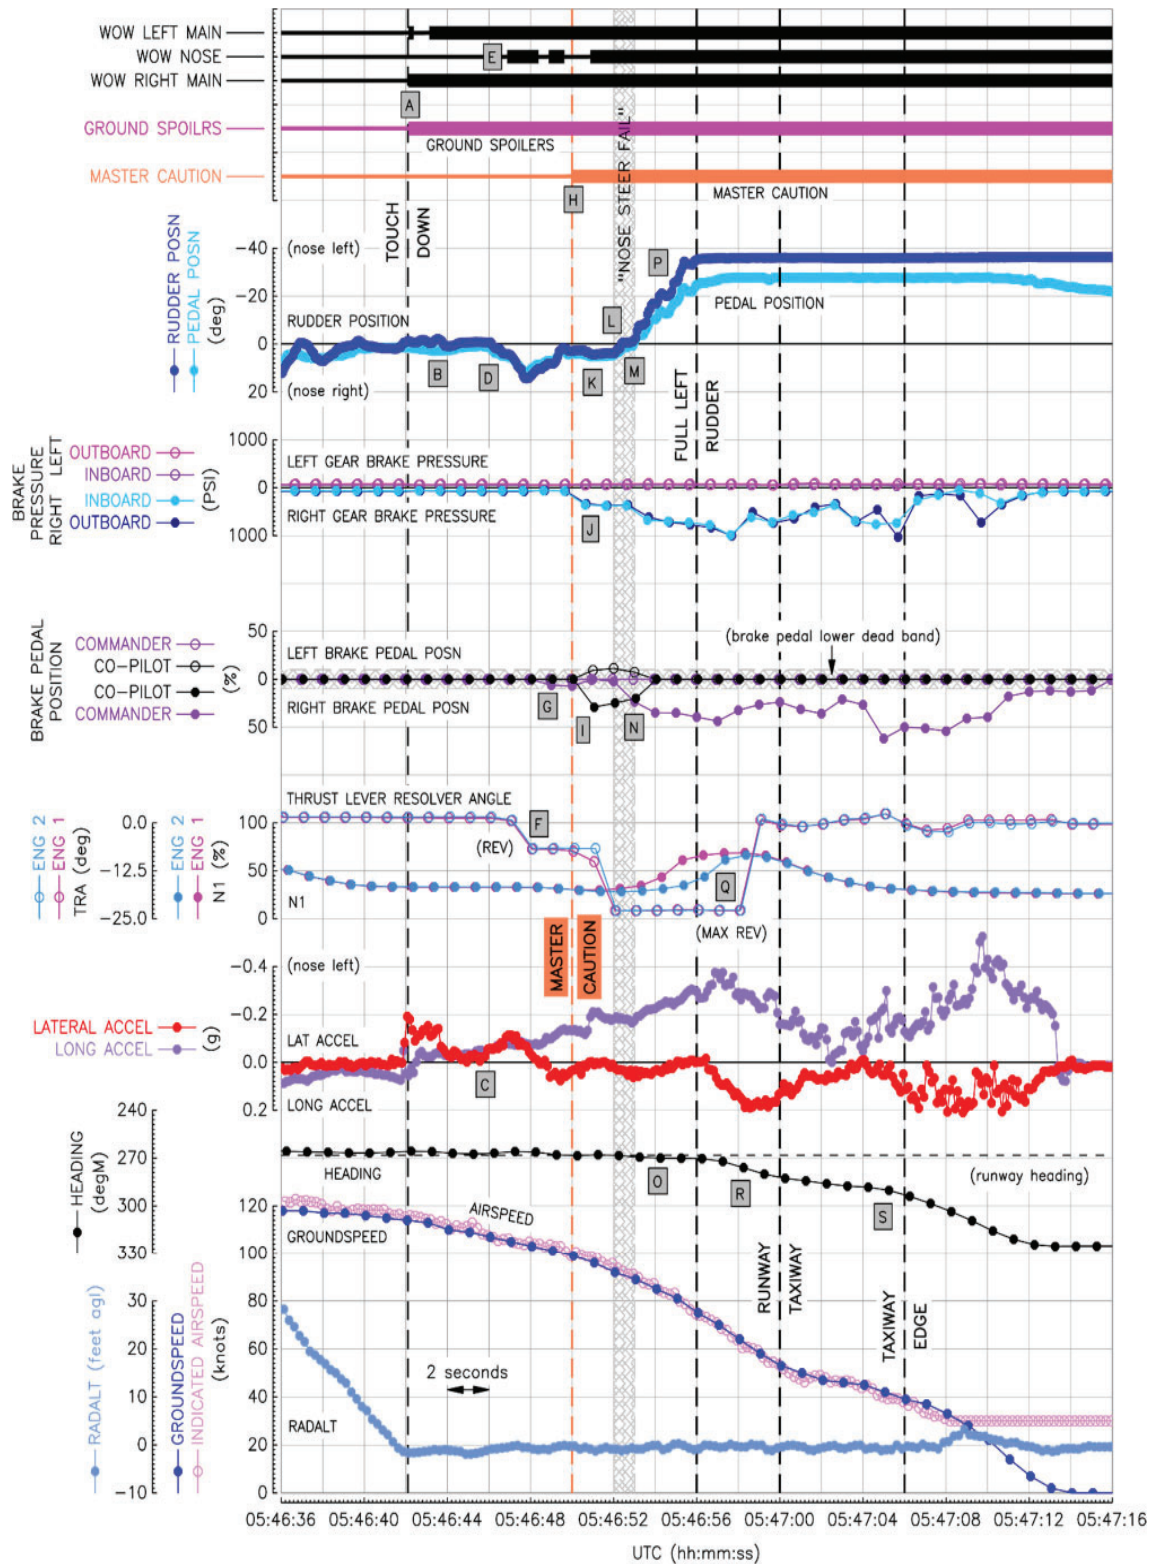
**Figure 3**  
Recorded data for the landing

The key points from Figure 3 are:

- 0546:42 – the aircraft touched down on mainwheels [A] slightly right wing down and nose left. The airspeed was about 115 KIAS and the ground spoilers deployed.

- Small right rudder pedal inputs<sup>2</sup> made [B] to straighten up the aircraft (still on just the main gear).
- The aircraft started to turn left [C] – one of the crew immediately applied right rudder pedal to counter this movement [D].

- The nosewheel touched down nearly five seconds after initial ground contact of the main wheels [E].
- The thrust levers [F] were pulled back from IDLE to REV[ERSE].

- A small input on the commander's right brake pedal is recorded [G] but within the brake pedal's dead band<sup>3</sup> so brake pressure was not applied. The input lasted about two seconds.

- The nosewheel 'bounced' twice over a period of four seconds during which a MASTER CAUTION occurred (with corresponding illumination of the MASTER CAUTION button, and a single chime heard on the CVR recording) [H].

- The co-pilot applied a small input to the brake pedals – left travel is in the dead band and just under one quarter travel on the right [I] so only right gear brakes were applied [J]. A corresponding input on the right rudder pedal is also recorded [K].

- Two seconds after the MASTER CAUTION is issued, the commander verbally announced a "NOSE STEER FAIL" (heard on the CVR recording) [L] just as the thrust levers were pulled back to MAX REV[ERSE]. A left rudder pedal input was made [M] (co-pilot still applying right brake) with a corresponding right brake pedal input by the commander [N].

- The aircraft started to veer to the right [O] and increasing amounts of left rudder (and right brake by the commander) were applied. Maximum rudder deflection was reached after four seconds [P] and no further braking by the
