CLASSIFICATION: ACCIDENT/INCIDENT

- File Number: *BAAI/ACR-002-2021*
- Responsible entity: *Bureau of Air Accident Investigation*
- Occurrence status: *Investigation ongoing*

- Registration: *9H-QCJ*
- State of Registry: *Malta*
- Flight Number: *N/A*
- Manufacturer: *The Boeing Company (USA)*
- Model: *737-800*
- Year built: *2016*
- Serial Number: *62690*

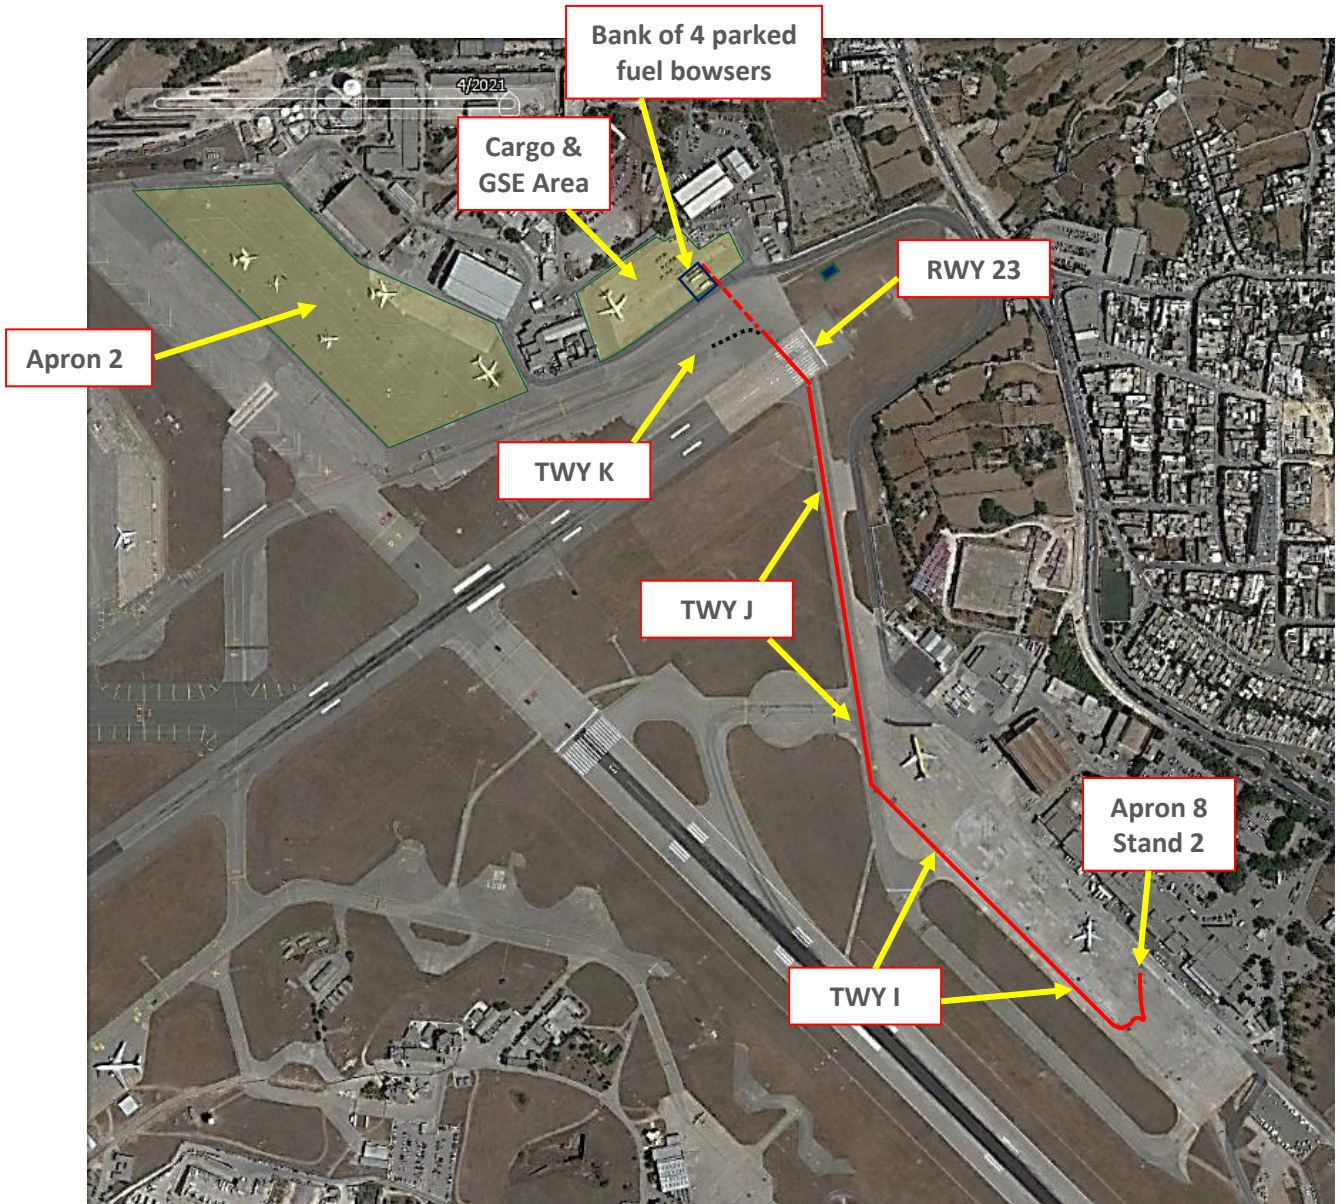
9H-QCJ was being repositioned from Apron 8 to Apron 2 under tow. The aircraft was pushed back from Stand 2 onto TWY I and the tow proceeded along TWY I and TWY J, crossing RWY 23. As the tow truck turned onto TWY K, the tow bar became detached and the aircraft proceeded straight, entering the Cargo and GSE Area and coming to rest against a bank of 4 fuel bowsers parked side by side. (Figures 1 and 2).

Figure 1: Aerial view of LMML (Google Earth), with overlay showing the tow path followed and place of aircraft impact with parked fuel bowzers.

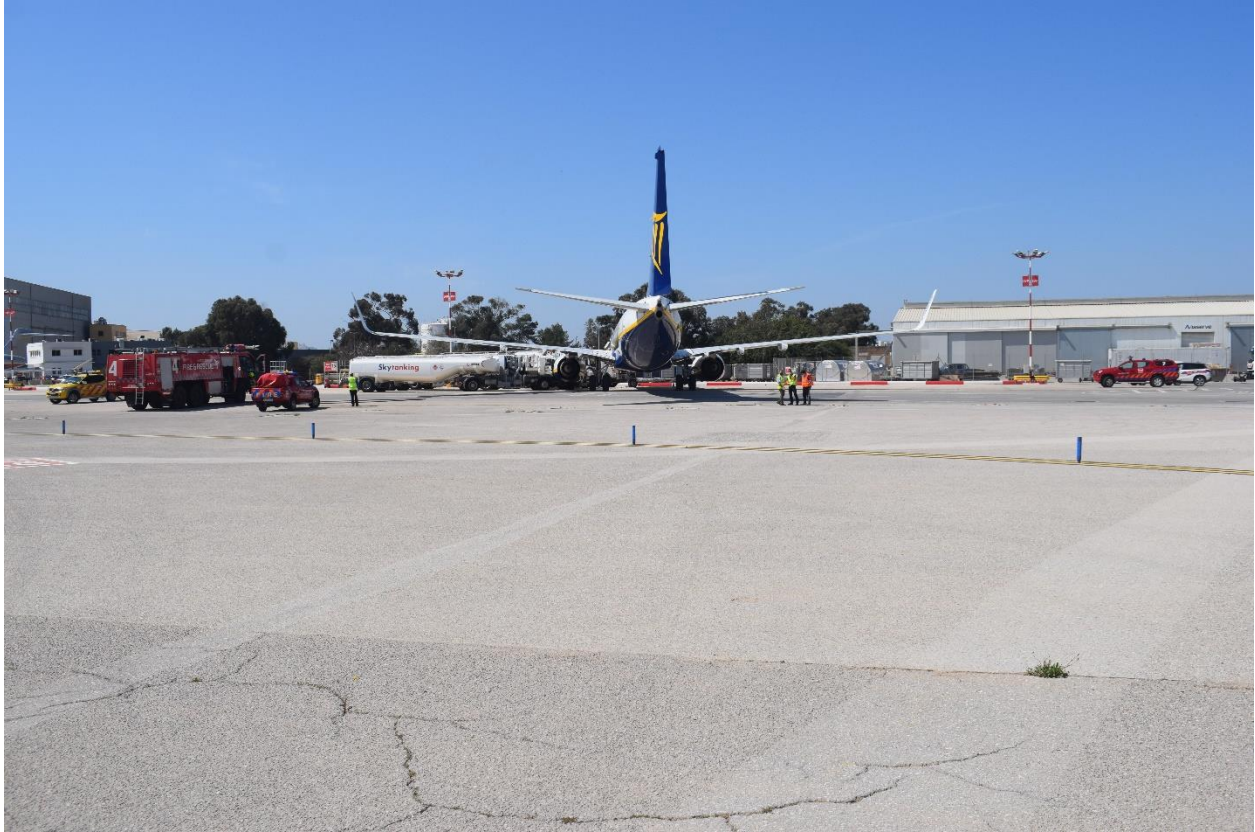
- Highest damage to aircraft: *Moderate*
- Third Party Damage: *Moderate damage to two parked fuel bowzers;
Minor damage to one parked fuel bowser.*

Figure 2: *The aircraft at rest against the bank of four fuel bowsers.*
