## **AIRCRAFT ACCIDENT REPORT** (Ref. N0 1/2018)

### **Report on the Accident of Aircraft Registration Number VP-BZE, blown off its parking position on 27th December 2017**

## Report Number 1/2018

Place of accident:	Apron 4, Malta International Airport
Date and time:	27th December 2017
Number of persons on board:	Nil
Number of fatalities or injuries:	Nil

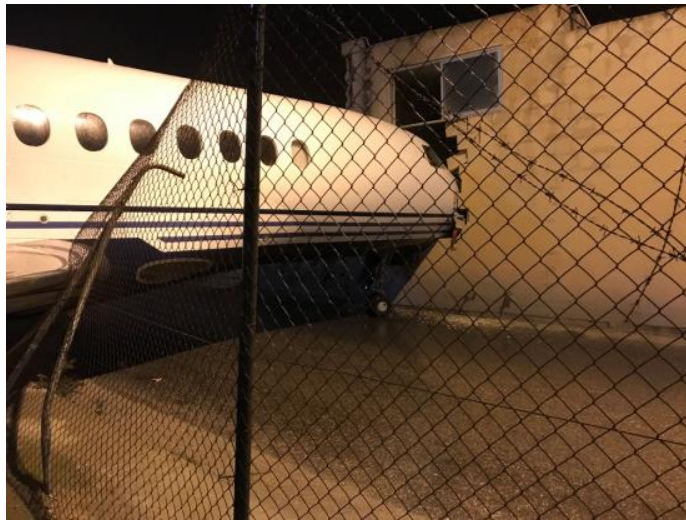
*Fig.1. The result of the accident.*

On the 27th of December 2017 at approximately 20.30 UTC, a Dassault Falcon 7X registration number VP-BZE departed the stand, rolled down the slope on the north-western edge of Park 4, went through the airport perimeter fence, crossed the road and crashed into the building across the road, where it came to a halt. At the time of the accident, there was no one on board and the aircraft was not being tended to. It was dark with patches of rain; the surface wind on Runway 05, which is close to Park 4, was reported to be ranging between 220°–230°, gusting to 35 kts.

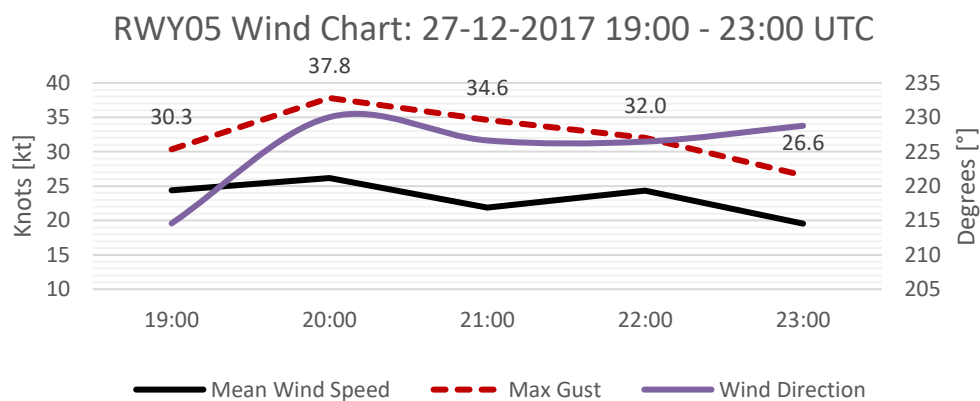
Fig. 2. The atmospheric conditions on RWY05 which is close to PARK4.

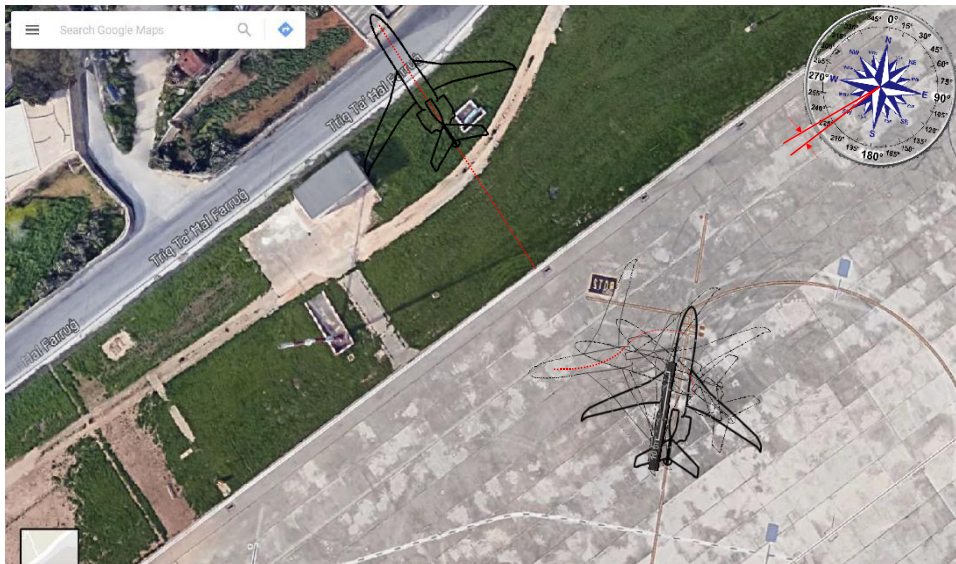
**1.1 The Accident:** The aircraft parking position was stand 2 on Park 4 that is located at approximately 35° 51' 18.4" N, 14° 28' 2.9" E, Aircraft heading 9.5° (true north). At the time of the accident, the wind was blowing from the port rear quarter of the aircraft that tended to propel the aircraft forward and rotate it anticlockwise in the direction of the wind, due to the natural weather-cocking effect caused by the fin (Empennage).

Fig. 3. Schematic of the aircraft motion during the accident.

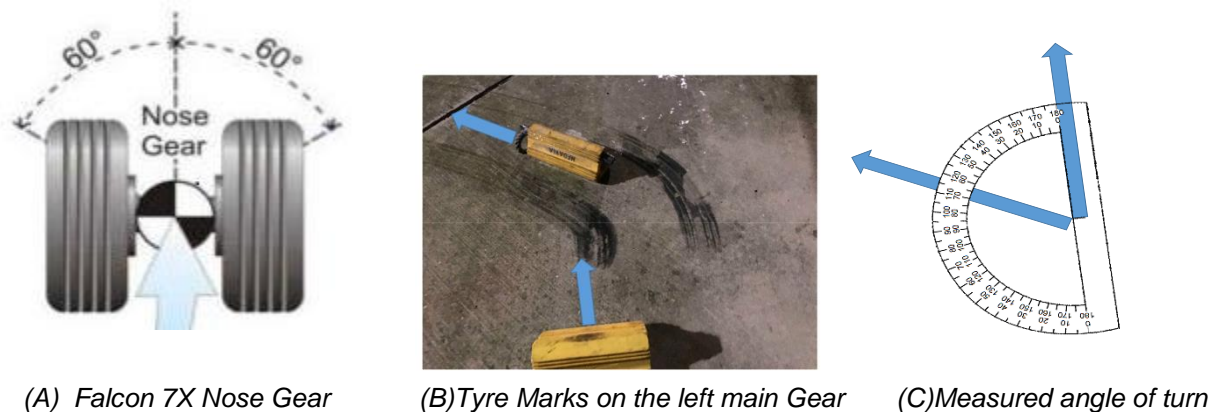
Fig. 4B. Photographs of the chocks as found on-site

Note 1. Fig 4 Shows photographs of the position of the chocks as found on-site indicate that the aircraft was chocked on the outer wheel of the port undercarriage and at the nose gear. Tyre marks consistent with the motion of the aircraft as captured on CCTV (Appendix B) and the wheel dimensions and pair combination were observed.

(A) Falcon 7X Nose Gear

(B) Tyre Marks on the left main Gear

(C) Measured angle of turn

**1.2** This effect became sufficiently strong to castor the nose wheel and deflect it anticlockwise. The aircraft rotated to the left on its outer tyre on the port undercarriage, with the two nose wheel tyres narrowly missing their chocks. The rotation continued up to a point where the angle between the tyre and chock became acute enough to dislodge the front chock (*Left Main-Gear Fig 4 B*), a movement that left the aircraft completely free. The aircraft, by this time, had

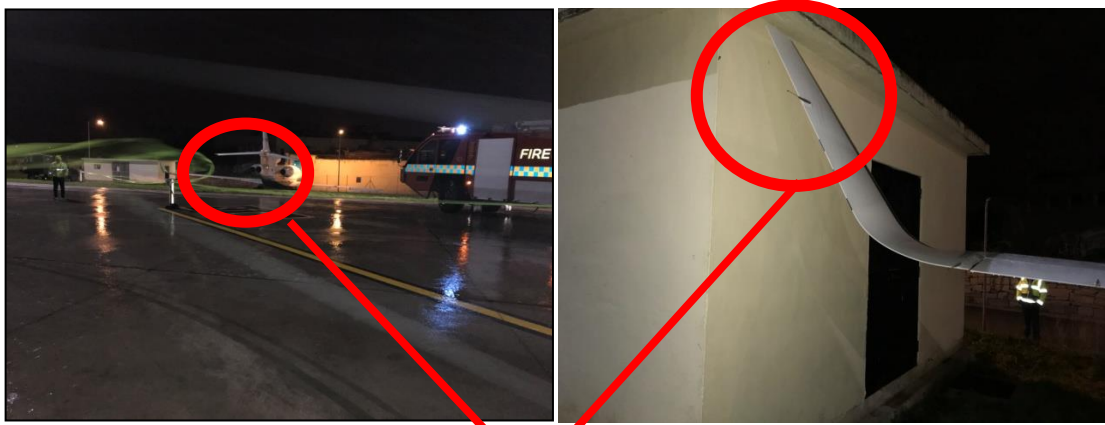
*Fig.5. A photograph showing how the left winglet missed the High Voltage Distribution Centre wall by approximately 4 centimetres.*

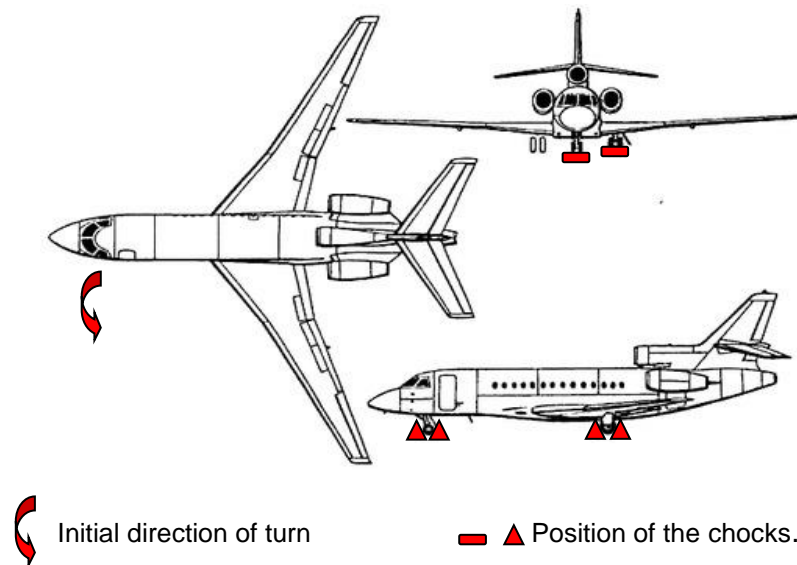
During the on-site investigation, the Captain confirmed that on the day preceding the accident, 26th December, the aircrew had parked the aircraft with the Park Brakes OFF in accordance with the standard practice for this type of aircraft. The ground handlers confirmed that they provided their standard service which included placing chocks on the nose-wheel and the left main-gear.

Fig.6. Diagram intended to offer a general idea of the manner in which the aircraft was chocked. It does not represent the exact position of the chocks. The aircraft involved in the accident was only chocked on the nose wheel and the left undercarriage

1. All aircraft should be chocked on the port and starboard main under-carriage and the nose wheel when the park brakes are selected “off” and the aircraft is left unattended.
2. Ground service providers should amend their standard services to include all items in *Recommendation 1* for aircraft parked outdoors for an extended period of time.
3. Crews should be aware of and strictly adhere to the recommended standard procedures, unless the recommended standard procedure in the *Ground Servicing Manual* is less restrictive than the Airport or CAD recommended procedures. In such cases the most restrictive shall apply.
4. It is recommended that Dassault clarify the meaning of “High Wind” in the Dassault Falcon 7X Technical Manual.

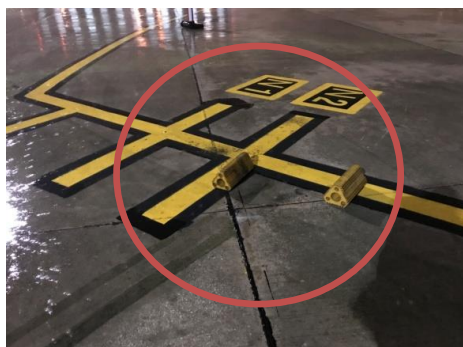
Fig. 7. Show the Nose-Wheel chocks as they were found after the accident.

**2.3.3** The distance between the chocks, tyre marks and the fact that the nose-wheel chocks were still almost parallel to each other, suggests that the position they were placed in when securing the aircraft was not disturbed by the movement of the aircraft. (Fig.7). This suggests that the nose-wheel chocks were not blocking the nose-wheel from moving as they were intended to do.

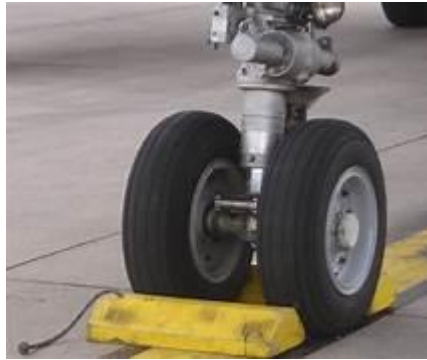
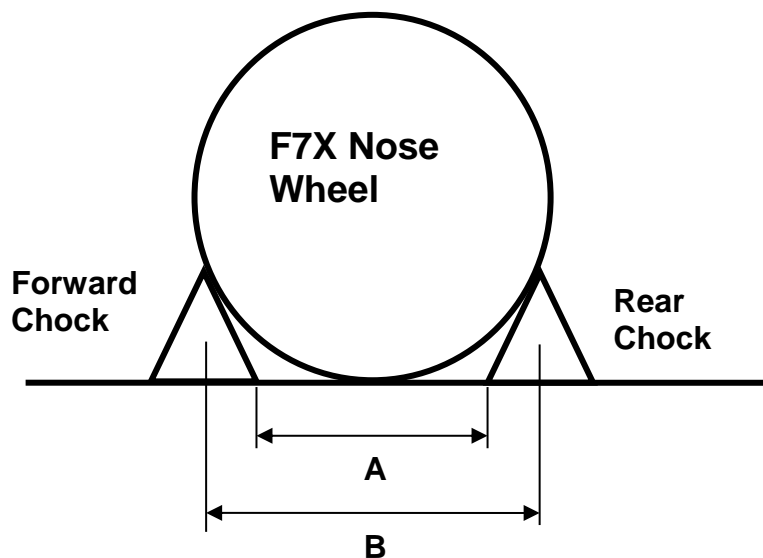
Fig. 8A. Example of properly placed Chocks on the nose-wheel.

Fig 8B

*Note 6. Chocks placed as shown in the example (Fig.8A&B) would not allow the nose-wheel to castor. The actual distance between the chocks at the base (equivalent to the distance "A" on the diagram) was measured to be 43cm.*
