# Accident Report

COLLISION BETWEEN  
BOEING 737-800 9H-QCJ  
UNDER TOW  
AND  
PARKED FUEL TANKERS  
AT  
MALTA INTERNATIONAL AIRPORT  
2<sup>ND</sup> APRIL 2021

<b>Location:</b> Taxiway K / Cargo & GSE Area at Malta International Airport.	<b>Report Number:</b> BAAI/020421
<b>Date &amp; Time:</b> 2 <sup>nd</sup> April 2021, 1130hrs (Local)	
<b>Defining Event:</b> Collision with parked vehicles.	
<b>Aircraft:</b> <b>Type:</b> Boeing 737-800 <b>Registration:</b> 9H-QCJ <b>Aircraft Damage:</b> Substantial <b>Injuries:</b> NIL <b>Flight Conducted Under:</b> N/A (under tow)

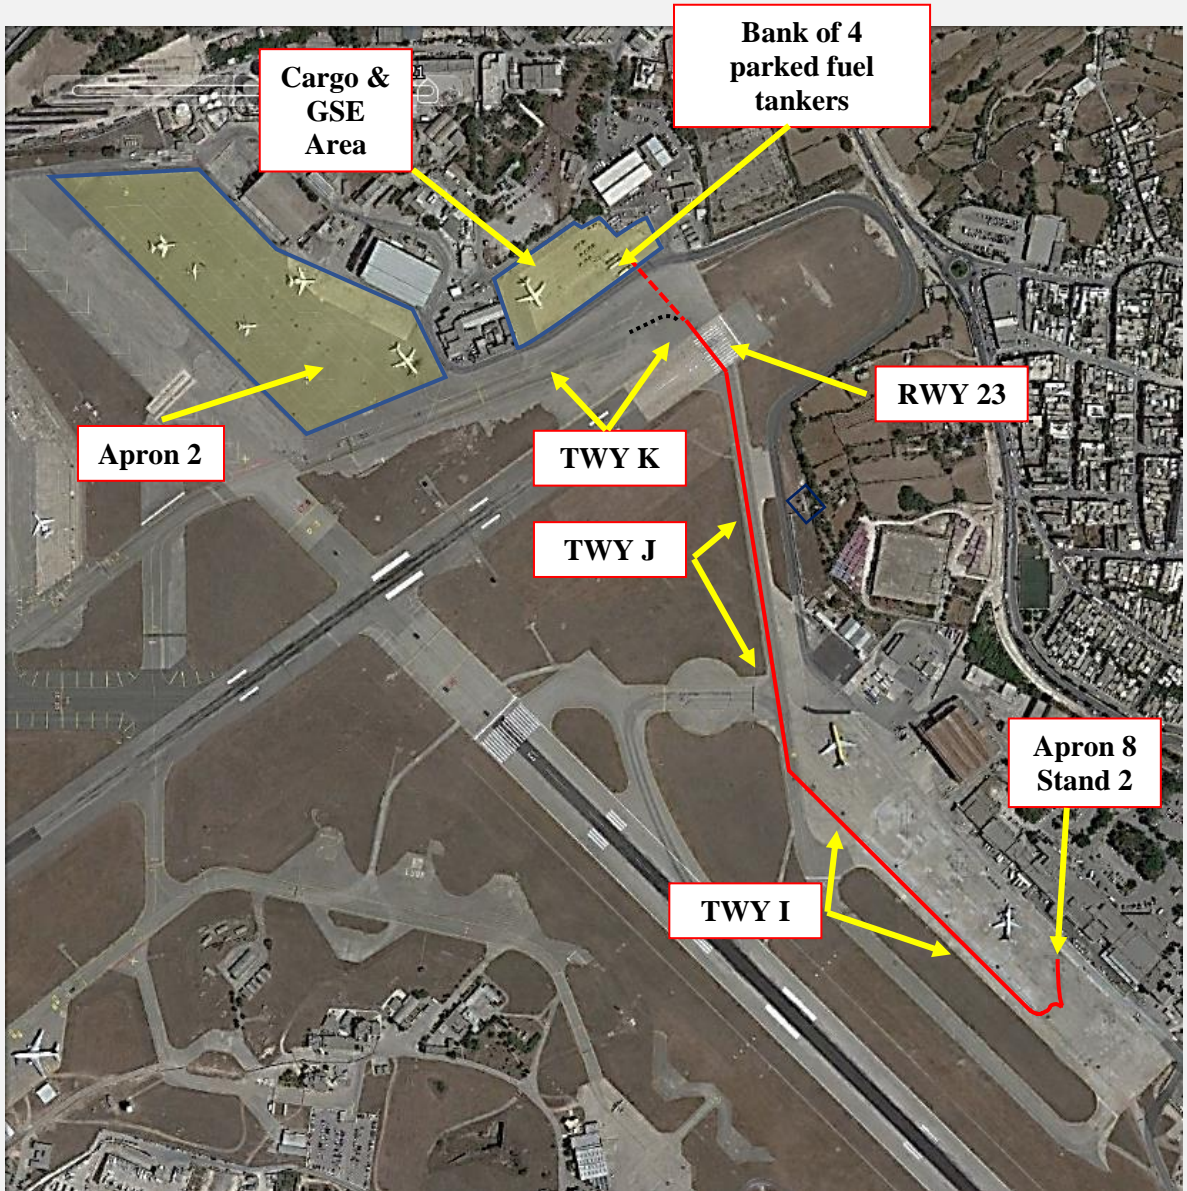
The tow bar was connected to 9H-QCJ and the aircraft was pushed back onto TWY I (India) under the supervision of the wing walker. The wing walker then alighted the tug and the tow proceeded along TWY I (India) and TWY J (Juliet) prior to crossing RWY 23. On vacating RWY 23 and as the tug turned left on TWY K (Kilo), the tow bar became detached from the aircraft. 9H-QCJ then continued straight until it collided with and came to rest against a bank of four parked fuel tankers inside the Cargo and GSE area (Figures 1 and 2).

**Figure 1:** Aerial view of LMML (Google Earth), with overlay showing the tow path followed and place of aircraft impact with parked fuel tankers.

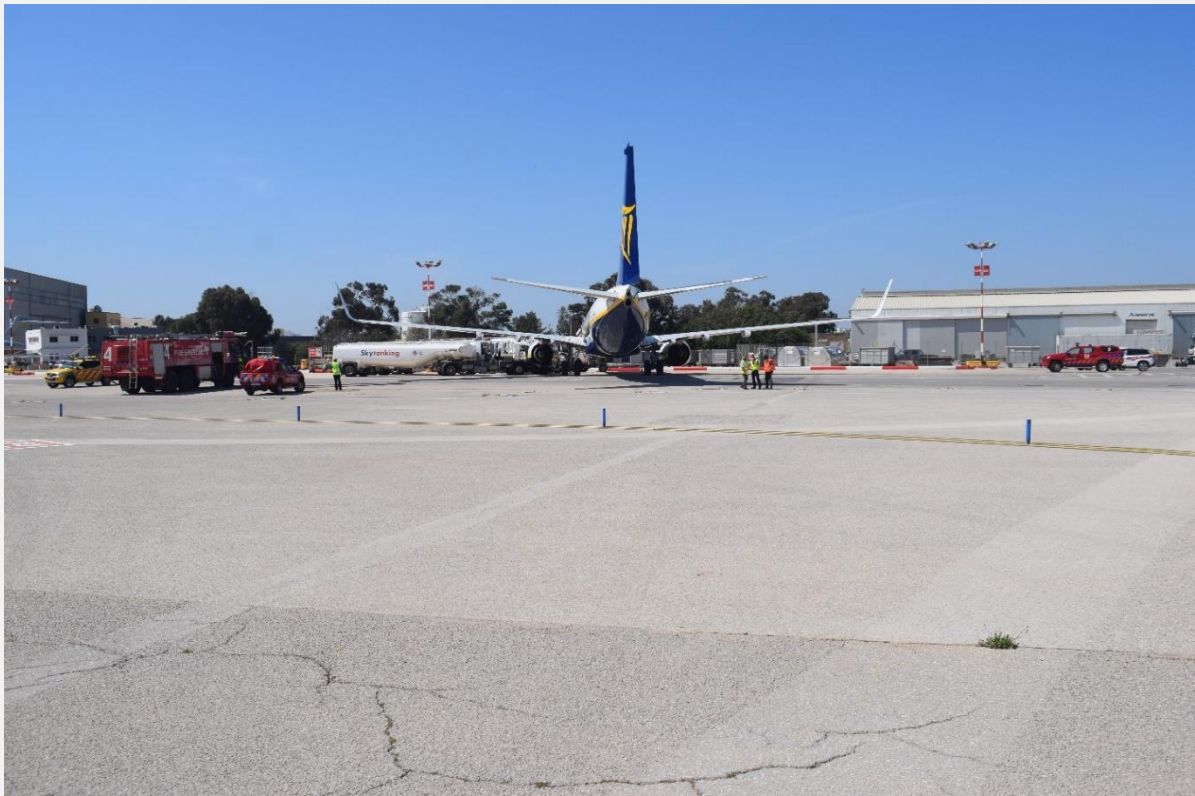
**Figure 2:** The aircraft at rest against the bank of four fuel tankers.

**9H-QCJ:** Substantial, in the nose and No. 1 Engine areas.

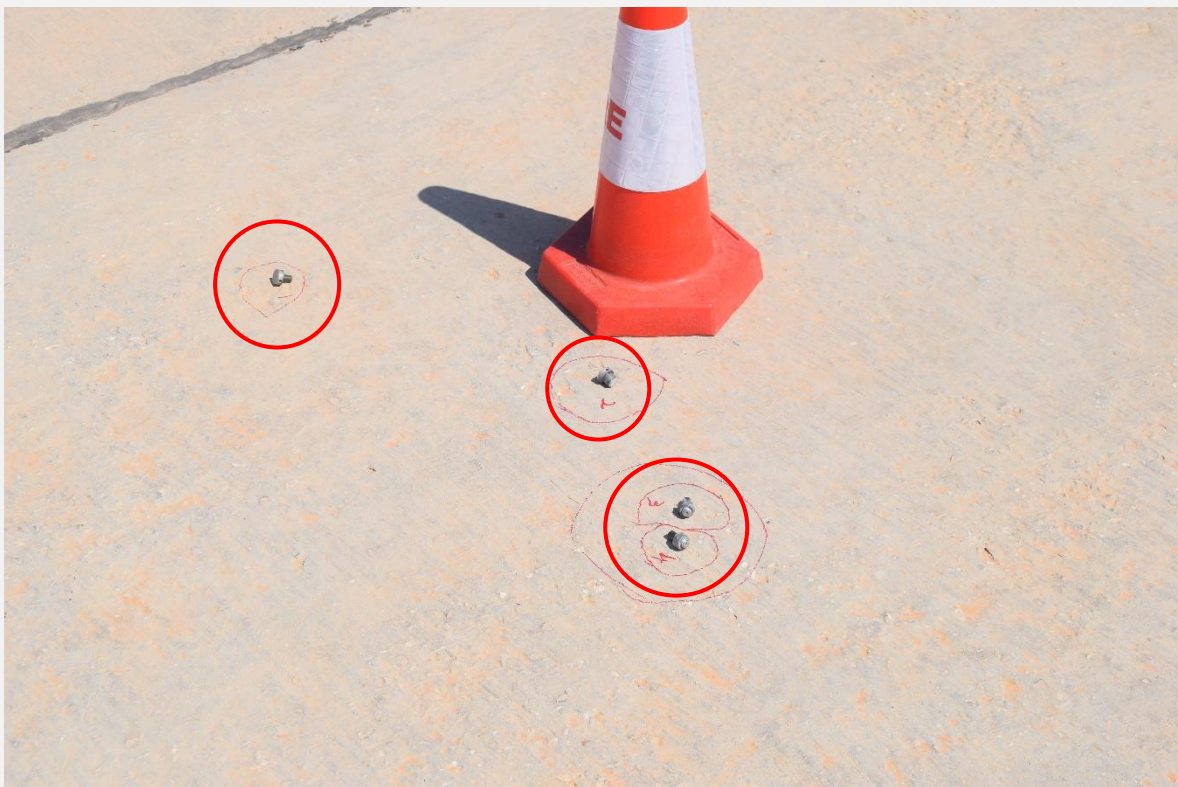
During the field investigation, the bottom part of two shear pins, one head and the bottom part of a retaining pin were found on Apron 8 close to the intersection between Stand 2 and TWY I (India) (Figure 3).

**Figure 3:** Broken shear and retaining pin parts found on Apron 8.

*Two shear pin bottom parts (marked 3 and 4); one shear pin head (marked 1); one retaining pin head (marked 2).*

The close proximity of the four items and the shearing of the retaining pin correspond to a sharp and sudden shear stress that would be experienced in a braking event as the one that occurred.

1. The correct shear pins in the tow bar are in place and not damaged;
2. Aircraft brakes are available throughout the duration of the tow;
3. Aircraft electrics are switched on if required and operational as necessary;
4. The cockpit seat is correctly adjusted to allow for effective operation of brakes;
5. The view from the cockpit seat is unobstructed;
6. Effective communication is established between the brake operator and the rest of the tow crew and, in particular, with the tug driver;
7. The aircraft can be safely secured and evacuated in the event of an emergency.

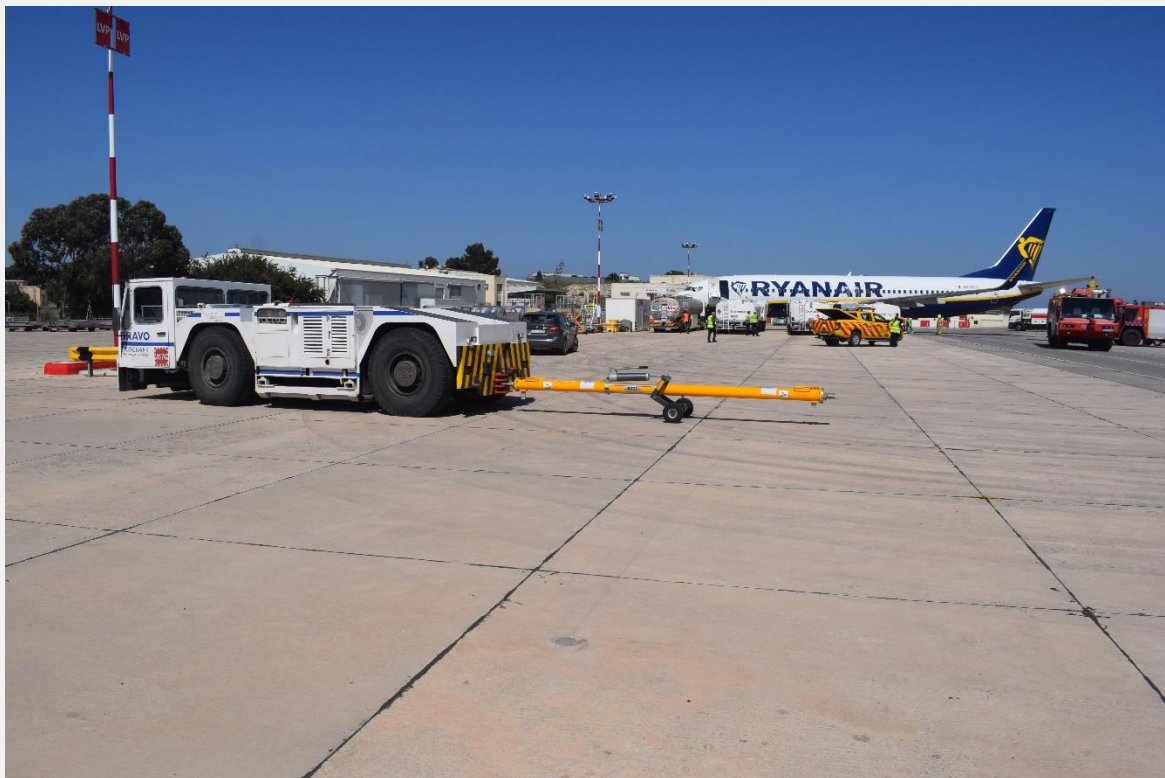
The tug used in the accident movement was a Douglas DC10-4H (Figure 4), which is ballasted at 32 metric tons and has a rated drawbar pull of 20 metric tons. The Boeing 737-800 has an empty operating mass of just over 40 metric tons, requiring a drawbar pull of under 2 metric tons in dry conditions. The use of such a tug is permissible for push back and towing of narrow body aircraft of the category of the Boeing 737, but the weight of the tug in comparison with that of the aircraft and its drawbar pull increase the risk of excessive stresses being transmitted through the tow bar and may result in the shearing of the installed shear pins, which are matched to the specific aircraft being towed. This is particularly so in the event of sudden braking as that occurring in the accident event.

**Figure 4:** The Douglas DC10-4H tug and tow bar used in the accident event.

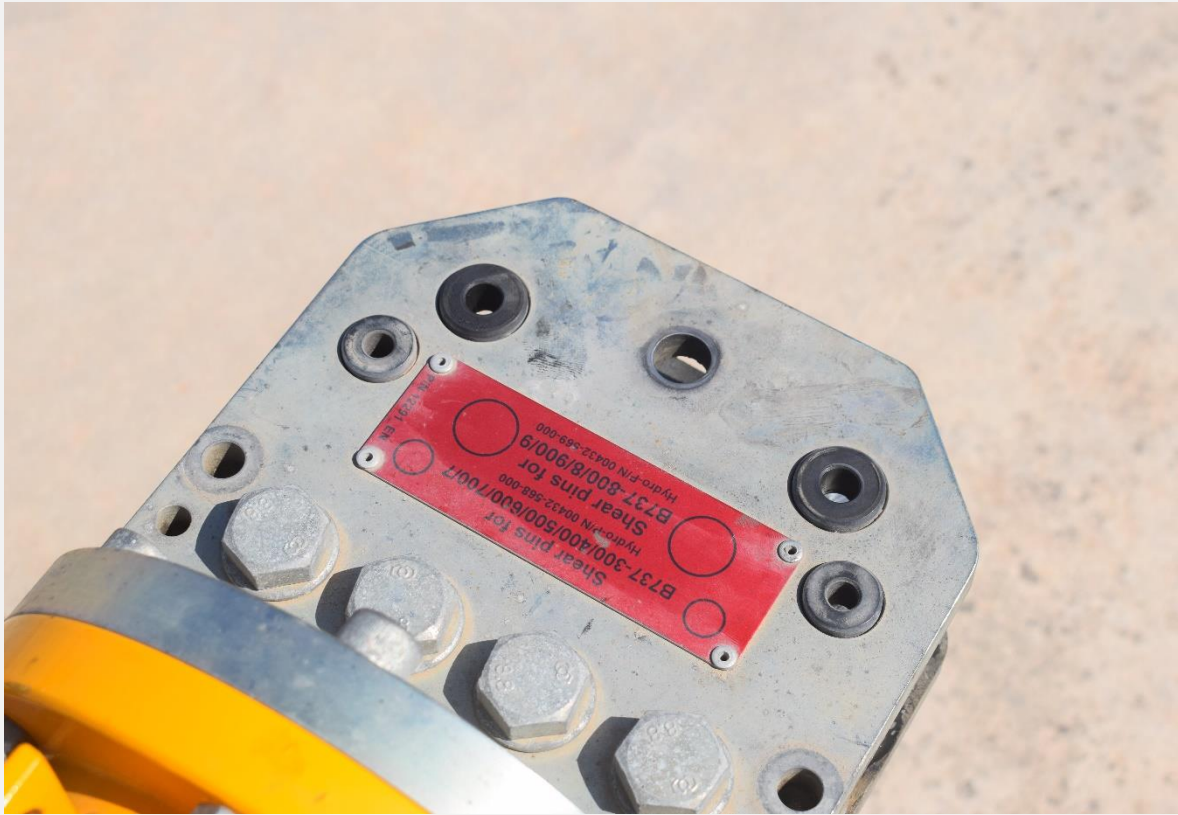
The tow bar used was of the approved type for the Boeing 737-800. The tow bar head has 2 10mm shear pins and a larger retaining bolt to reduce the risk of separation in the event the shear pins fail (Figure 5). The eyelet of the tow bar was directly attached to the bar and did not have a shock absorber, which is optional on approved tow bars. The absence of a shock

absorber allows larger shock loads to be transmitted through the tow bar and this increases the risk of shear pin failure.

**Figure 5:** The tow bar head attachment lug.

*Two sets of shear pin holes for different aircraft models as marked. The centre hole is for the retaining pin.*

The shear pins and retaining bolt have two grooves to allow failure at two points, where the tow head mates with the attachment lug. The findings on Apron 8 indicate that the tow proceeded with one shear pin completely broken, the second shear pin sheared at least at the lower point and the retaining pin sheared at the upper point.

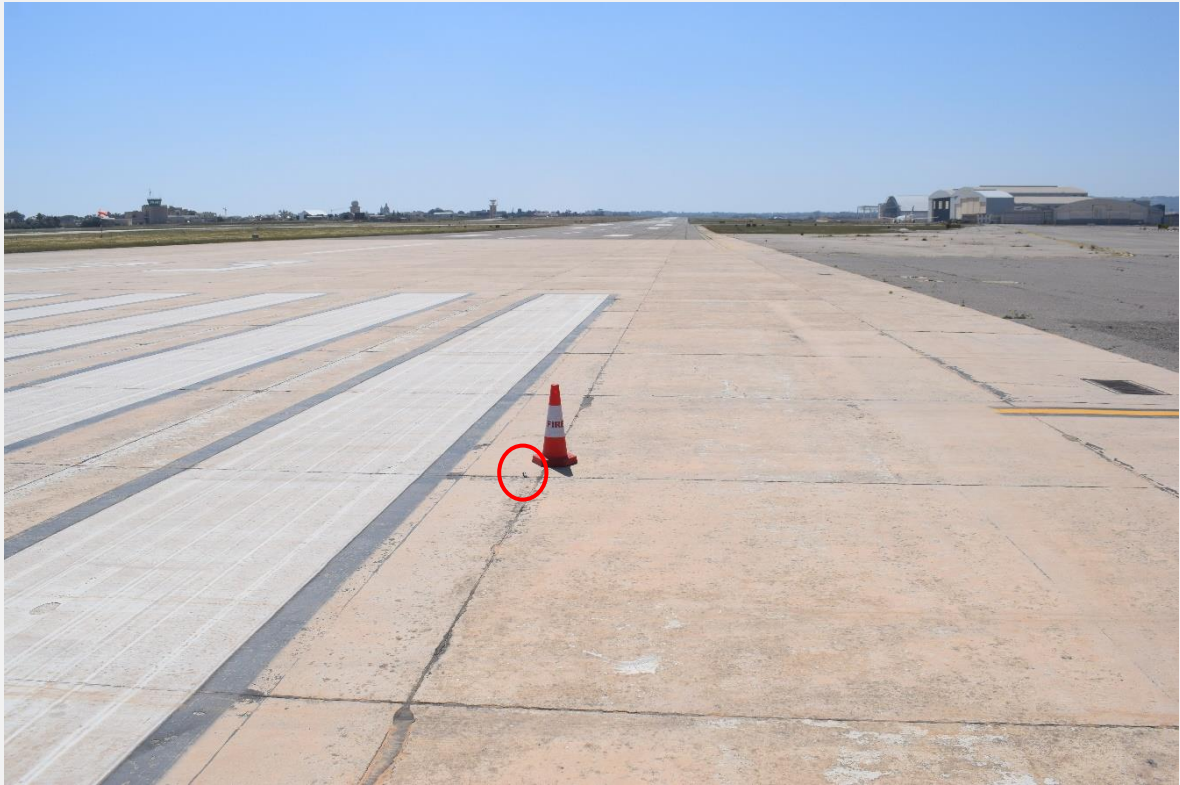
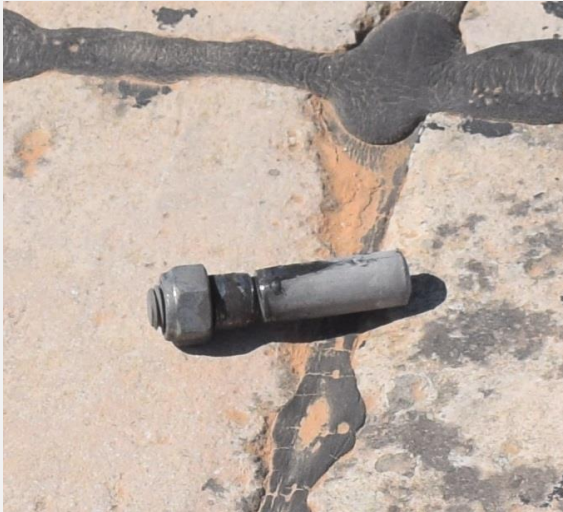
During the field investigation, the remaining part of the retaining bolt was found on RWY 23 (Figures 6 and 7) and the head of the second shear pin was found on TWY K (Kilo) (Figures 8 and 9).

**Figure 6:** The remaining part of the retaining bolt (circled) found on RWY 23.  
*The aircraft crossed the runway from left to right. TWY K (Kilo) commences just beyond the gutter.*

**Figure 7:** Close-up view of the remaining part of the retaining bolt found on RWY 23.

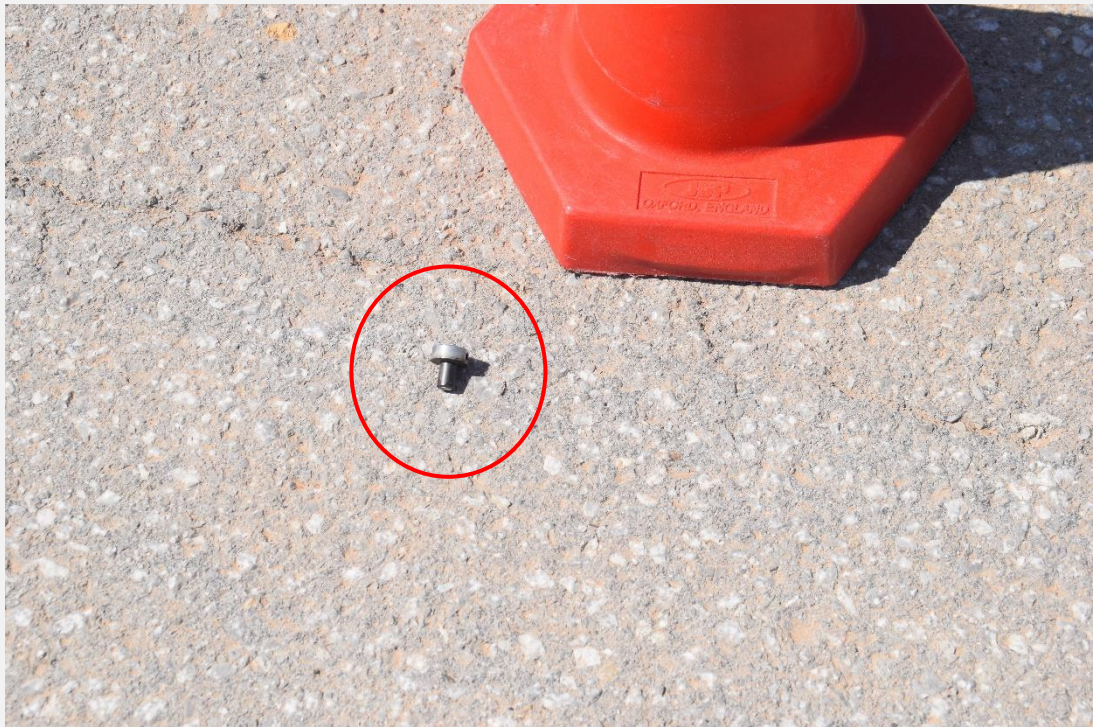
**Figure 8:** The head of the second shear pin found on TWY K (Kilo).

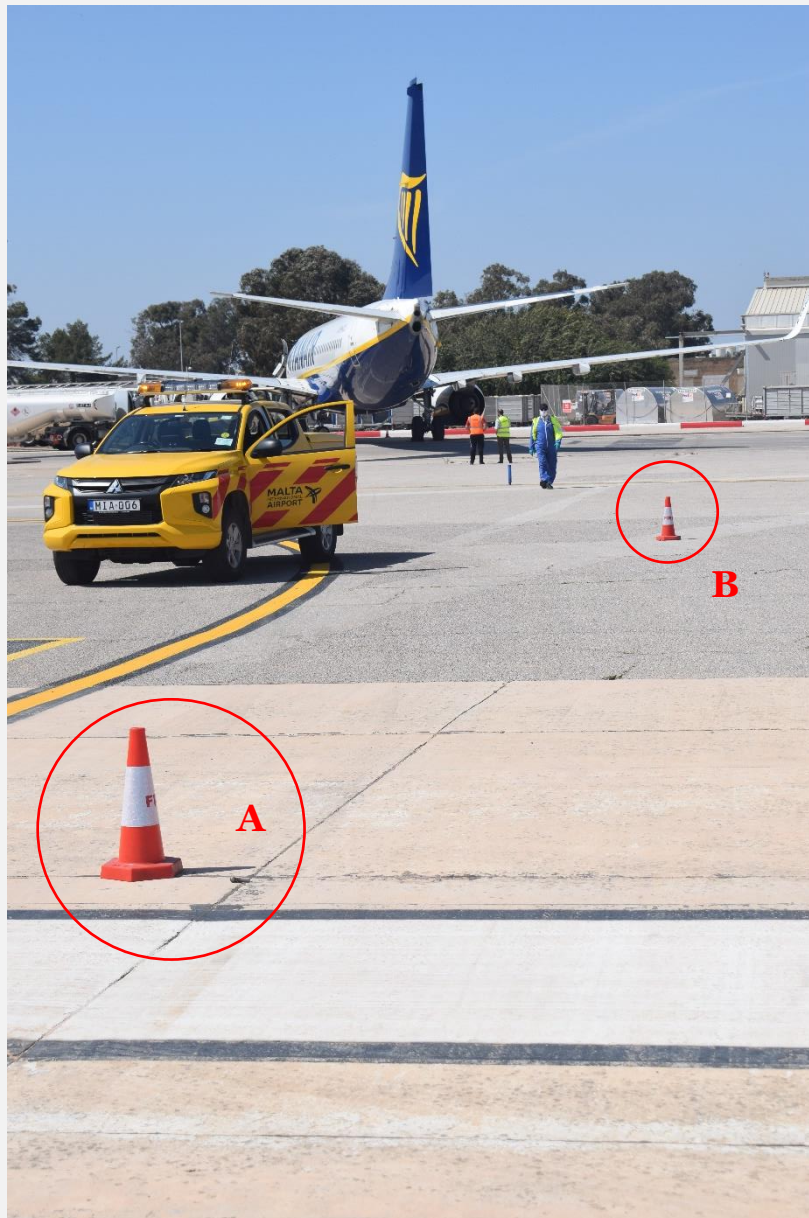
**Figure 9:** The retaining bolt on RWY 23 (marked 'A') and the head of the second shear pin on TWY K (Kilo) (marked 'B') in relation to the aircraft at rest.

The findings indicate that the tow proceeded from TWY I (India) on the top part of one shear pin and the bottom part of the retaining bolt. The bent retaining bolt without the head was probably held in place under continuous tension on the tow bar, falling out when the dynamics did not further keep it in place. The tow then proceeded on only the upper part of one shear pin, which gave way as the tug commenced to turn the aircraft to the left on

TWY K (Kilo). Figure 9 indicates that the aircraft commenced the turn, then proceeding straight as nose-wheel steering is disabled during tow to allow the nose-wheel to caster.

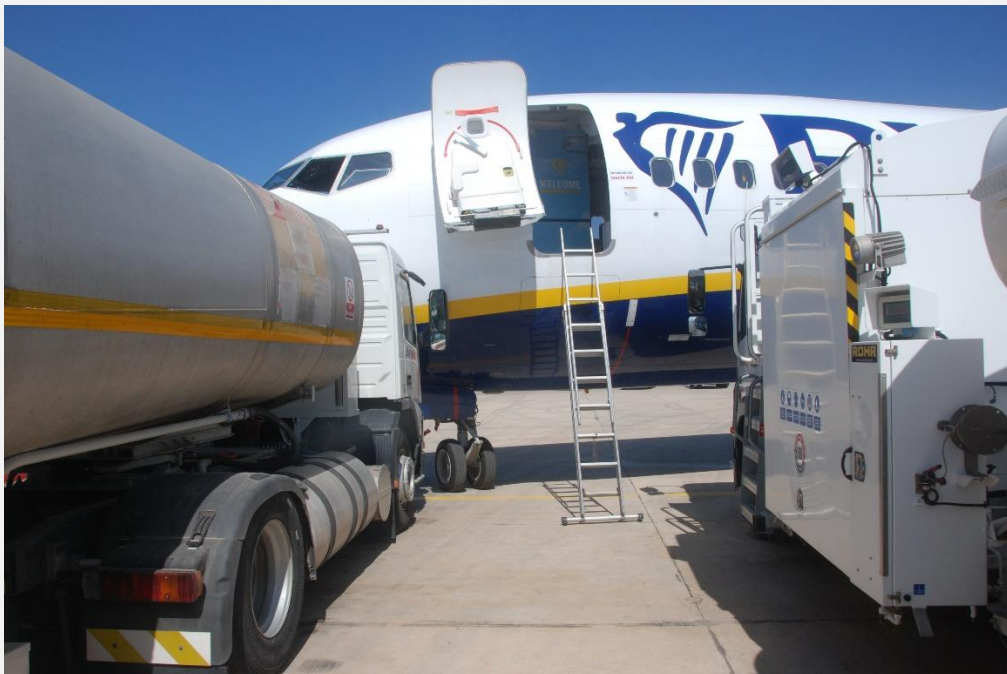
Following the collision, the brake operator was fearful of a fire and attempted to vacate the aircraft quickly, opening Exit Door L1 (Figure 10). He opened the door and was then told to switch off the APU by RFFS crew, who had, by this time, arrived at the scene. The brake operator returned to the cockpit to switch the APU off. He then vacated the aircraft via a ladder placed against the aircraft by RFFS crew.

**Figure 10:** Exit Door L1 on the accident aircraft open.

The brake operator also reported that he did not check for a fire or fuel spillage before opening Exit Door L1 and that none of the emergency slides were armed before starting the tow. Given the proximity of the L1 Exit Door to the fuel tankers and the possibility of fire, the aircraft should have been exited immediately from the starboard rear door (Service Door R2) by deploying the emergency slide. Once the RFFS crew arrived on site, they should have directed the brake operator to close Exit Door L1 and to exit from Service Door R2.

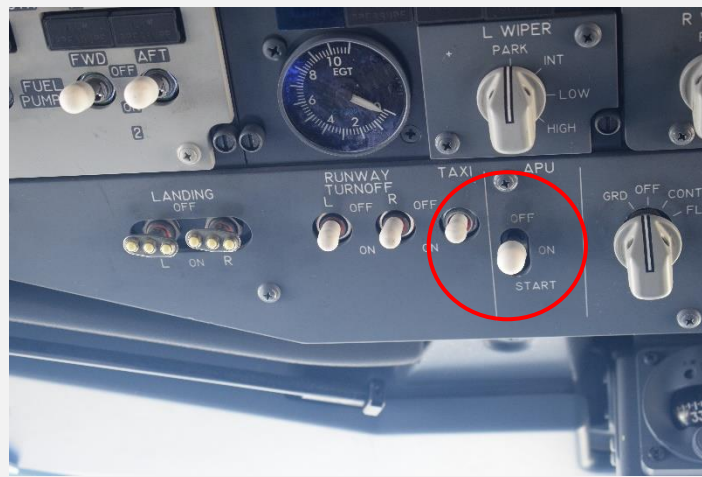
In the field investigation, the cockpit was found to be not correctly configured for tow and indicated that, after the collision, the normal APU shut-down procedure was not followed. The APU switch on the Overhead Panel was found in the 'ON' position; the AC Power switch 'ON' and the Battery Power switch 'OFF'. On the Boeing 737-800, DC Power provides power to the APU ECU and when this is turned off, the APU shuts down. The 'APU GEN' switches were 'ON' and the 'BUS TRANS' switch was on 'AUTO' (normal position), indicating that the electrical power generators on the APU were connected to the AC bus. The APU Fire switch on the Central Pedestal was in the normal (down) position.

**Figure 11:** The APU switch found in the "ON" position during the field investigation.

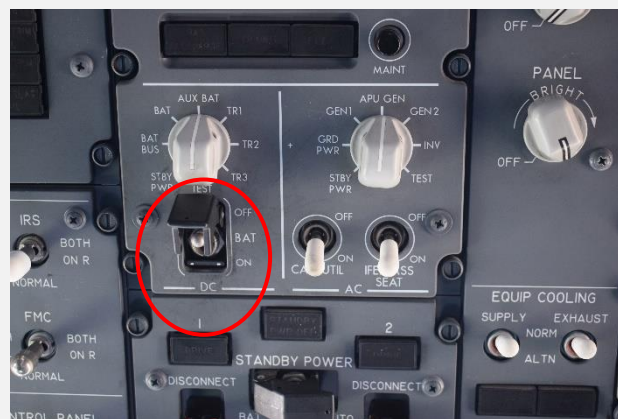
**Figure 12:** The battery power switch found in the "OFF" position during the field investigation.

*For the Battery switch to be in the "OFF" position, the switch guard will be open as shown in the figure.*

During the field investigation, the APU was found not to be running but the APU air-inlet door was found in the open position (Figure 13), indicating that the APU was not shut down as per normal procedure. This is consistent with the APU being switched off by selecting the Battery Power switch to “OFF” (Figure 12).

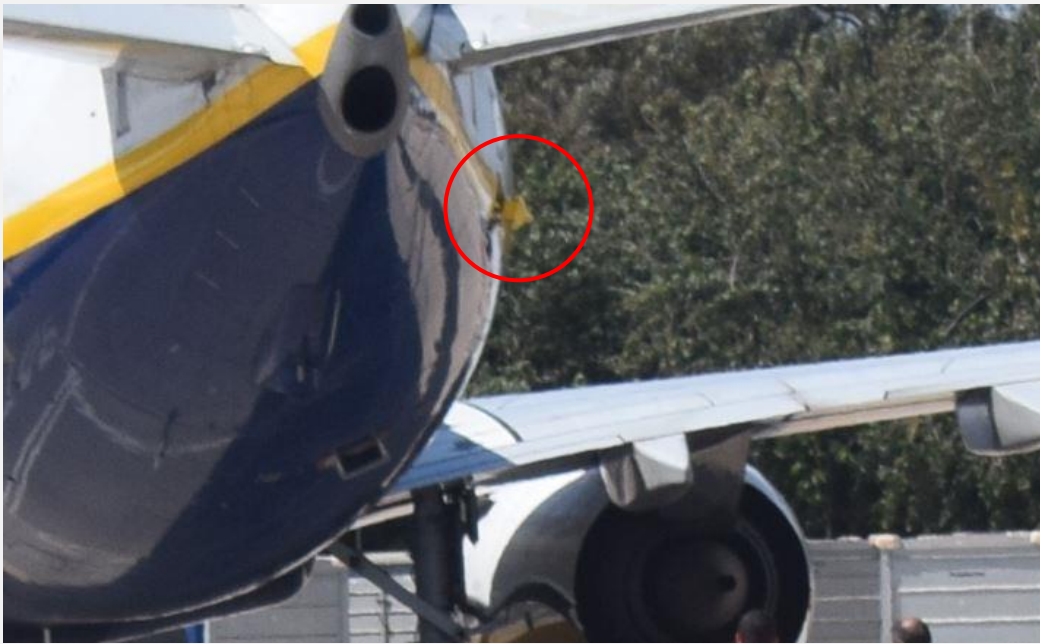
**Figure 13:** The APU inlet door in the open position with the APU shut down.

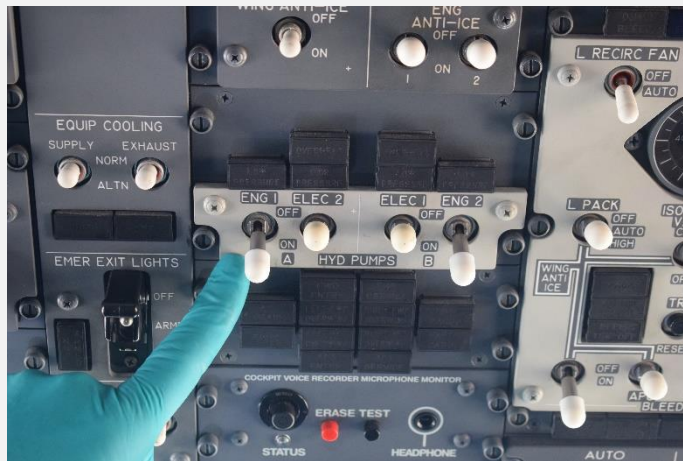
The aircraft operator reported that the aircraft involved in the accident had last operated a flight that landed at LMML at 1430hrs on 1<sup>st</sup> April 2021. The aircraft was therefore on the ground for more than 20 hours before the start of tow from Apron 8. The Boeing 737-800 brake accumulator is capable of providing brake pressure for eight hours and can be used to apply brake pressure when charged. Since the tow occurred more than 20 hours after the last operation of the aircraft, the hydraulic system should have been energized to provide braking capacity during tow. When asked if the hydraulic pumps were switched on before starting the tow, the brake operator replied that he did not switch the hydraulic system on. Consequently, the tow was started without the braking system of the aircraft being operational.

**Figure 14:** The electrical hydraulic pumps found in the “OFF” position during the field investigation.

The lack of brake pressure was a contributing factor for the brake operator not being able to apply the brakes effectively.
