Serious Incident Report

LOSS OF SEPARATION IN FLIGHT

AIRBUS A321-271NX HA-LVH

TECNAM P2002JF SIERRA 9H-VLT

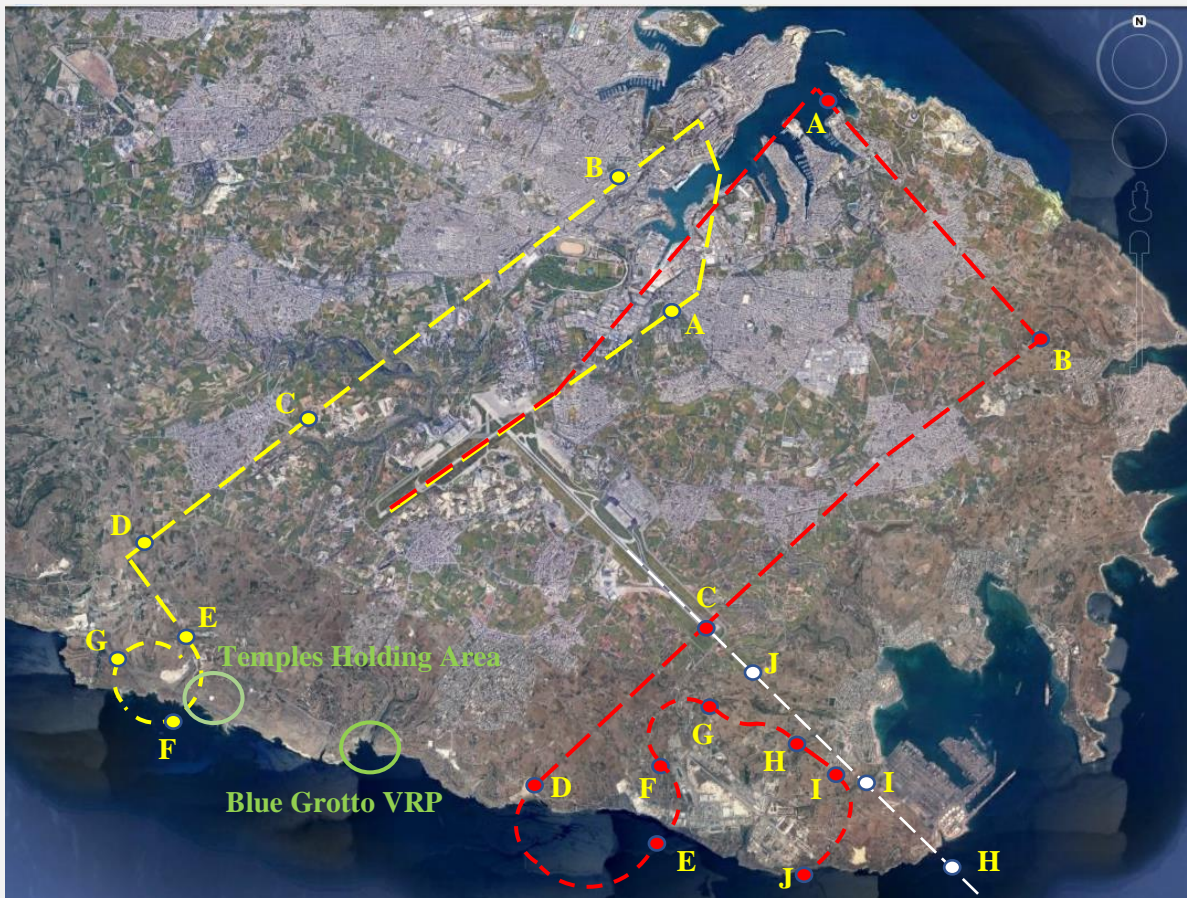
At 1226:45 HA-LVH was 9.5 nautical miles from the threshold of RWY 31 and its crew contacted Tower to report established on the ILS of RWY 31. In the meantime, 9H-VLT was crossing the threshold of RWY 31 on the right hand downwind leg for RWY 05. The light aircraft that had conducted the touch-and-go behind 9H-VLT was now ahead of 9H-VLT in the left hand circuit (Figure 1, Point C).

At 1228:51 9H-VLT arrived over the coast at an altitude of 1,400 feet and started a wide orbit to the left. In the meantime, at 1228:56 the other light aircraft on the left hand downwind leg started turning towards the Temples Holding Area at an altitude of 1,100 feet (Figure 1, Point D).

Figure 1: The paths flown by HA-LVH, 9H-VLT on the other aircraft in the circuit.

At 1229:06 (which coincided with the end of the read-back communication of HA-LVH in response to the ATC instruction to proceed with the approach), 9H-VLT stopped turning and was now nearly on a heading reciprocal to the approach path at 1,000 feet altitude and to the west of the approach path, approximately 0.5 nautical miles from the threshold of RWY 31 (Figure 1, Point G).

At 12:29:22 Tower gave HA-LVH clearance to land. At this moment, 9H-VLT was at 1,000 feet, approaching HA-LVH, which was at 1,100 feet and descending (Figure 1, Point H):

The two aircraft continued on reciprocal tracks, crossing each other at 1229:45 when 1.5 nautical miles from the threshold of RWY 31, with 9H-VLT passing approximately 200 feet above and to the left of HA-LVH.

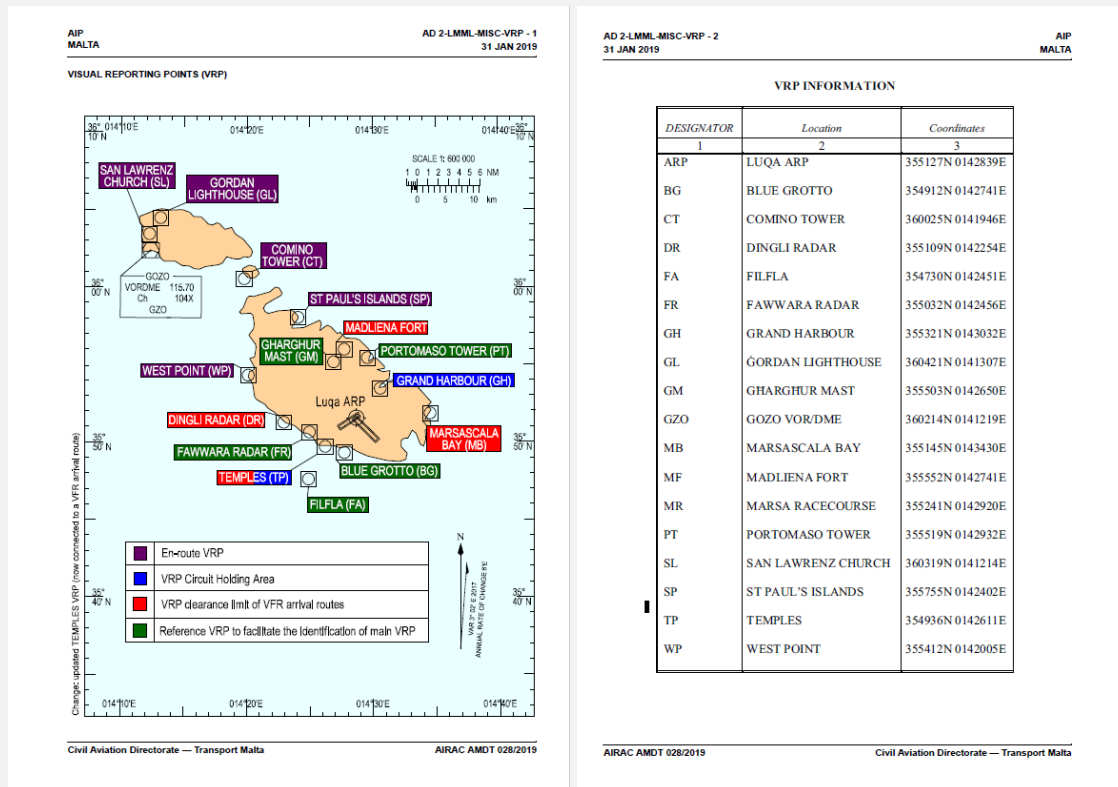
Visual reporting points (VRPs) are points on land that are used by pilots flying under VFR to report their position. The VRPs around Malta are published in the Malta AIP (Figure 4).

The Blue Grotto VRP is not easily and unambiguously identifiable from the air. The grotto itself is hidden from nearly all angles and the distinguishing features of the

Figure 4: The VRPs as published on the Malta AIP [Source: Malta AIP, AD2-LMML-MISC-CHA1-1 03 APR 2014].

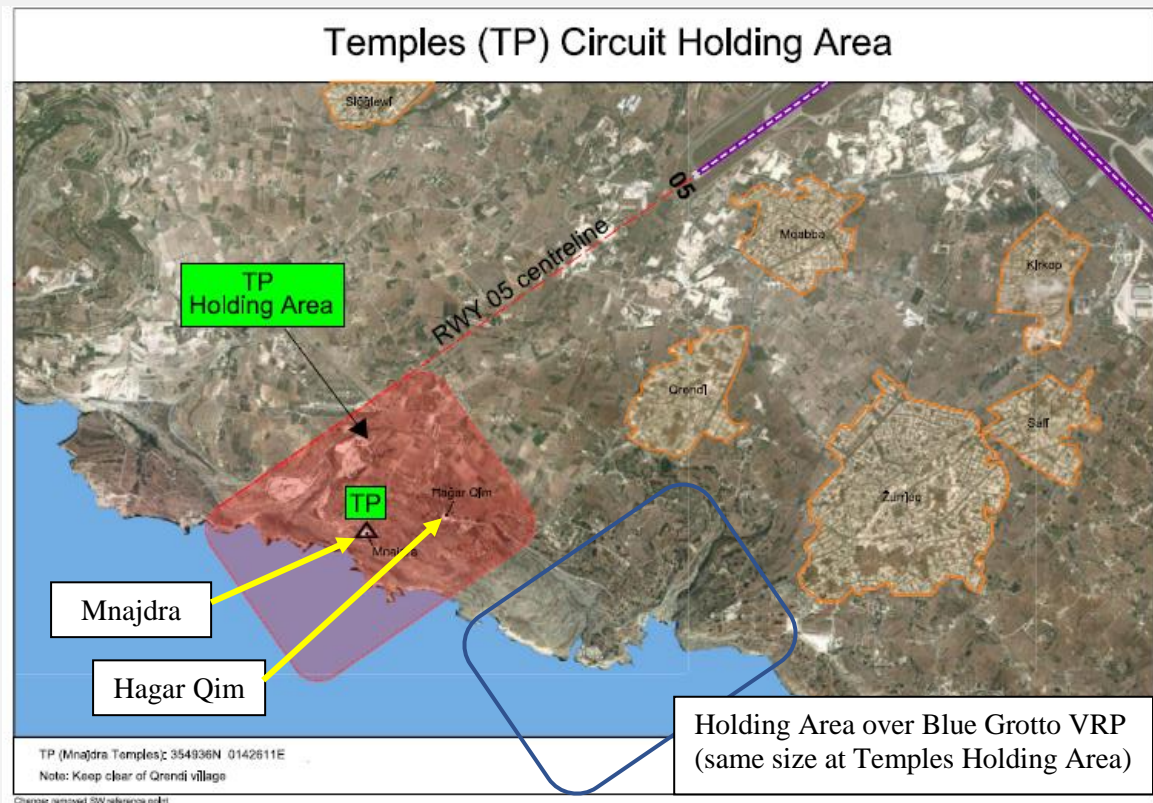
The combination of instructions by ATC leading to two aircraft to orbit simultaneously at Blue Grotto and Temples Holding Area at the same altitude raises concern on whether adequate separation would have been assured. Figure 6 illustrates the same circuit area allocated to Temples Holding Area being allocated to the Blue Grotto VRP. The figure suggests that an inadequate buffer zone would exist. In addition, whilst Mnajdra Temple forms the published centre of the holding area, there is a risk that aircraft orbit over Hagar Qim Temple (which features a similar tent to Mnajdra Temple and forms part of the Hagar Qim – Mnajdra temple complex) instead, further to the East within the holding area. This, in turn, would result in the aircraft exiting the published zone during an orbit, coming closer to Blue Grotto.

Figure 6: The Temples (TP) circuit holding area with the same area size placed over the Blue Grotto VRP to illustrate proximity of the two circuit areas [Adapted from: Malta AIP, AD2-LMML-MISC-CHA3-1 31 Jan 2019].

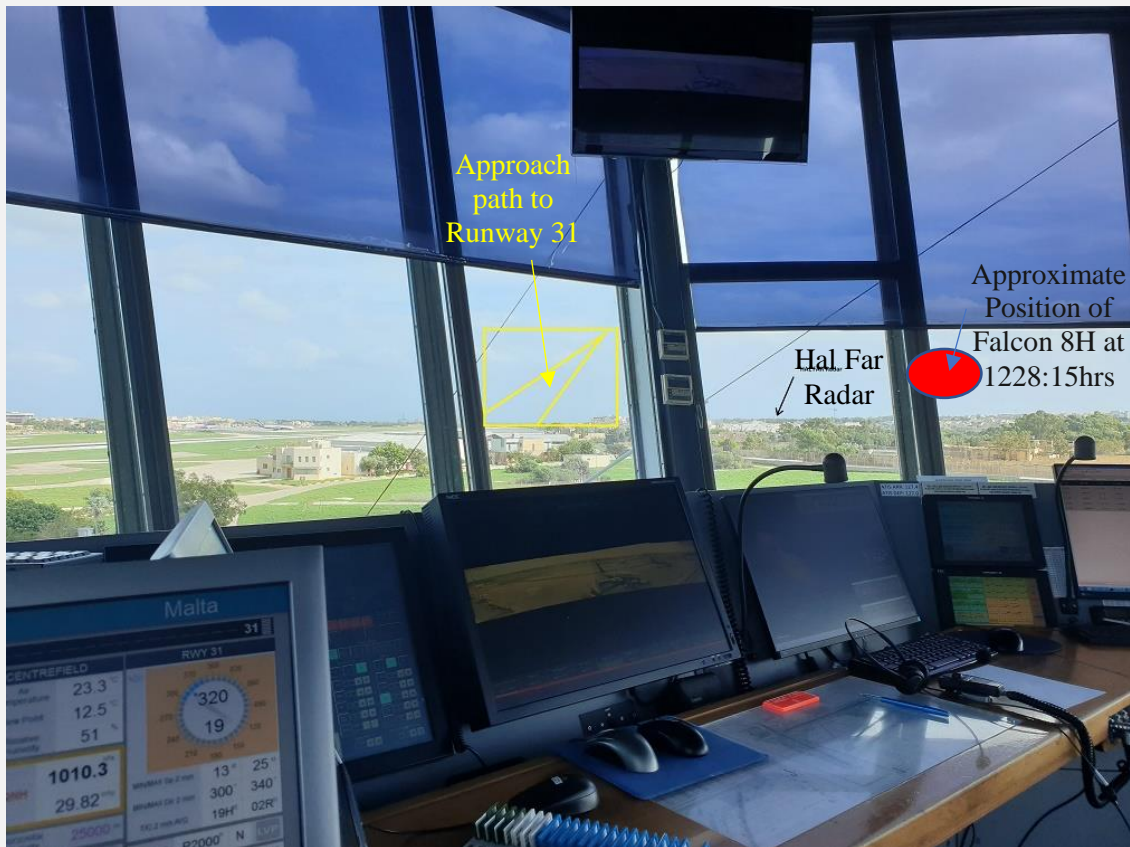
In turning left and flying down the coast, 9H-VLT left the circuit and proceeded to fly within the Luqa ATZ (Class D airspace). In the meantime, Tower was tending to other traffic and HA-LVH was on final approach to land on RWY 31. The Tower controller reported that when he saw 9H-VLT approaching the approach path of RWY 31 (which corresponds to the aircraft approaching the Hal Far area from the sea – Figure 1 just prior to Point E) his intentions were to instruct 9H-VLT to orbit right in order to maintain separation. However, during the instruction the situation from his viewpoint changed, prompting the change of instruction for 9H-VLT to fly to Blue Grotto. An aircraft of the size of the Tecnam P2002JF in the prevailing lighting conditions is visible when in the Hal Far area but its precise attitude and heading may be difficult to judge from the control tower (Figure 7).

Figure 7: View of the approach to RWY 31 and the South-East coast from the Luqa Aerodrome tower, also showing the approximate position of 9H-VLT at 1228:15hrs [Adapted from source: MATS]
