**9H-AEB runway excursion at Malta International Airport  
1<sup>st</sup> November 2021**

<b>Location:</b> Malta International Airport	<b>Accident Number:</b> BAAI/SIR 011121
<b>Date &amp; Time:</b> 1 <sup>st</sup> November 2021, 15:00	<b>Registration:</b> 9H-AEB
<b>Aircraft:</b> Piper PA-34-200T Seneca II	<b>Aircraft Damage:</b>
<b>Defining Event:</b> Runway excursion during landing from RWY31	<b>Injuries:</b> No injuries Reported

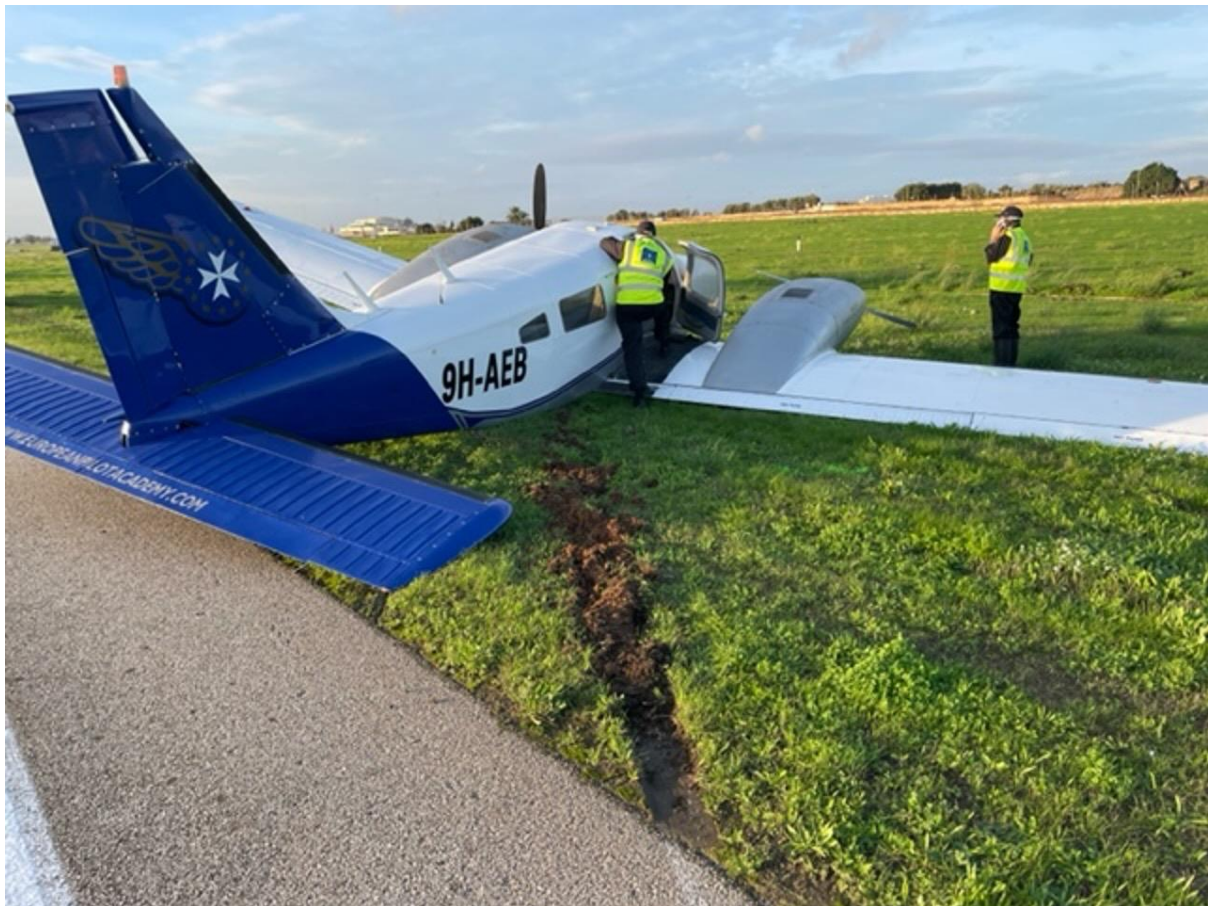
4.1 The BAAI was called onsite shortly after the accident. The aircraft lay resting on the grass adjacent to RWY31. Markings on the runway indicate that the aircraft had skidded on the runway for 300m before coming to rest. The footrest ploughed through the grass, as shown in Fig. 1. Fig 2. shows the landing gear (*on the right-hand side of the aircraft*) that had failed to fully extend. Fig. 3 shows the final resting position of the aircraft relative to RWY31. Fig. 4 shows a trajectory of the airplane after touchdown.

*Fig. 1. Aircraft in its final resting position (tail view).*

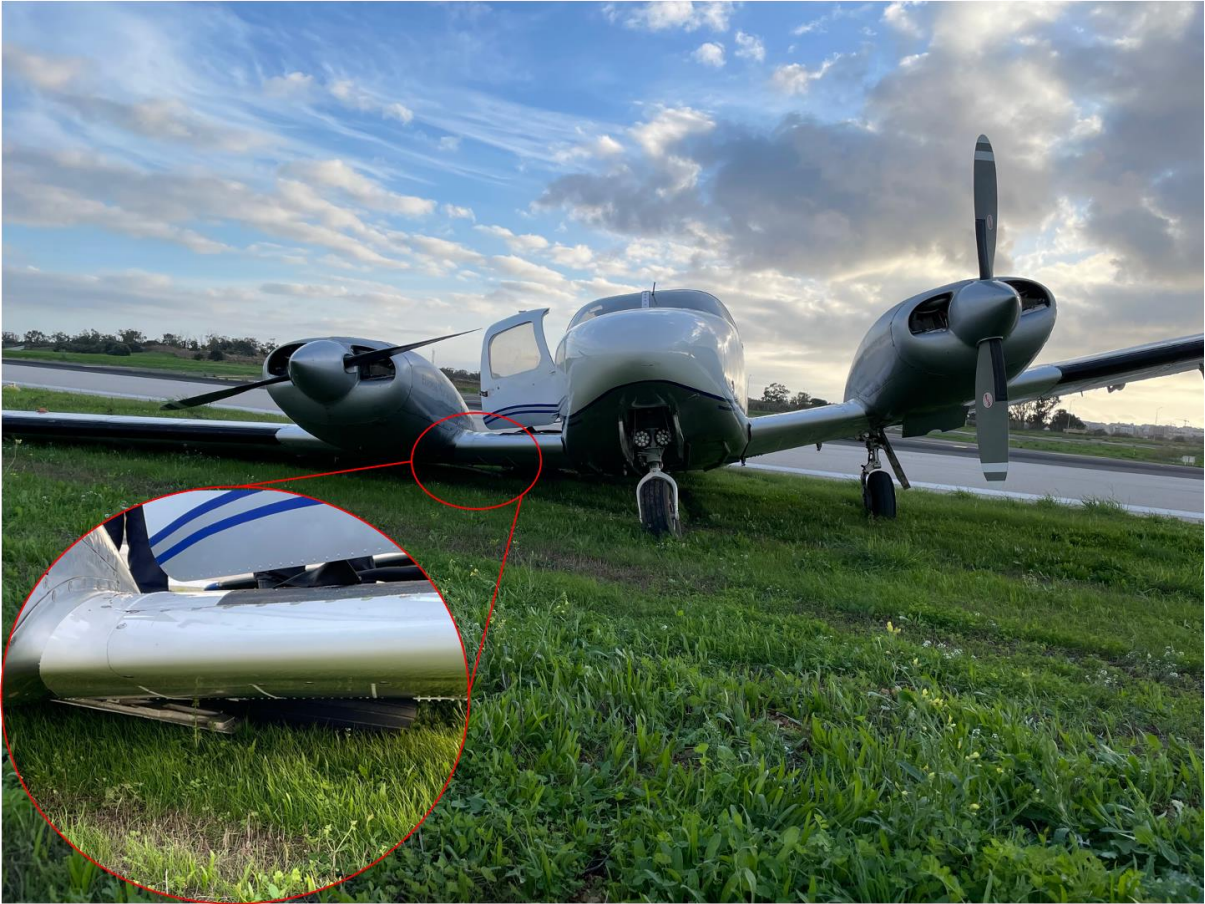
2.3 During the approach to land, after selecting the gear down, the right main landing gear did not extend to the full down and locked position.

*Fig. 2. The aircraft in its final resting position (nose view) with detail of un-extended landing gear*

5.14 The engineering section within the school offered no reason why the landing gear became stuck in an intermediate position. The fault was described as being intermittent, which may be more difficult to diagnose. It was highlighted that in the past there had been incidents in which the pressure goes down and the hydraulic pump switches on for a few seconds. This leads to a suspicion of a leakage in the hydraulic system. Piper suggested that this may also be due to a fault in the microswitch. Other potential causes may include an improper lubrication of the arm and centre springs which may be worn and do not lock into position. This investigation could not clearly identify the source of the engineering problem.

Since the fault may be intermittent, it is recommended that in the repair process, the hydraulics are inspected for leakages and the associated wiring, and electrical systems are inspected for any signs of dormant failures. As a precaution, it is suggested to consider changing the landing gear wiring and microswitches. Other moving and non-moving parts of the landing gear should be thoroughly inspected for correct operation.

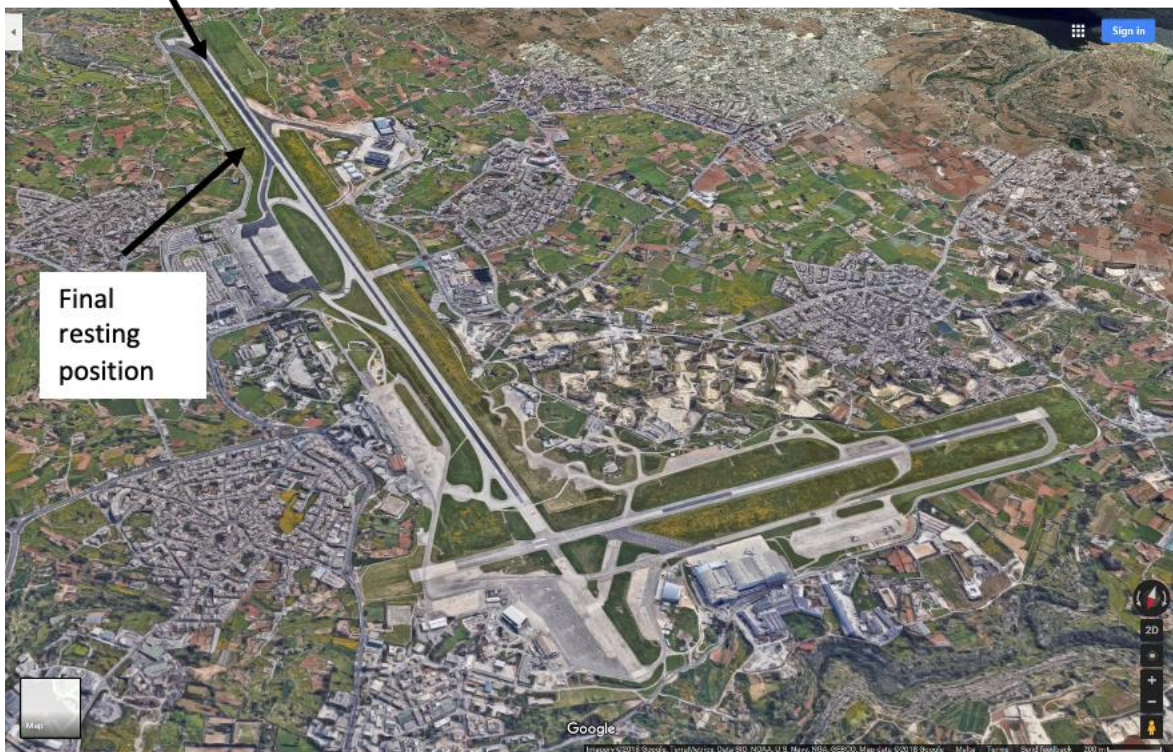
Fig. 3: Overview of the airport runways.

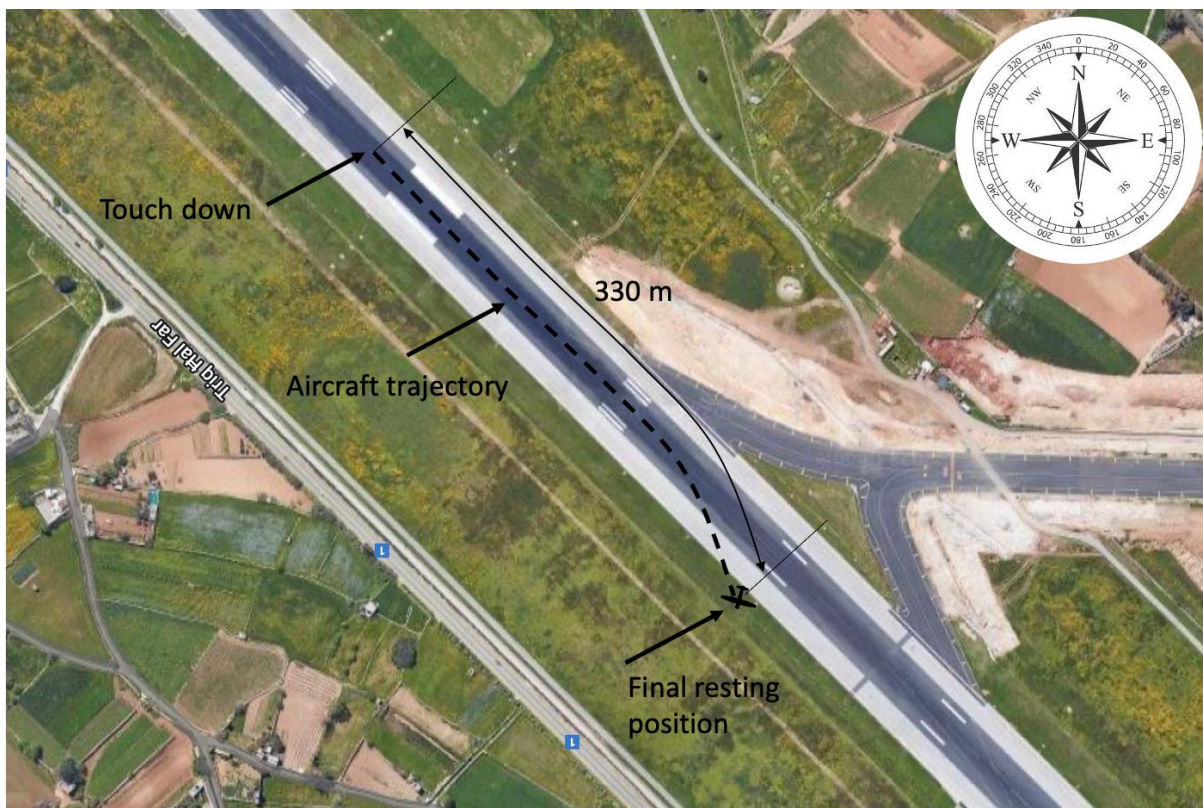
2.6 After landing, the aircraft skidded on the runway for 300 meters, following which it suffered an excursion into the grass.

Fig. 4: Sketch of the aircraft trajectory on the runway.
