TECHNICAL REPORT

IN-030/2024

**Incident occurred on 12 October 2024
between a BOEING 737-800, with
registration 9H-QBL and BOEING 737-
800 with registration EI-IFS, at the
airport of Las Palmas de Gran Canaria -
GCLP
(Las Palmas, Spain)**

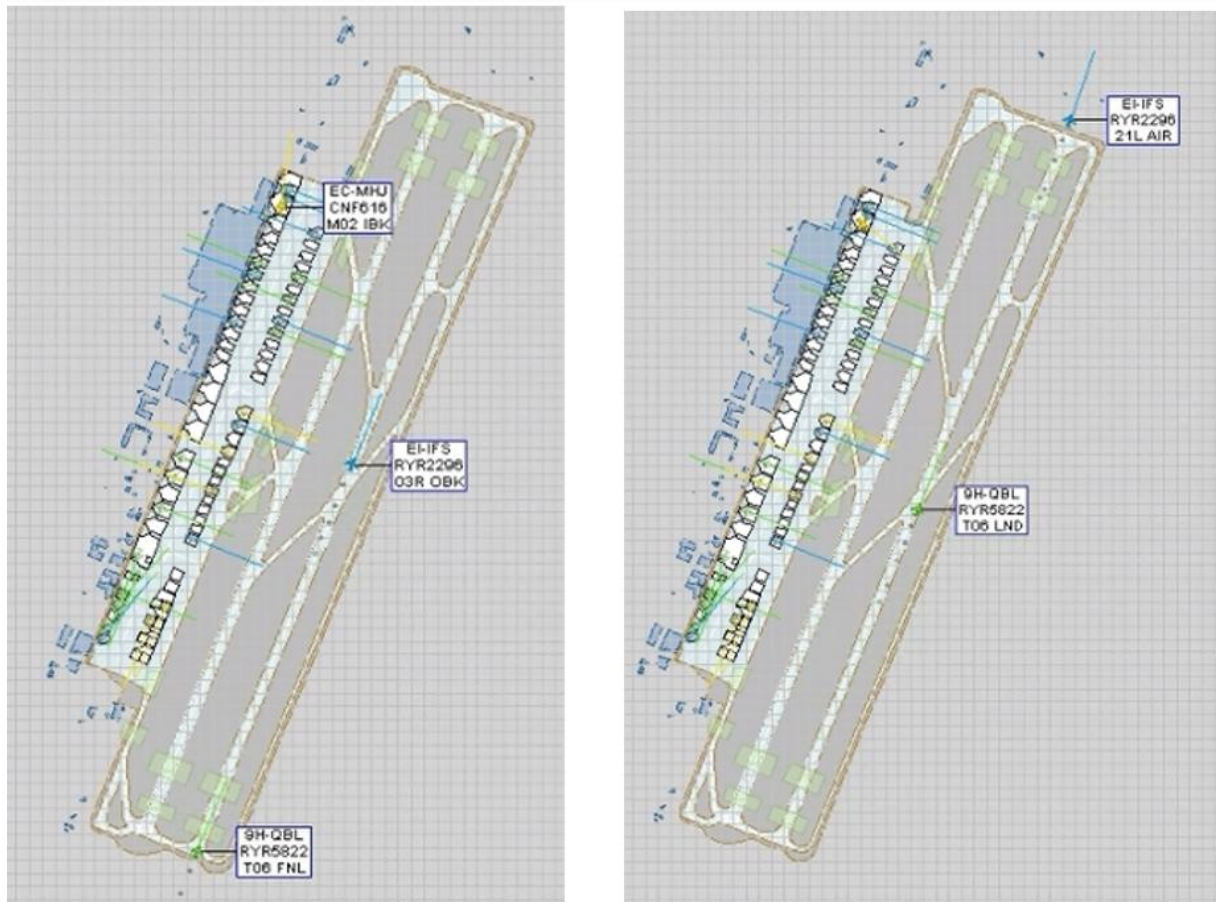
Figure 1. Relative positions of the aircrafts

At 09:17:02, RYR2296 had passed exit S5, while RYR5822 was located at the very short end, at the beginning of the threshold of the runway.

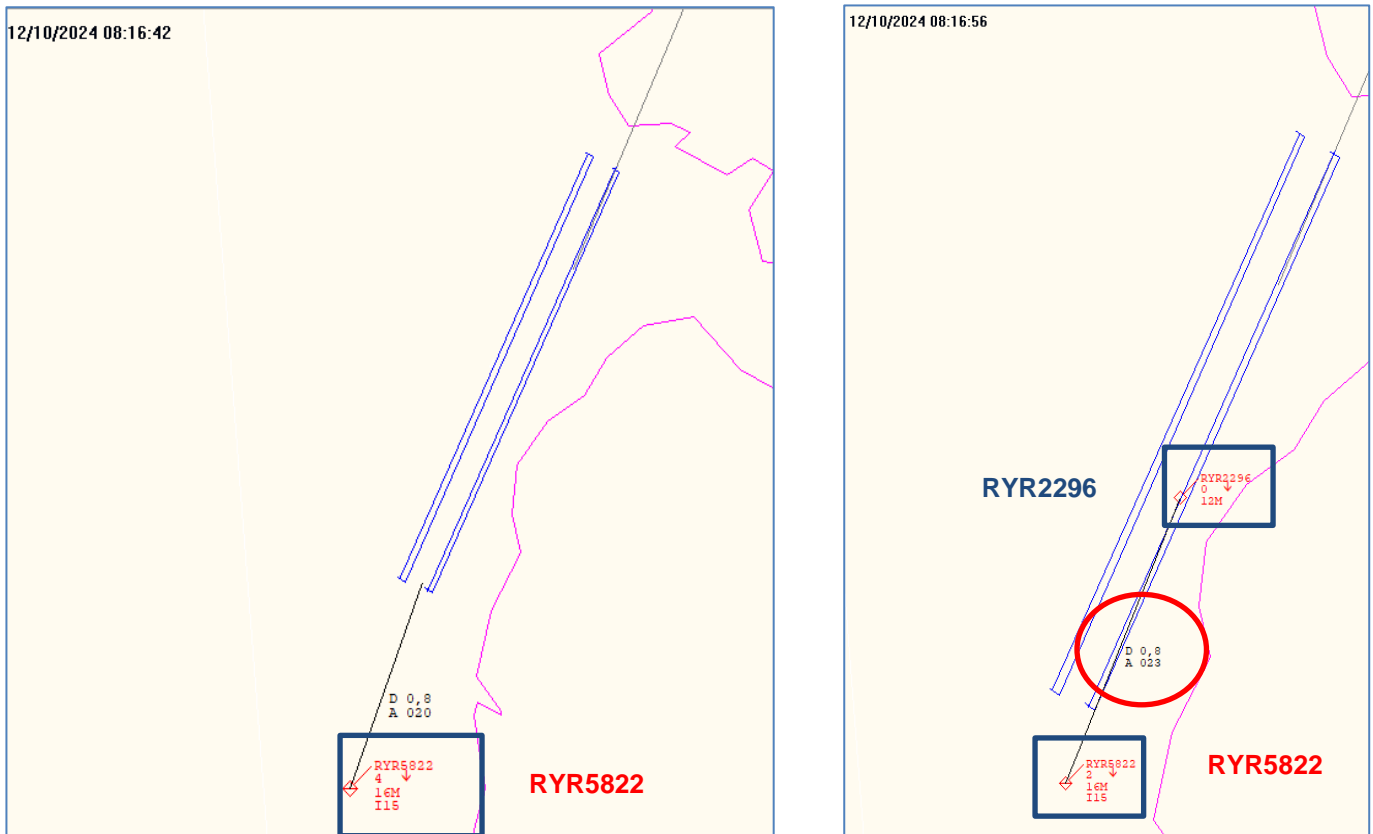
Fig. 3: Position of aircraft at 09:16:42 (left) and 09:16:56 (right)

At 09:16:56, the crew of RYR5822 again reported the missed approach advised that without receiving a response from the control tower, the track placed them 0.2 NM from the threshold of runway 03R and at an altitude of 200 ft, while RYR2296 was on the runway on take-off roll, the distance between them being 0.8 NM horizontally and 200 ft vertically.

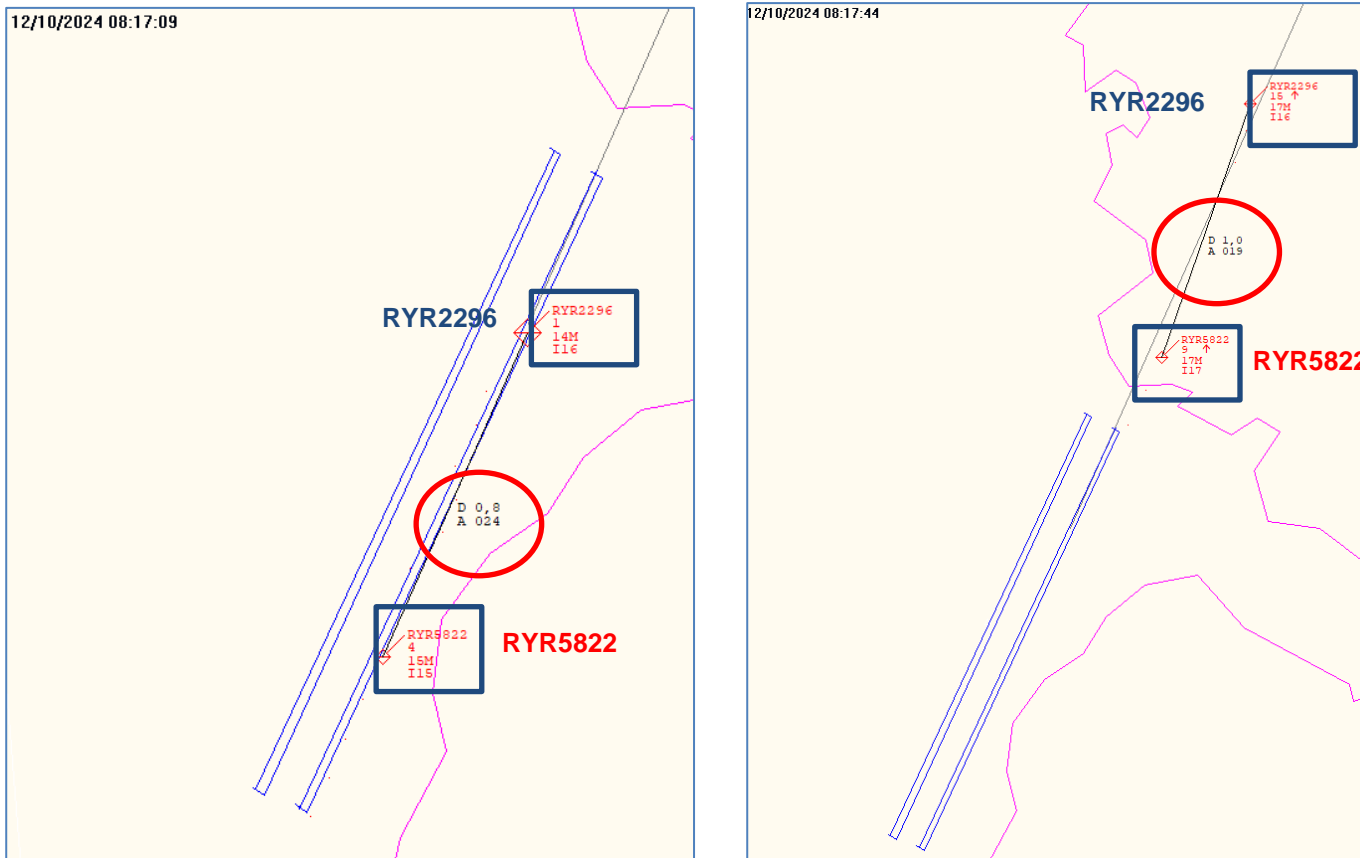
Figure 4. Relative positions of the aircraft at 09:17:09 and 09:17:44 respectively

Subsequently, at 09:17:18, when the two aircraft were already in the air, they were closest to each other, with a horizontal separation of 0.9 NM while at the same altitude, with no communications with the tower.

At 09:17:44, their trajectories began to diverge. At that time they maintained a horizontal distance of 1 NM and a vertical separation of 199 ft.

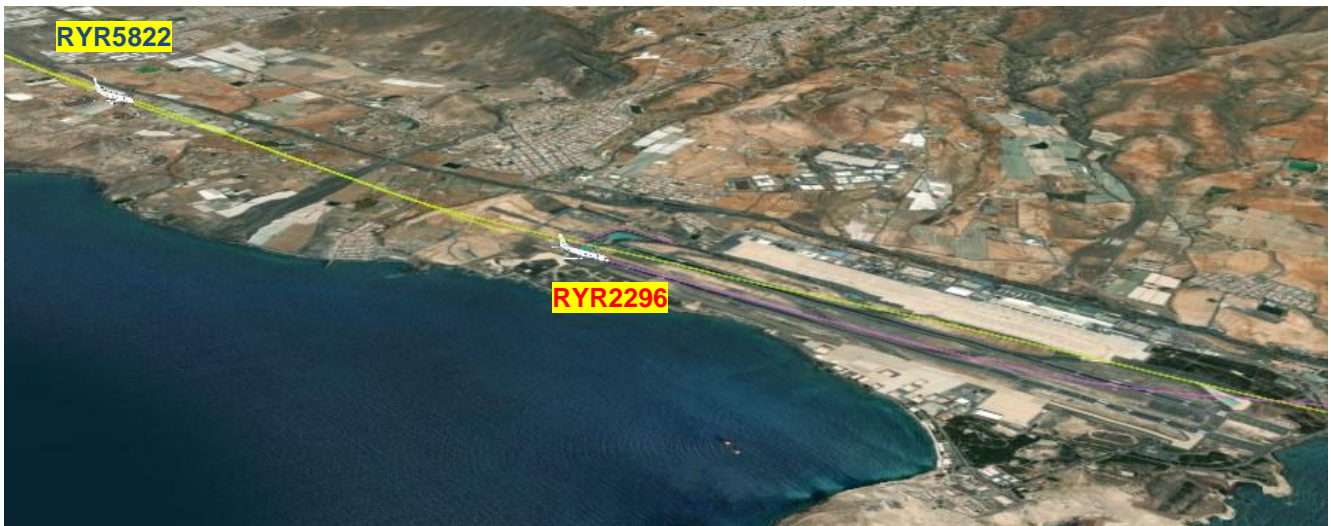
Figure 7. Time at which the aircraft with call sign RYR2296 commenced take-off (09:16:14)

The BOEING 737 - 800 with call sign RYR5822 had a speed of 170 kt, was at an altitude of 350 ft, approaching the runway.

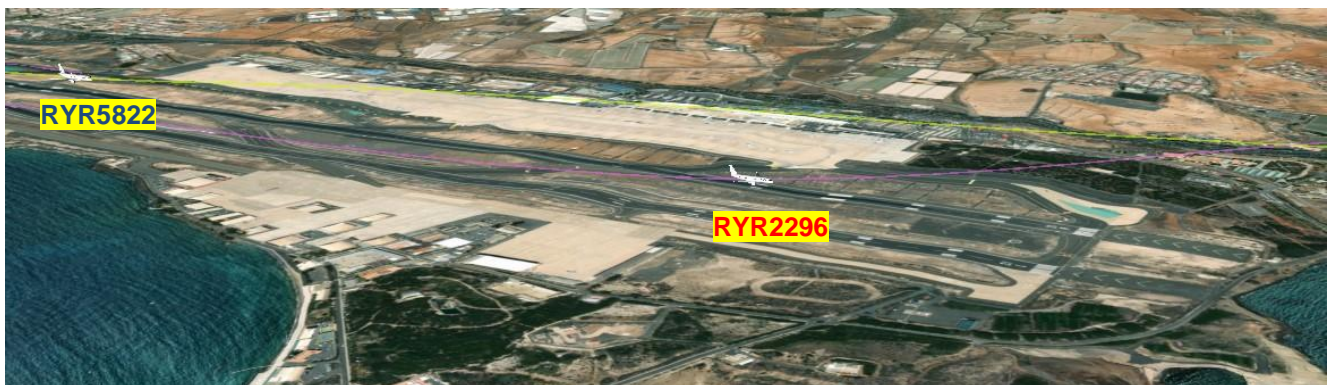
Figure 8. Moment when the minimum separation occurred (09:17:04)

The authorisations given by control were conflicting and this was what caused the loss of separation between the two aircraft, as one aircraft was authorised to take off when there was another on final, which it finally decided to abort, with both aircraft flying over the runway at the same time.

In addition, the altitudes at which the aircraft were previously instructed caused a closer approach, as the aircraft that was going to land was authorised to maintain a runway heading of 2,000 ft while the aircraft that was taking off had been authorised to climb to 3,000 ft, thus producing a crossover of altitudes.

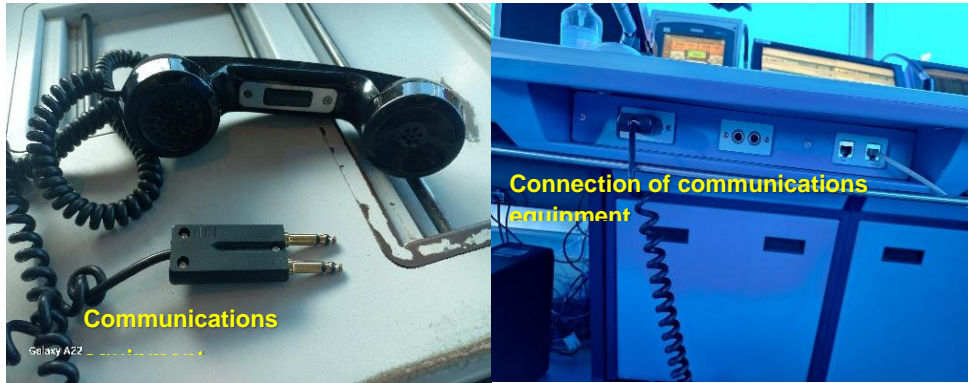
Figure 10. Connections of the communications equipment

The phone and headset jack has two 6.35 mm stereo jack plugs, which can be plugged into different positions, both of which are underneath the console board and therefore not directly visible, as shown in the figure below.

- ENAIRE's investigation has not been able to clarify whether the problem was actually caused by the phone not being connected properly or whether the foot pedal used to transmit as an alternative to the telephone was stuck when tested at the beginning of the session and this was the reason why communications were not being transmitted. However, the light on the communications panel was illuminated indicating that transmission was taking place.

In regard to the second of the issues noted above, i.e. the failure of transmission, the latent conditions were noted by the the instructor himself, who said that at the start of the work there was an issue because the phone was locked and he managed to unlock it when he pressed the foot button, after several attempts.

He also commented that he was sure that it was his phone that was not plugged in properly and insisted that sometimes the phone would get stuck and that in such cases they would call the maintenance service, who would usually solve the problem by restarting the computer system. It follows from the above that there is probably either a design or manufacturing problem, or perhaps both, as it does not seem logical that there should be periodic failures in communications, when that is the essential task of the control tower workstations.

For this reason, a recommendation will be issued to study the possibility of including in the controller's relief checklist, in all control units, a section which includes the obligation to check whether the communications equipment is working properly.

REC: 03 / 25. It is recommended that ENAIRE study the possibility of including a section in the checklist for controller relief, in all control units, which includes the obligation to check whether the communications equipment is working correctly.
