A safety investigation report for an A320-214 aircraft, Reg. No. 9H-AHS

A safety investigation report for the A320 aircraft,
Reg. No. 9H-AHS; incident involving fumes in the cabin.

Location: Malta International Airport	Accident Number: BAAI/SIR- 171122
Date & Time: 17 th November 2022, approximately 07:44 LT	Registration: Air Malta, Reg. No. 9H-AHS.
Aircraft: A 320-214, Reg. No. 9H-AHS	Aircraft Damage: No aircraft damage was reported at the time of landing.
Defining Event: Aircraft returned to Malta shortly after take-off due to fumes/vapour in the cockpit and forward passenger cabin.	Injuries: No injuries Reported

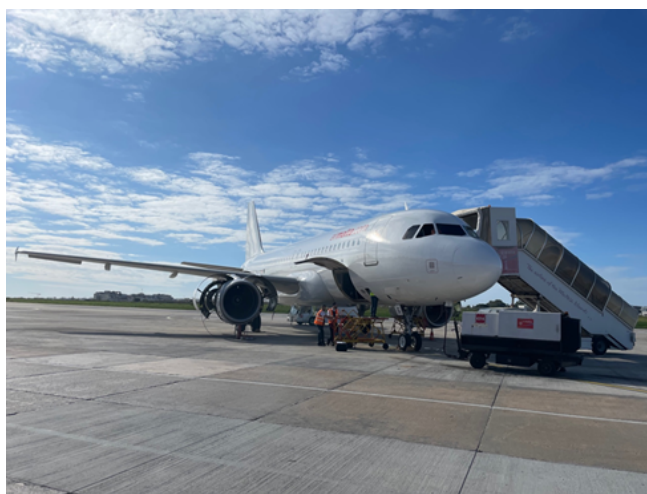
Fig 1. Image of the A320-214 following the incident.

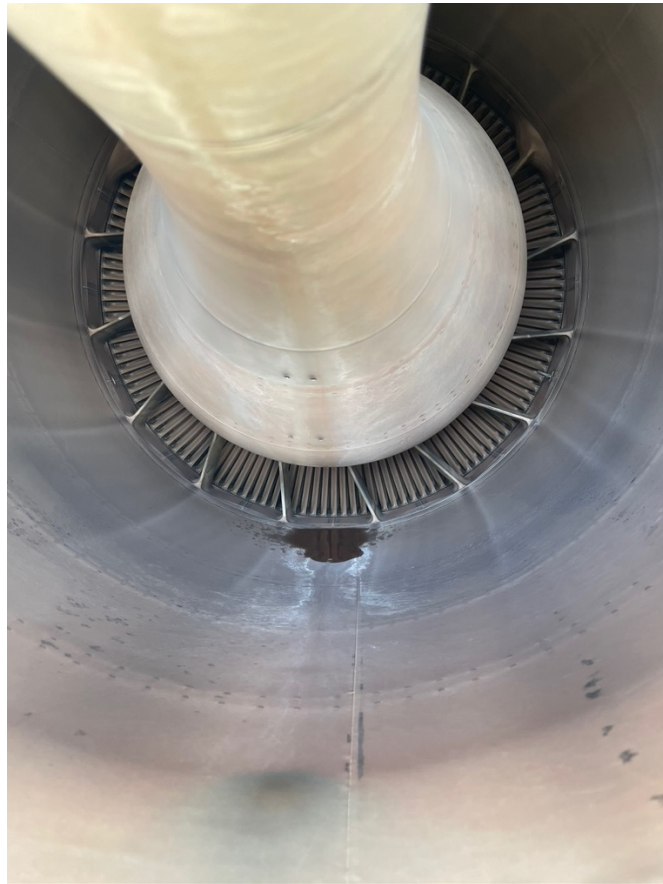
- Inspection of the electrical fuse boxes located at the front and rear of the cabin. No anomalies were detected, allowing for the exclusion of electrical sources from further consideration.
- A visual examination of the engines was performed. During this inspection, a pool of liquid was observed in the bypass duct of Engine 1, whereas Engine 2 showed no such evidence. Figure 2 illustrates a photograph of the liquid pool within the bypass duct of Engine 1, and Figure 3 displays a photograph showing liquid traces along the bypass stator blade.

These observations led to the preliminary hypothesis that oil traces might have infiltrated the bleed air system, warranting further investigation. In addition, data from the Cockpit Voice Recorder (CVR) and the Quick Access Recorder (QAR), stored on a PCMCIA card, were retrieved by BAAI for detailed analysis.

Fig 4: Excess pool of liquid sitting in the bypass duct, as seen from the aft

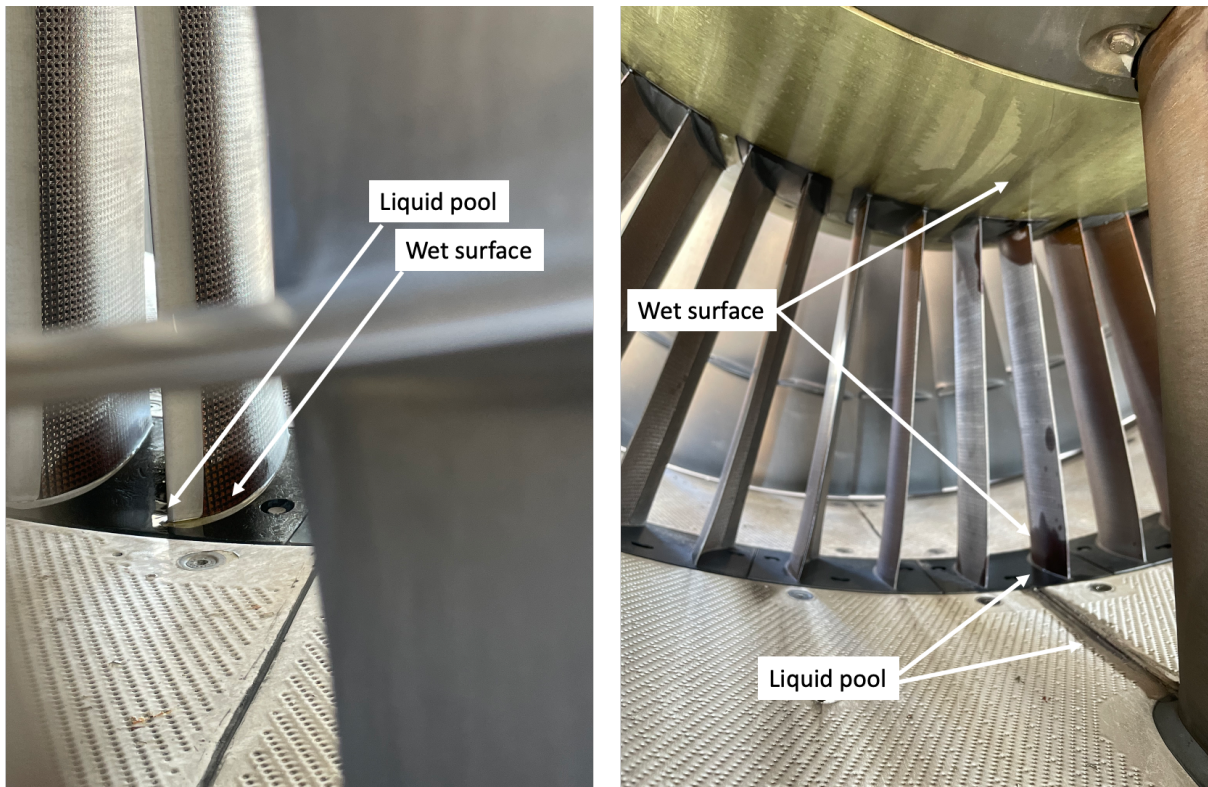
Fig 5: Traces of liquid along the bypass stator blade.

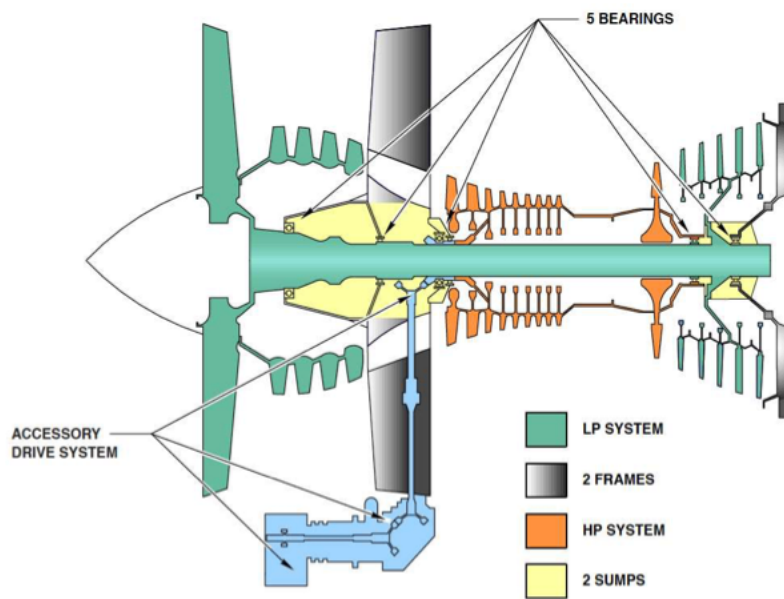
Fig 6. General schematic of the engine, highlighting the main components and bearings.

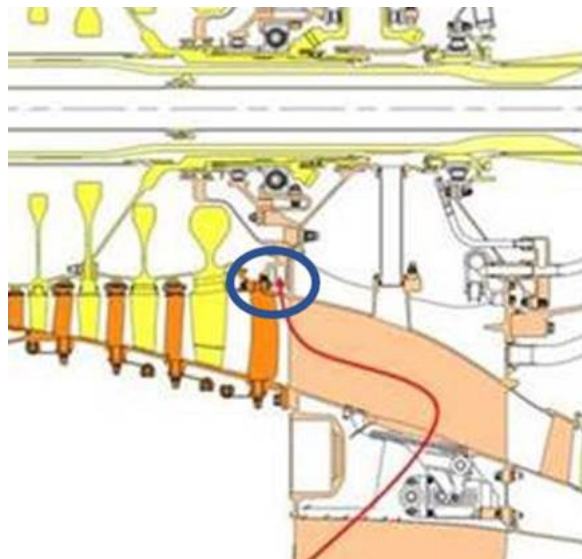
Figure 7. Trace showing how oil from Bearing No. 3 could seep through the components and settle in the bypass cowling. (reference Appendix1)

The investigation conclusively determined that the failure of the seal in bearing No. 3 resulted in oil traces from Engine 1 entering the engine core air stream. The air system utilizes bleed air supplied directly to the cockpit and cabin, where the contaminated oil traces, appearing as mist, were introduced into the cabin air supply. Operating under high temperatures within the

engine compressor, the oil experienced thermal degradation, which produced a distinctive "burnt oil" odour.

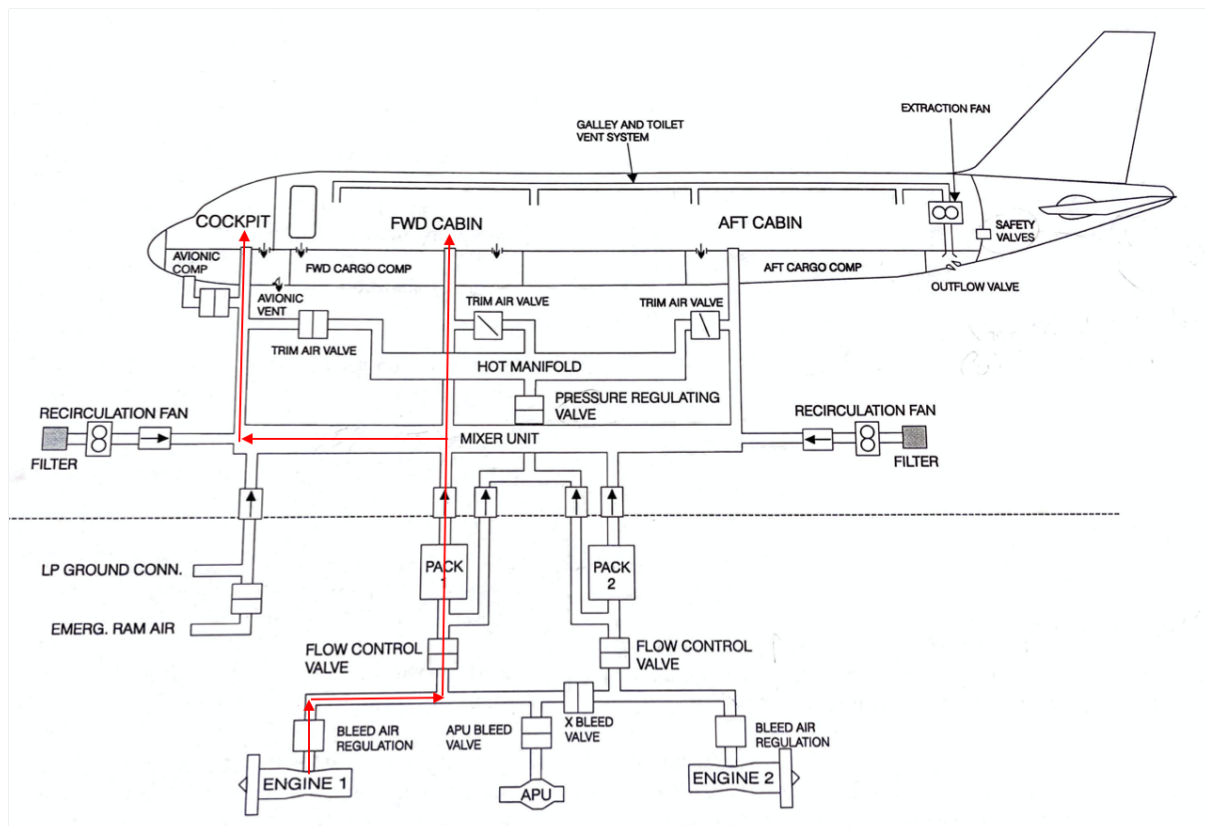
Figure 6 illustrates the pathway through which bleed air from Engines 1 and 2 is directed towards the environmental control system (ECS) packs. These packs subsequently channel the air into a mixer unit, which combines the air streams and distributes them to the cockpit, forward cabin, and aft cabin. Notably, the bleed air from Engine 1 follows a shorter trajectory to the cockpit and forward cabin, elucidating why these sections were impacted first by the contamination.

Fig 8: Schematic of the bleed air for the aircraft, highlighting (in red) the route of the bleed air from engine 1 to the cockpit and the forward cabin.

The Bureau of Air Accidents Investigations (BAAI Malta) has established that the cause of the fumes in the cockpit and forward galley with a pungent odour of burnt oil was a result of a broken engine seal. It was shown that engine No. 1 suffered a failure in the seal of bearing No.3. This resulted with oil mixing with the mainstream air, with a portion of it finding its way through the bleed air, through pack 1 and into the cockpit and forward galley.

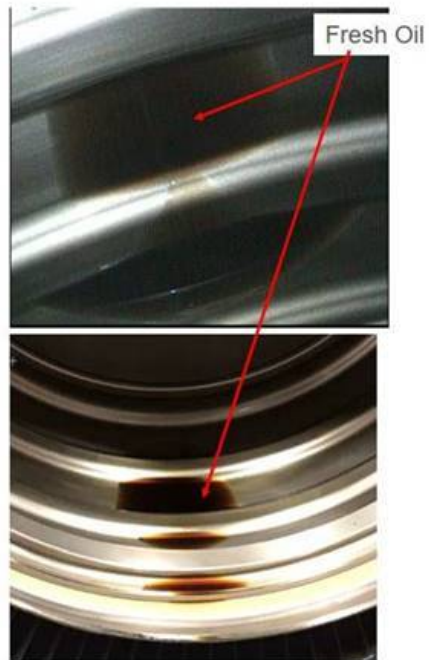
- The Bearing No. 3 Fwd Seal was already inspected as part of AMM 71-00-00-810-802-A and showed oil wetness, which is not unusual in a limited quantity.

Re-inspect the Bearing No. 3 Fwd Seal pressurizing tubes, especially 2ea lower positions (see below) to enable a comprehensive assessment.

Go through the tubes and try to watch the tube walls and the Teflon seal area as good as possible as well for possible Teflon delamination.
