AIRCRAFT ACCIDENT REPORT (Ref. N0 1/2017)

Report on the Accident of Aircraft Reg. No. 9H-SEP. *Crash Landing.*

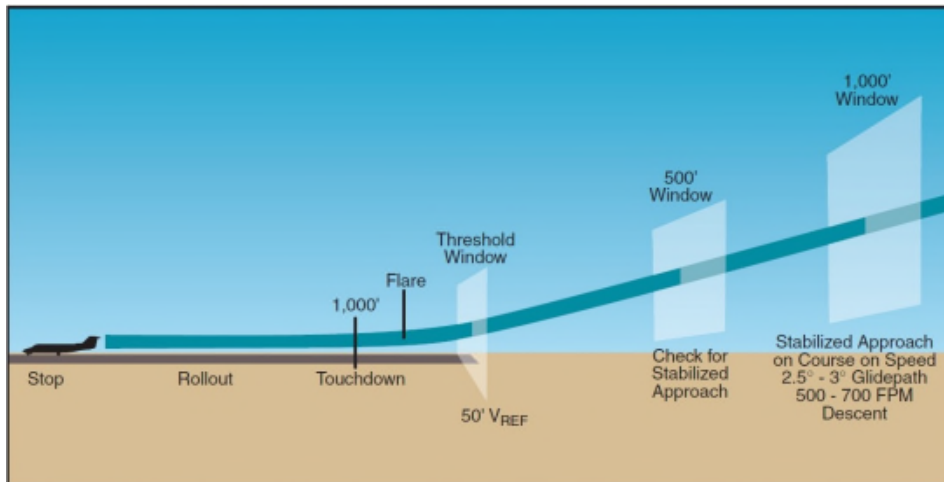
Fig8

- The rest of the approach was flown below the glide slope thus increasing the rate of decent which would have required a reduction in power to maintain the correct approach speed.
- The established VFR procedure was not being followed thus considerably reducing safety for the persons on board the aircraft as well as third persons living beneath the “glide-path” (glide-slope), motorists and pedestrians using the adjacent road.

- Putting in danger other aircrafts and airport vehicles that could have been standing-by on TWY Juliet.

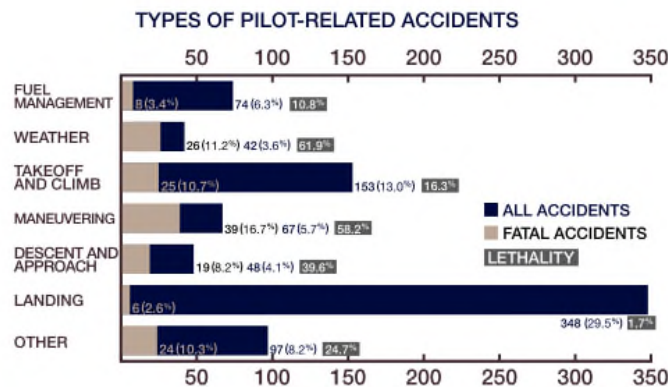
Fig12

In aviation one must remain focused on safety and safety should never be compromised or traded for something of lesser importance. The chart below gives a pictorial statistic of which phase of flight present the biggest challenge for pilots. Clearly the landing phase and the take-off phase is where most concentration is required and it is these two phases that determine the handling capabilities of a pilot.
