A safety investigation report for the runway excursion of the Cessna 172, Reg No. 9H-AEX

Location: Malta International Airport	Accident Number: BAAI/SIR-001-2020
Date & Time: 3 rd November 2019, approximately 8:45 am (Local)	Registration: 9H-AEX
Aircraft: Cessna 172	Aircraft Damage: Aircraft suffered a punctured nose wheel and damaged nosewheel hub.
Defining Event: Runway excursion following landing on RWY 31	Injuries: No injuries Reported

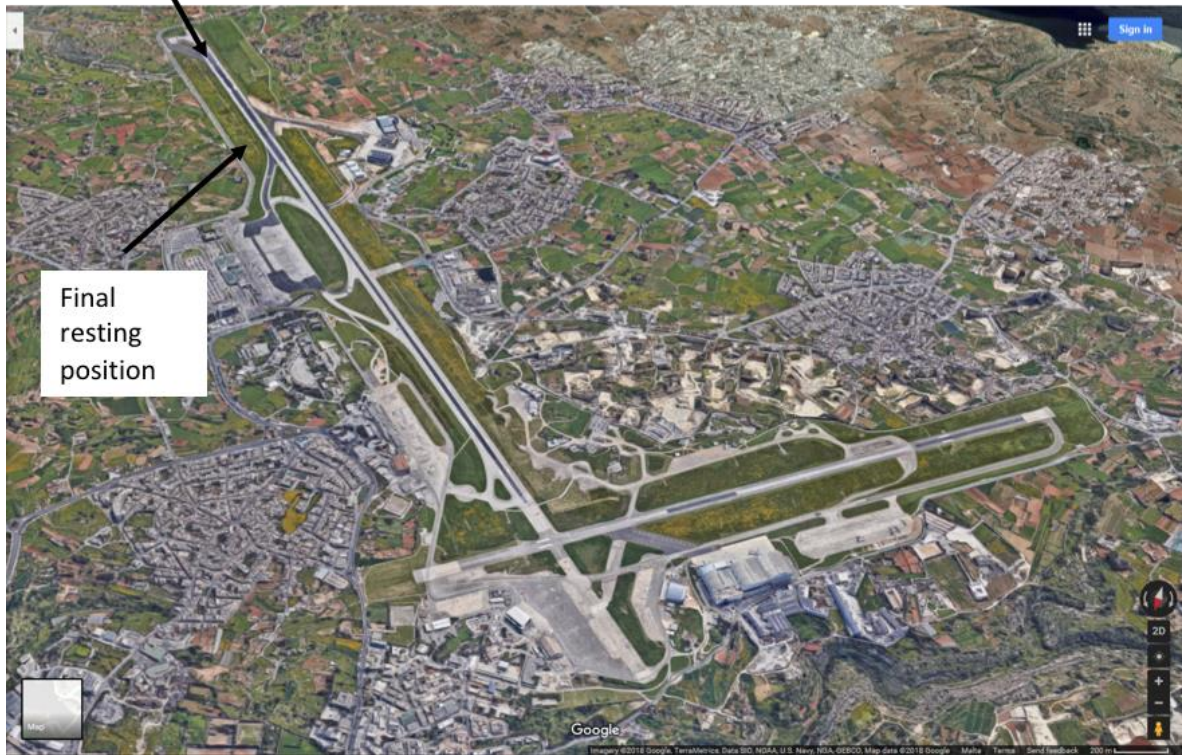
Fig. 2: Overview of the airport runways.

The aircraft came to rest on the grass at an angle to runway RWY 31. The touchdown position could be traced back from the surface marks left by the aircraft on the runway. Fig. 2 shows an overview of the airport layout, including the direction of the aircraft approach. Fig. 3 is a sketch of the aircraft final resting position. The touch-down marks and the final resting position are shown in Fig. 4 and Fig. 5. The punctured nosewheel tyre, damaged nosewheel hub and the runway edge light (*which is mounted on a concrete base*) are shown in Fig. 6 and Fig. 7, respectively.
