A safety investigation report for the runway excursion of the Tecnam P2002 JF, Reg No. 9H-PIC

Location: Malta International Airport	Accident Number: BAAI/SIR-002-2020
Date & Time: 1 st February 2020, approximately 8:00 am (Local)	Registration: 9H-PIC
Aircraft: Tecnam P2002 JF Sierra	Aircraft Damage: Significant: Damaged right wing-tip and buckled leading edge; Damaged propeller; Nosewheel collapse; Damaged engine and gearbox
Defining Event: Runway excursion following landing on RWY 23	Injuries: Slight injury reported

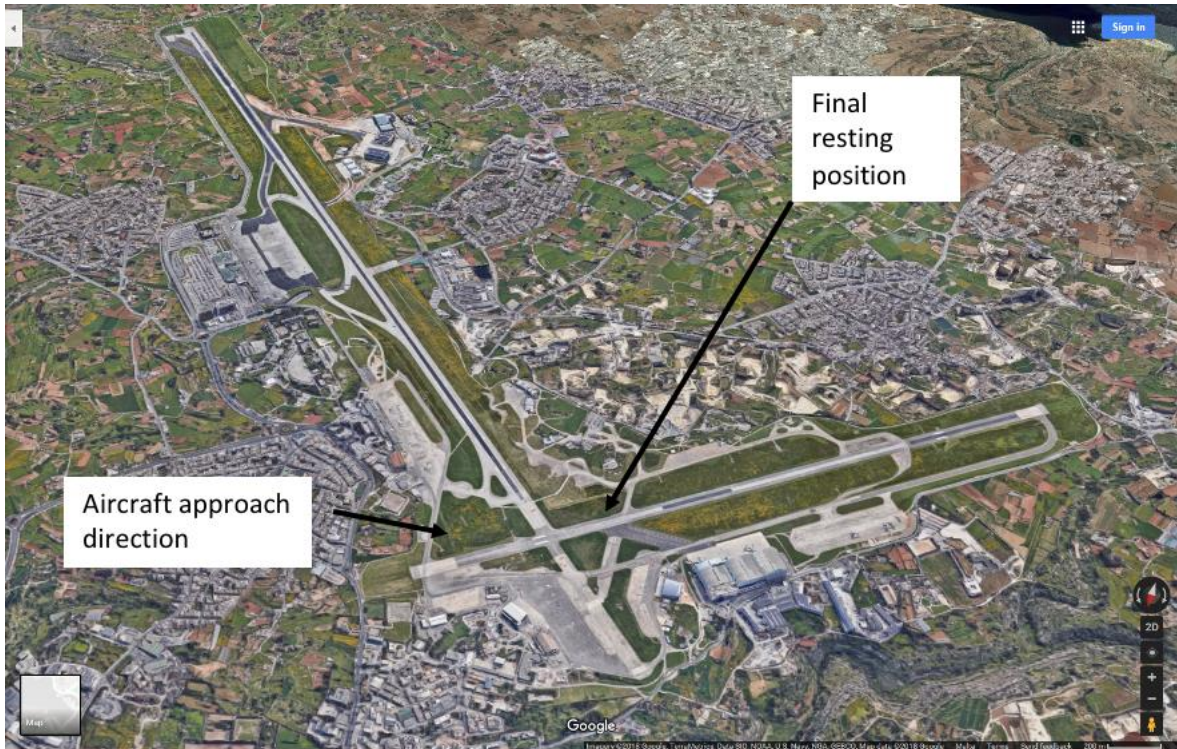
The aircraft was found on the grass just off the edge of RWY23 and at an angle to the RWY. The RWY showed marks of the propeller hitting the ground and of the nosewheel collapse. The aircraft right wing had scratching signs and suffered from a slight buckling at the leading edge.

Fig. 2: Overview of the airport with aircraft approach direction and final resting position.
