A technical review of the safety investigation report of the Fly Synthesis Amphibian aircraft, model: Catalina NG 582, registration number 9H-UTA

Summary and short description of the accident.

Aircraft: Fly Synthesis, Catalina NG 582 , Amphibian aircraft, registration no.: 9H-UTA.

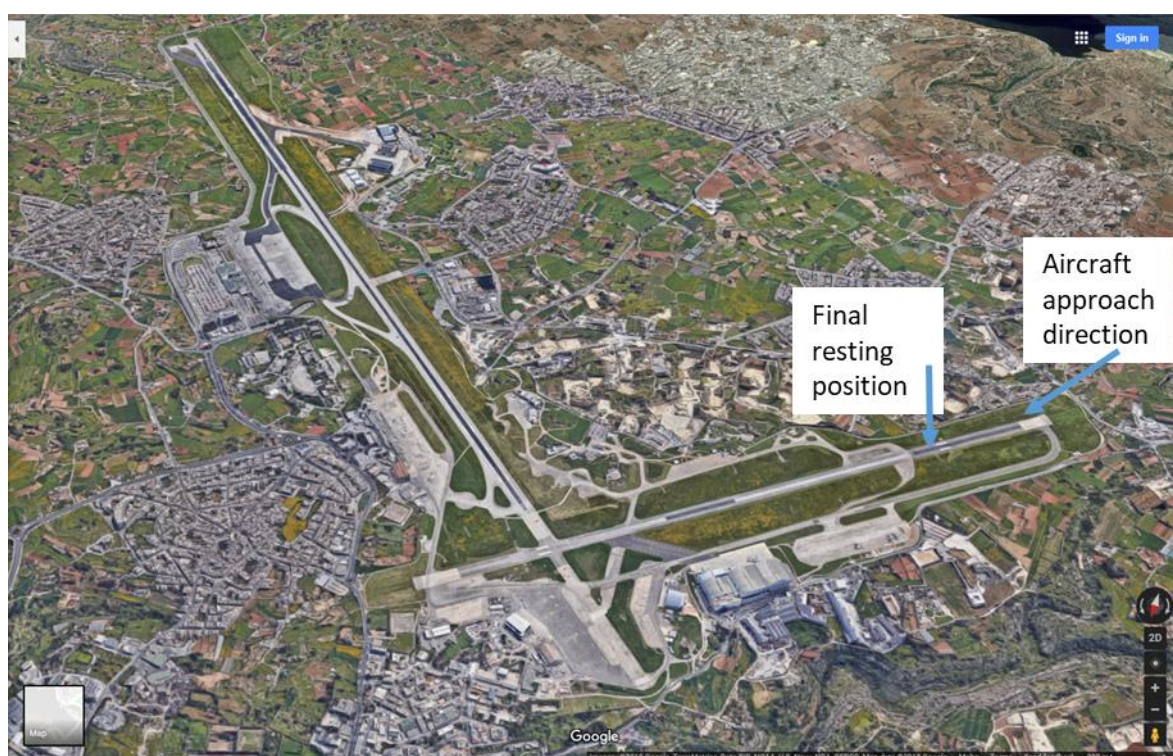
Location: RWY 05, Malta International Airport, Luqa as shown in Fig. 1.

Fig. 1. Overview of the runway with approx location of the final position.

On-site Evidence: The aircraft was found on the centre line of **RWY 05**, tilted to the right due to the retracted main wheel. Evidence of the touchdown position could be traced back from the surface scratches on the runway. It was estimated that the aircraft skid for approximately 107 m.
