Serious Incident Report

LOSS OF SEPARATION IN FLIGHT

AIRBUS A321-271NX HA-LVH

TECNAM P2002JF SIERRA 9H-VLT

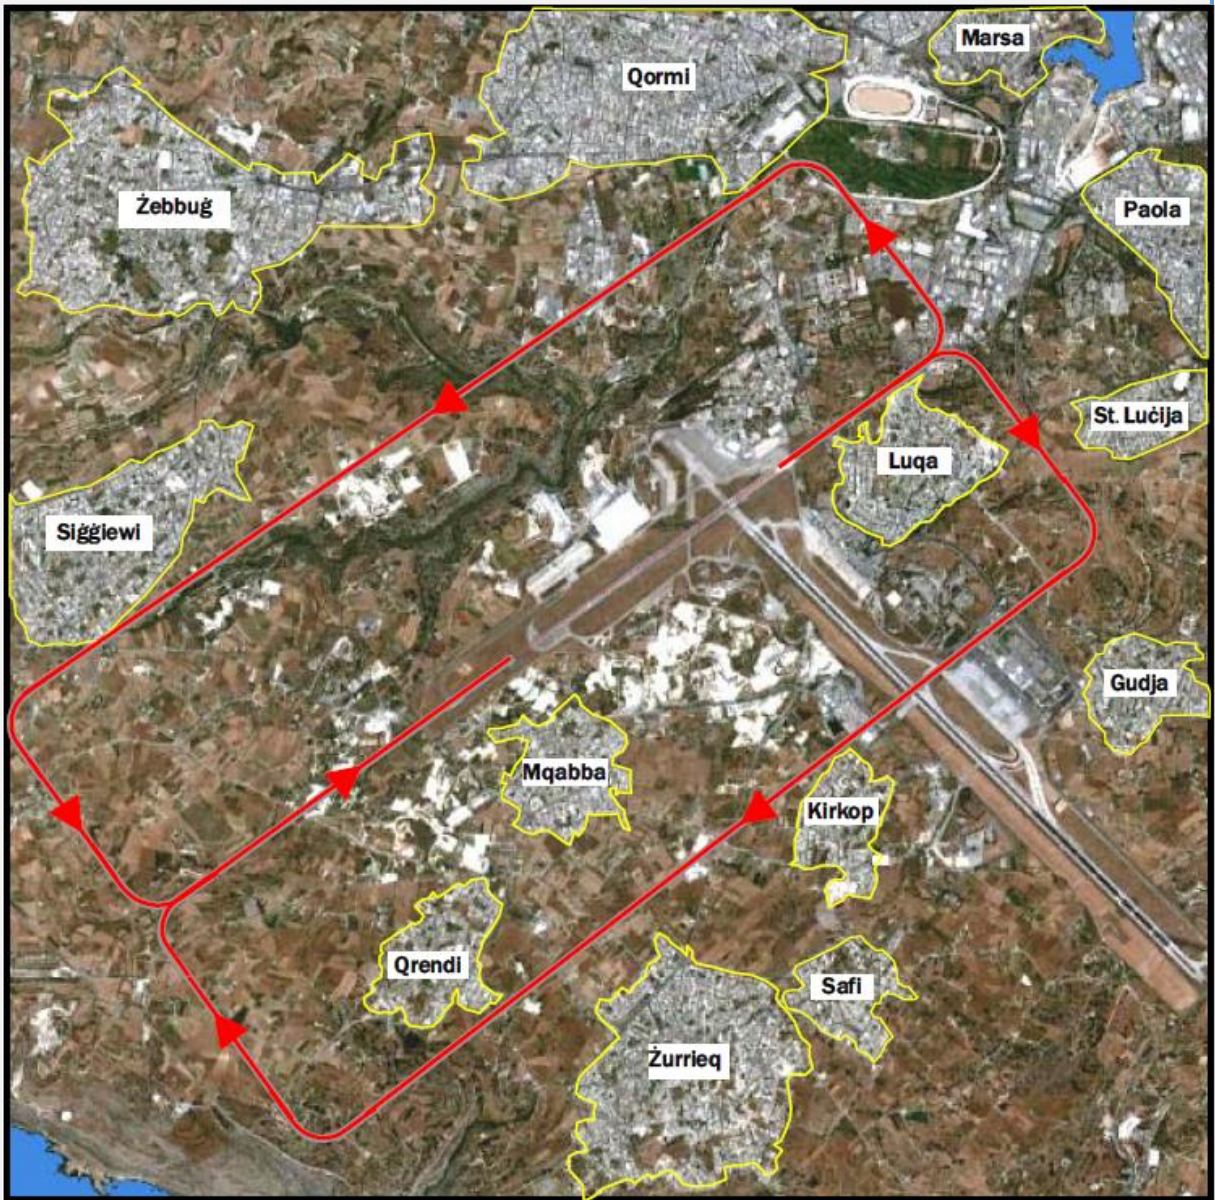
Figure 2: The circuit patterns on RWY 05 at LMML [Source: Malta AIP, AD2-LMML-MISC-VC1-1 03 APR 2014]

The standard visual circuit pattern on RWY 05 published in the Malta AIP is the right hand circuit, although variable (right or left) direction circuit patterns are applicable to light aircraft as instructed by ATC (Figure 2). Circuit altitude is restricted to 1,500 feet above

The continuous communication between ATC and other traffic whilst 9H-VLT was flying on the crosswind leg resulted in 9H-VLT flying a wide circuit, outside that defining the formal pattern (Figure 2). The extension of the cross-wind leg is, in itself, a manoeuvre that should not be a concern to the continued safety of a flight. In this context, however, it set in motion a chain of events that led to the incident.

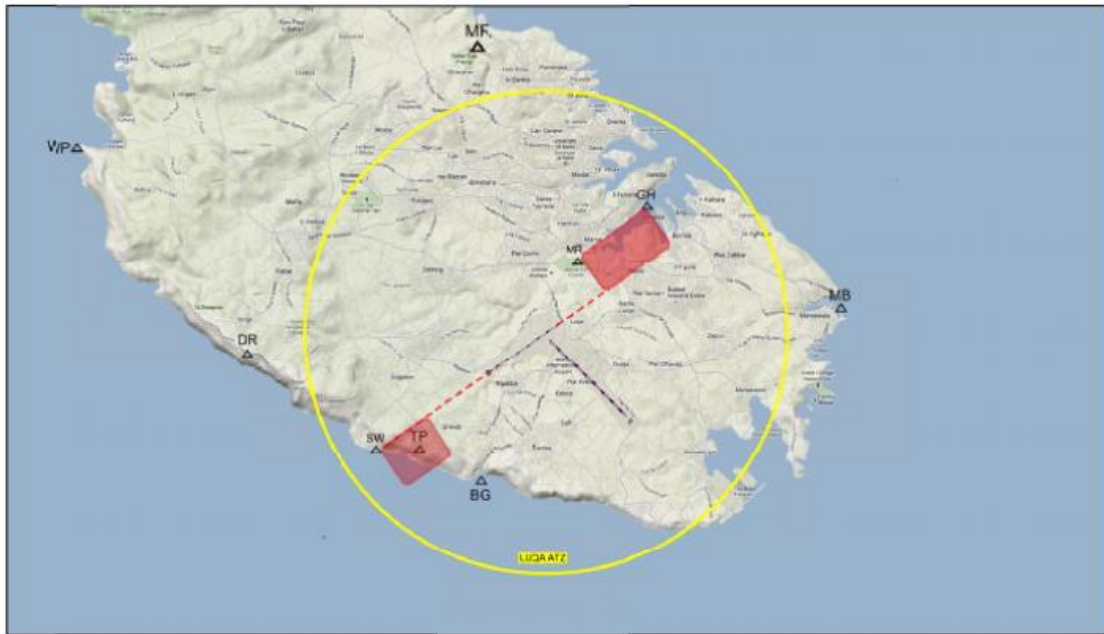
Figure 3: The Grand Harbour (GH) and Temples (TP) circuit holding areas [Source: Malta AIP, AD2-LMML-MISC-CHA1-1 03 APR 2014]

mean sea level (AMSL) or below unless otherwise instructed by ATC. In addition, the Grand Harbour and Temples designated circuit holding areas (Figure 3) are designed for holding light aircraft operating in the Luqa ATZ. Aircraft instructed by ATC to hold over these areas are considered as forming part of the aerodrome circuit traffic.
