**9H-AEB runway excursion at Malta International Airport  
1<sup>st</sup> November 2021**

<b>Location:</b> Malta International Airport	<b>Accident Number:</b> BAAI/SIR 011121
<b>Date &amp; Time:</b> 1 <sup>st</sup> November 2021, 15:00	<b>Registration:</b> 9H-AEB
<b>Aircraft:</b> Piper PA-34-200T Seneca II	<b>Aircraft Damage:</b>
<b>Defining Event:</b> Runway excursion during landing from RWY31	<b>Injuries:</b> No injuries Reported

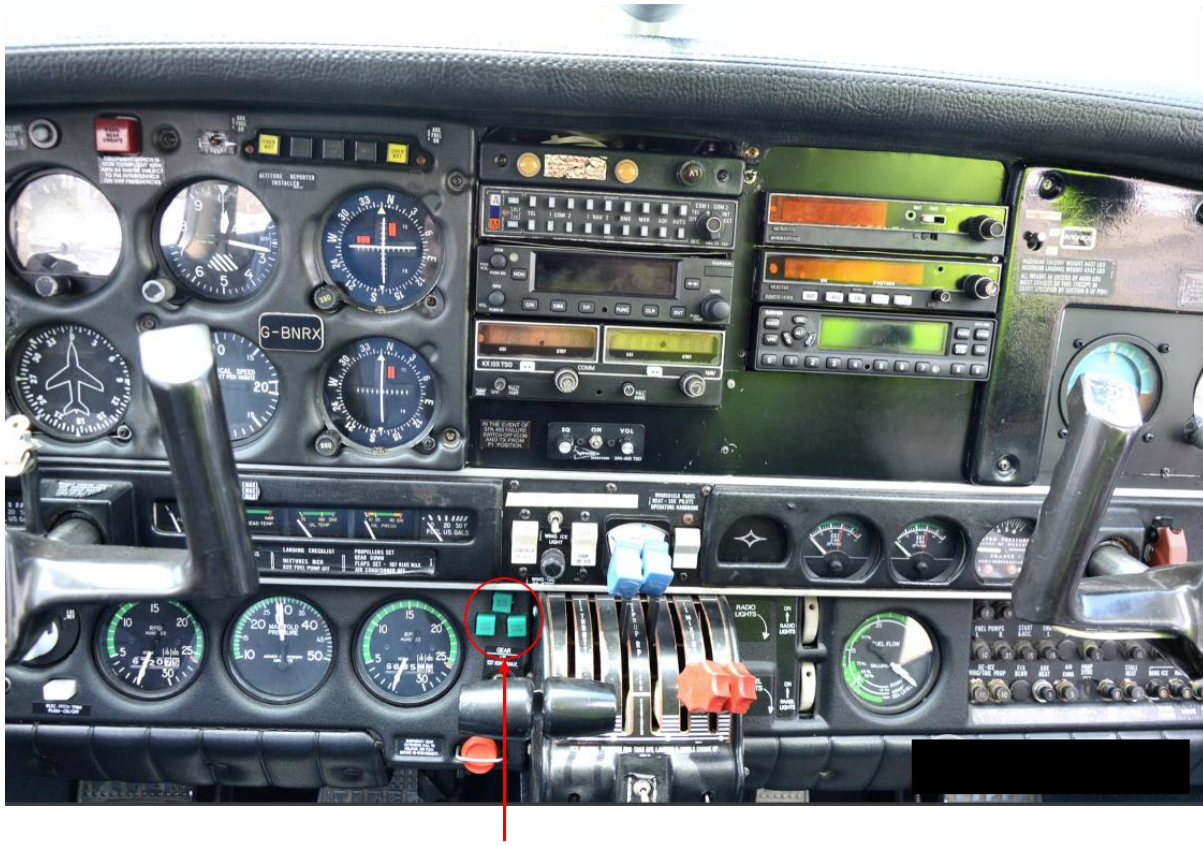
Fig. 5: Green lights indicating gear down and locked.

- 5.3 The aircraft is equipped with three green gear-down and locked lights as shown in Fig. 5 and a warning horn is sounded. These lights are connected to their respective DOWN limit switches on each gear and, when these operate, the lights illuminate.

Green lights on landing gear down and locked

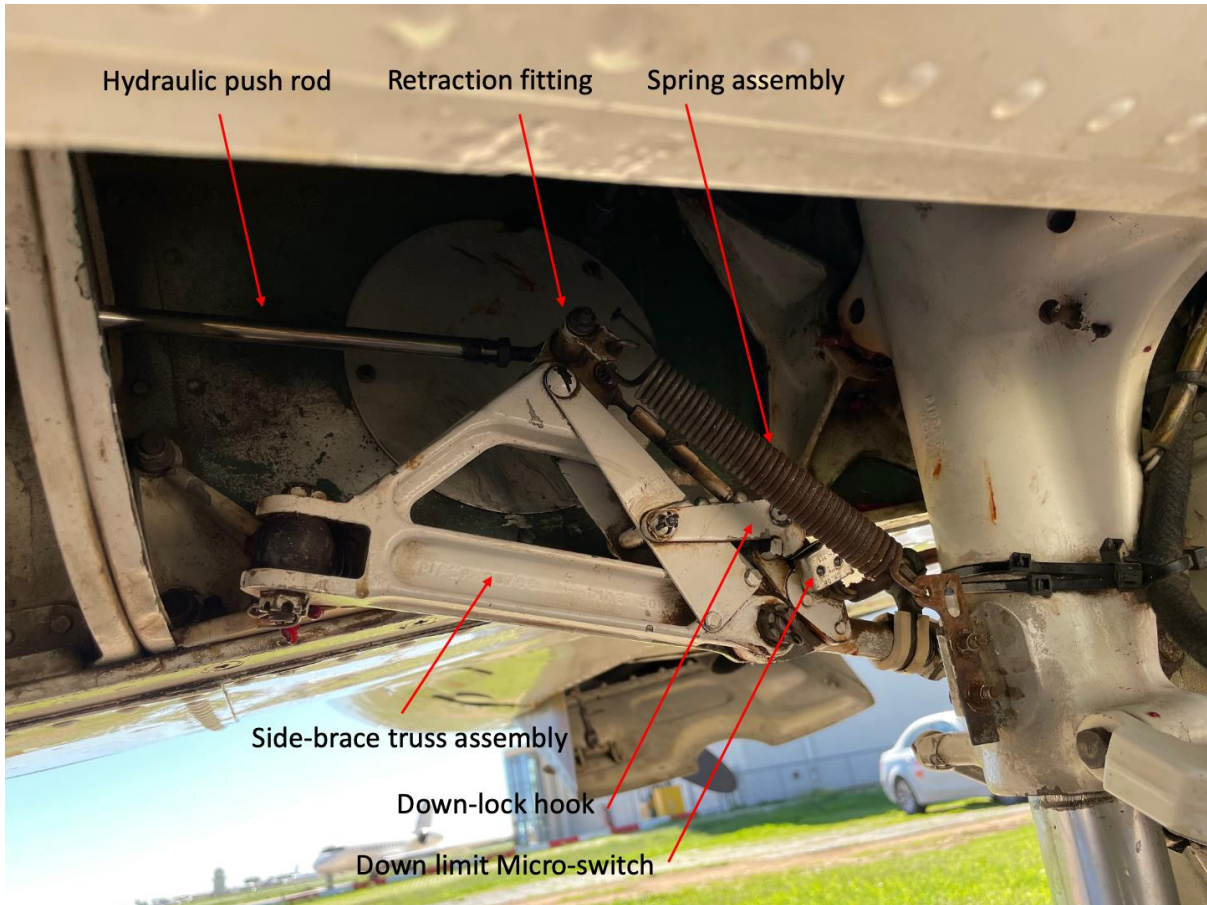
*Fig. 6. Photo of the landing gear assembly*

5.7 The nose landing gear doors are operated mechanically and close once the nose landing gear has retracted into its bay. As it does so, it applies upward pressure to a roller assembly in the roof of the nose landing gear bay. This assembly is connected by push rods to the doors and causes them to close as shown in Fig. 6.

5.14 The engineering section within the school offered no reason why the landing gear became stuck in an intermediate position. The fault was described as being intermittent, which may be more difficult to diagnose. It was highlighted that in the past there had been incidents in which the pressure goes down and the hydraulic pump switches on for a few seconds. This leads to a suspicion of a leakage in the hydraulic system. Piper suggested that this may also be due to a fault in the microswitch. Other potential causes may include an improper lubrication of the arm and centre springs which may be worn and do not lock into position. This investigation could not clearly identify the source of the engineering problem.

Since the fault may be intermittent, it is recommended that in the repair process, the hydraulics are inspected for leakages and the associated wiring, and electrical systems are inspected for any signs of dormant failures. As a precaution, it is suggested to consider changing the landing gear wiring and microswitches. Other moving and non-moving parts of the landing gear should be thoroughly inspected for correct operation.
