A safety investigation report for an A320-214 aircraft, Reg. No. 9H-AHS

A safety investigation report for the A320 aircraft,
Reg. No. 9H-AHS; incident involving fumes in the cabin.

Location: Malta International Airport	Accident Number: BAAI/SIR- 171122
Date & Time: 17 th November 2022, approximately 07:44 LT	Registration: Air Malta, Reg. No. 9H-AHS.
Aircraft: A 320-214, Reg. No. 9H-AHS	Aircraft Damage: No aircraft damage was reported at the time of landing.
Defining Event: Aircraft returned to Malta shortly after take-off due to fumes/vapour in the cockpit and forward passenger cabin.	Injuries: No injuries Reported

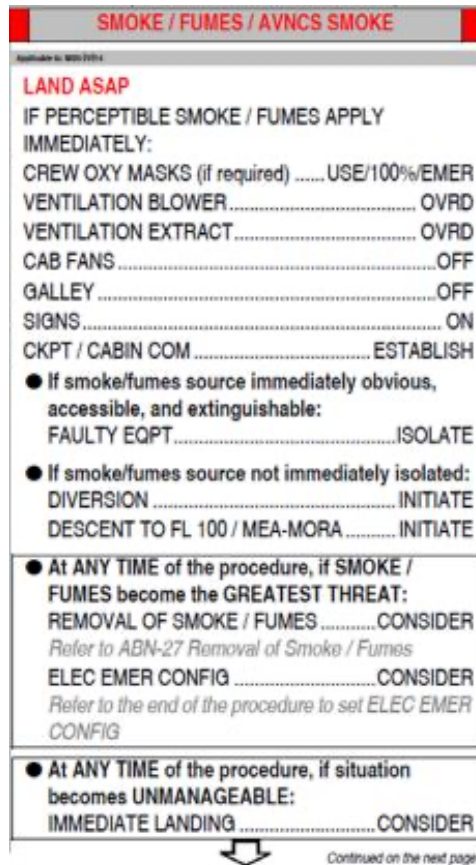
Fig 2. Airbus QRH

Airbus recommends that if smoke is detected without an ECAM warning, the crew should immediately consult the Quick Reference Handbook (QRH).

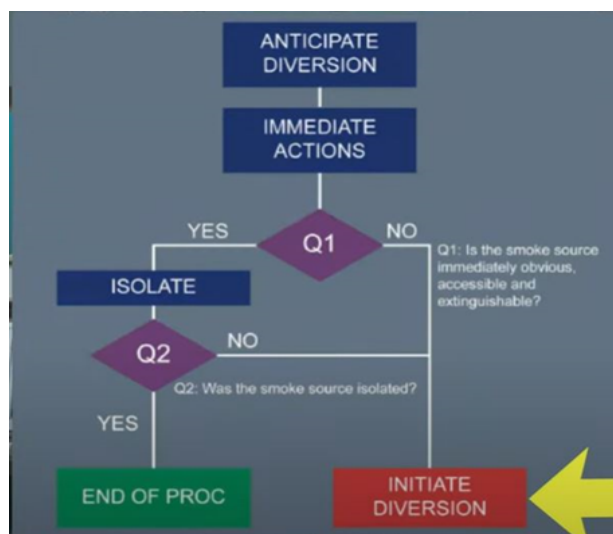
Fig 3. An Airbus suggested logical strategy for dealing with smoke and fumes problems.

Initially, the crew consulted the SMOKE/FUMES/AVNCS SMOKE checklist in the absence of ECAM warnings. As the fumes dissipated and considering the checklist was deemed too time-consuming, their focus turned towards landing the aircraft promptly. As a result, the crew focused on executing an overweight landing in order to minimize their time in the air.

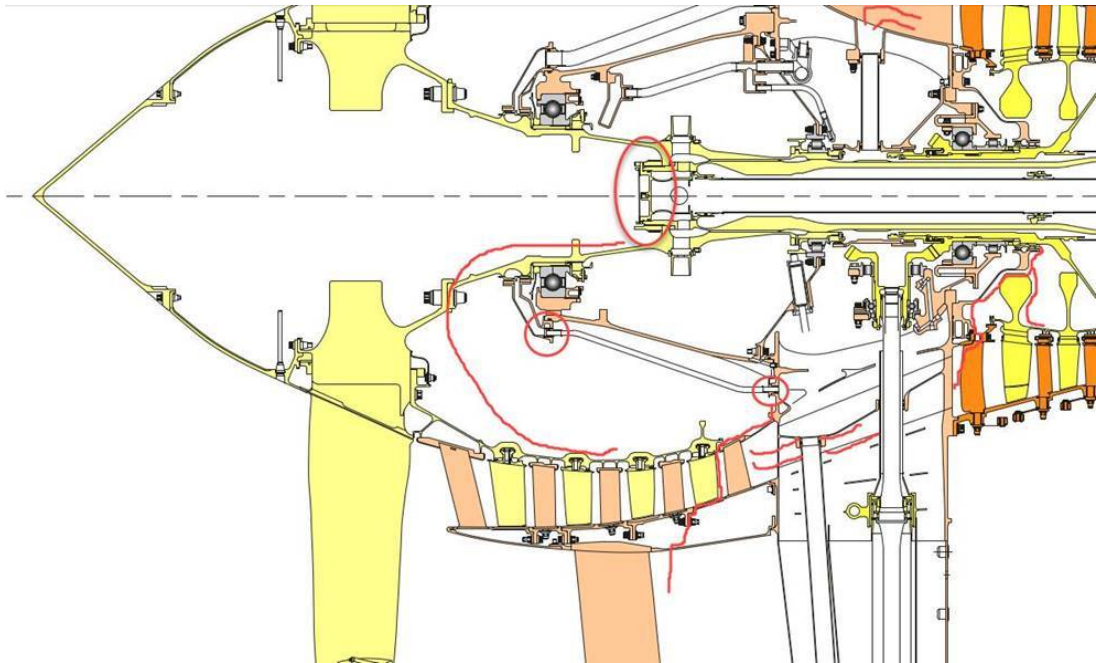
SPARE ENGINE CFM56-5B4/3 ESN 643943 BSI DUE TO CABIN OIL SMELL

2. Remove a Fan Disk bolt and inspect Bearing No.1 Stationary Seal body and seal area for obvious oil traces. Inspect inner Booster Spool area for fresh oil. Inspect the Fwd. Sump Scavenge / and Drain Tube for Oil drops/traces.

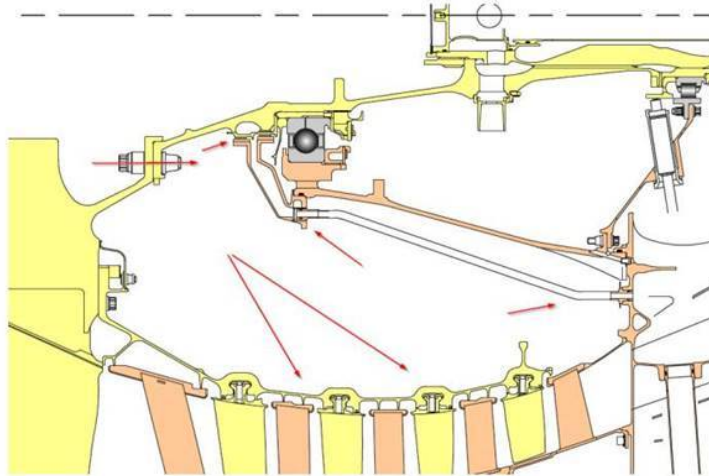
Bearing #1 seal and booster spool

- 1ea fan disk bolt must be removed

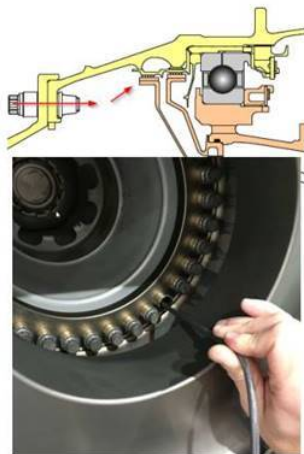
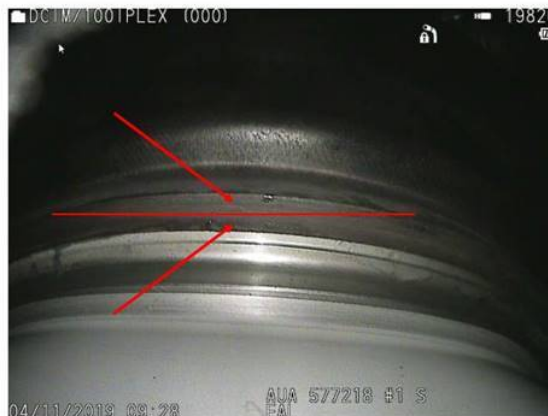
Bearing #1 seal

- Put the BSI (6mm flex / straight view) through the removed fan disk bolt to the fwd side of the bearing #1 seal area (No.1 Stationary Air/oil Seal) abrasible material.
- Turn the fan disk 360° to see the whole abrasible area. Take a video!

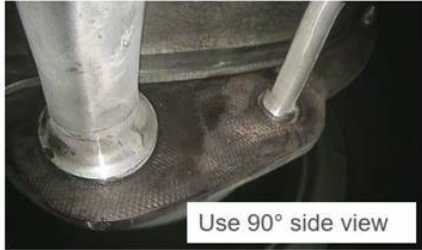
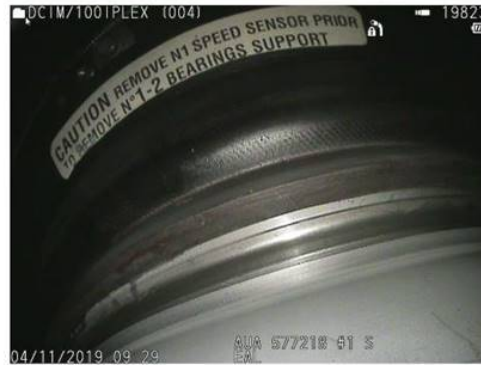
Bearing #1 seal

- #1 seal body, oil scavenge and #1 seal drain tube area.

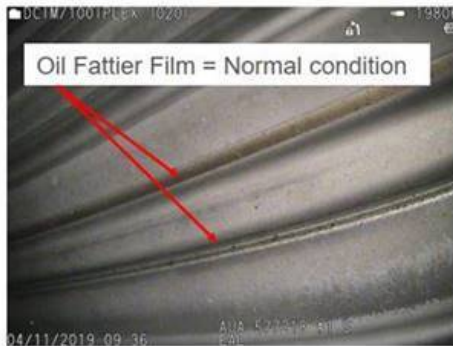
Booster Spool area and examples

- Use straight view.
- Oil fatter film is normal condition from the operation.
- Fresh oil is an oil leak indication from the #1 seal or oil tubes.

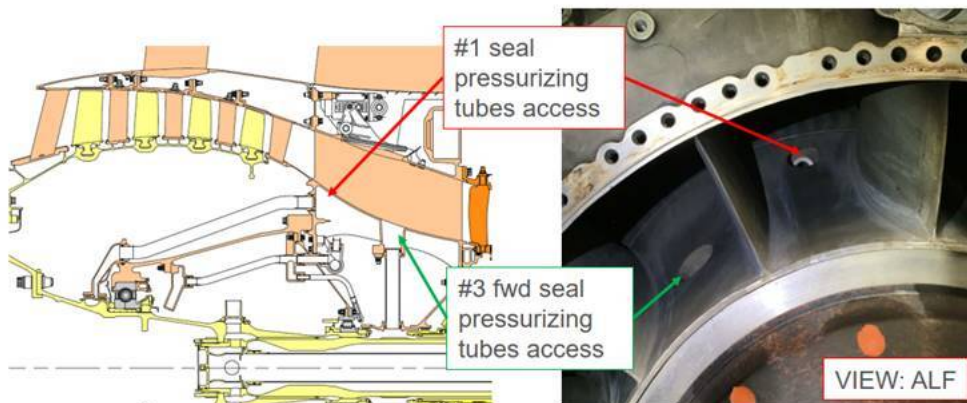
Fan Frame area locations

- The pressurizing tubes are located on the 1:30, 4:30, 7:30 and 10:30 o'clock position in the fan frame (Aft looking forward).
- Note: Also the #1 seal pressurizing tubes have there ports in the fan frame but in different locations and with different shapes
- Refer to next slides.

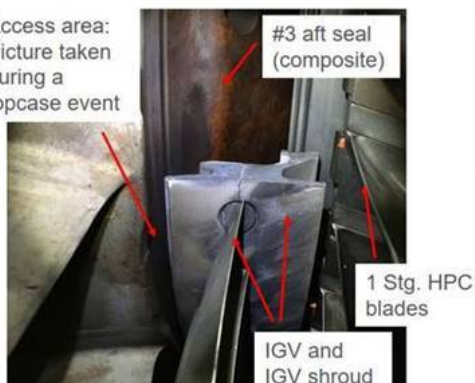
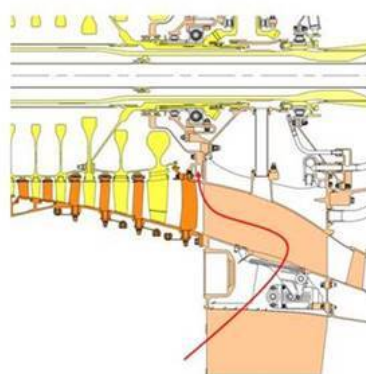
#3 Aft Seal Inspection

The #3 aft seal inspection (shown below) is not required again as it was already inspected and no oil wetness was found.

- Insert BSI trough VBV doors in 6 o'clock area and go trough the flowpath to the gap between the fan frame and the IGV shroud.
- Access is only possible if a composite #3 aft seal is installed.

Access area:
Picture taken during a
topcase event
